AIRPROX REPORT No 2015120

Date: 30 Jul 2015 Time: 1510Z Position: 5249N 00153W Location: ~ 5nm WNW Tatenhill

PART A: SUMMARY OF INFORMATION REPORTED TO UKAB

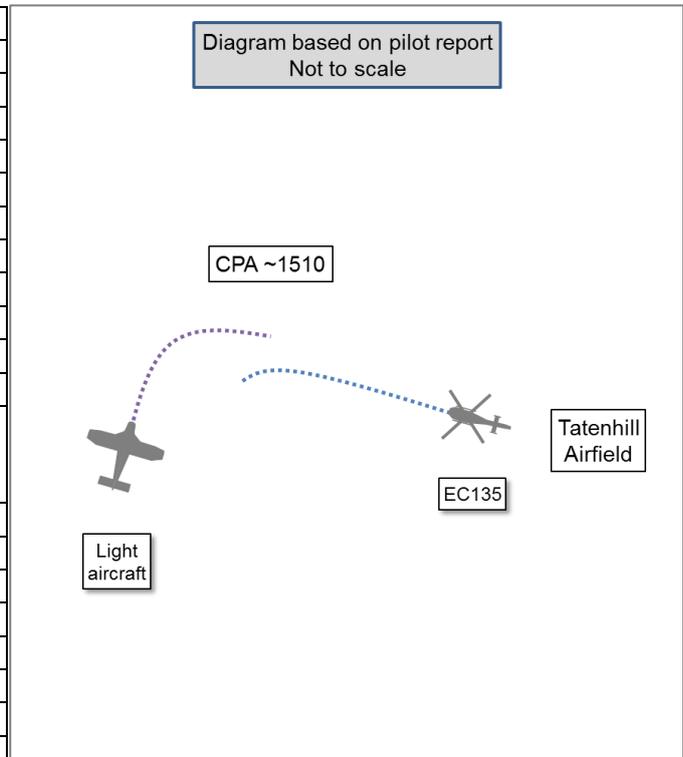
THE EC135 PILOT reports departing Tatenhill on a HEMS tasking. Shortly after departure another aircraft was seen at a range of 3nm, passing left to right and higher than their level altitude. He called the traffic to the helicopter crew for observation; it appeared to be tracking slightly behind. Having just left Tatenhill frequency, he called Birmingham Radar for a Basic Service and reported the other traffic in case its pilot was also working the Birmingham frequency. The other 'Robin like' aircraft was then observed to roll abruptly right and descend towards their current track, towards Tatenhill. Avoiding action was taken by rolling left away from the conflict, with the other aircraft passing close down the starboard side on a reciprocal course. The Airprox was initially reported on Birmingham Radar frequency with a follow up call by telephone later.

He assessed the risk of collision as 'High'.
