## IRPROX REPORT No 2015124

Date: 3 Aug 2015 Time: 1532Z Position: 5343N 00235W Location: 10nm ESE Warton

### PART A: SUMMARY OF INFORMATION REPORTED TO UKAB

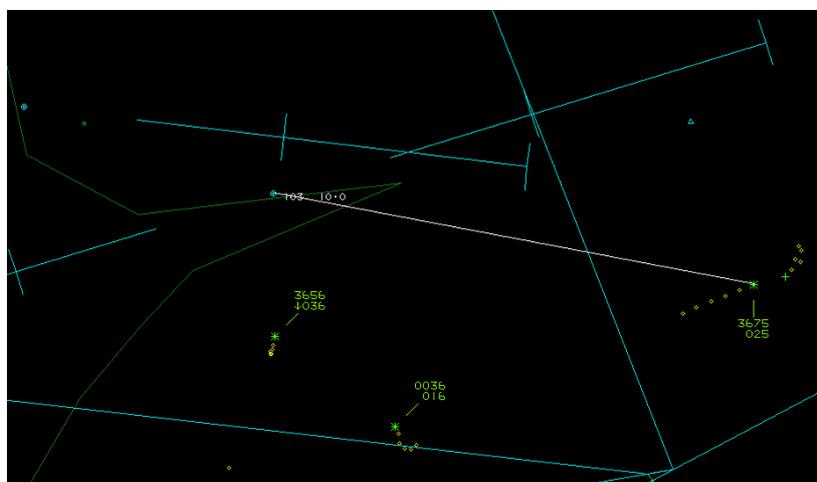
Figure 2: Swanwick MRT at 1532:02  
(depicting range from Warton and unknown aircraft ahead of the Typhoon)

At 1532:02, the controller issued a left turn to the Typhoon onto a left-base leg. This instruction was given when the Typhoon was 10nm from Warton. The pilot immediately reported sighting an aircraft approximately 200ft above and to the right. Figure 2 shows the range from Warton to the Typhoon (displaying code 3675) and also depicts another aircraft in apparent close proximity. The controller advised that there was nothing observed on radar and had to repeat the heading instruction as the Typhoon pilot requested the instruction again. [UKAB Note: although the unknown aircraft appeared on the Swanwick MRT replay, it may not necessarily have been displayed on the Warton radar].

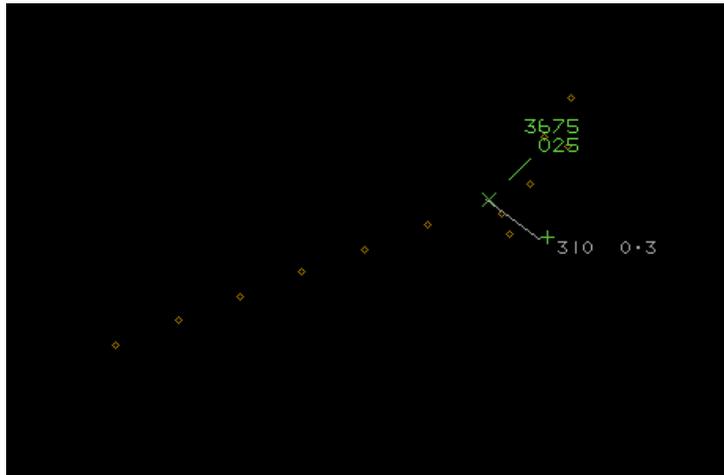
Figure 3: CPA - Swanwick MRT at 1532:07

The CPA with the unknown contact occurred at 1532:07 (Figure 3).
