AIRPROX REPORT No 2015128

Date: 10 Aug 2015 Time: 1015Z Position: 5251N 00246W Location: Sleep ATZ

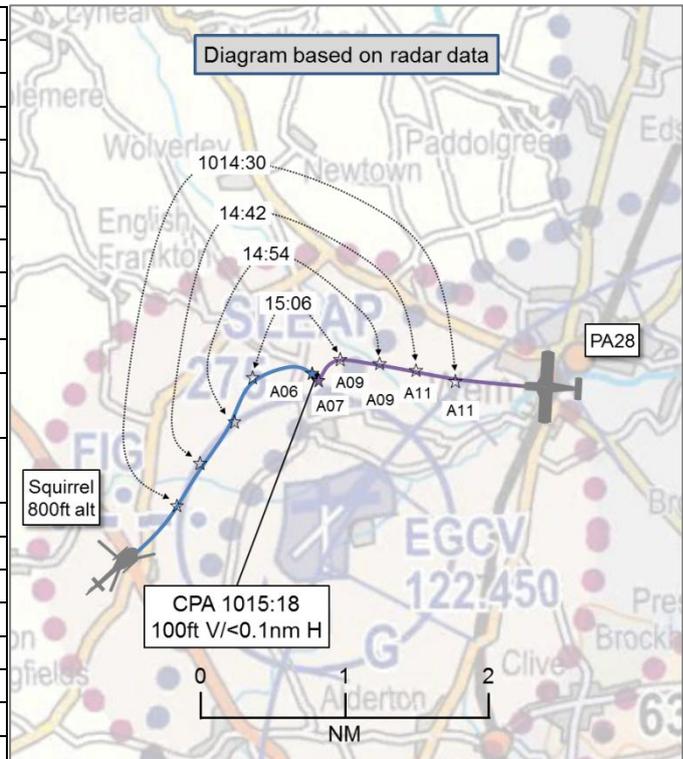
Recorded	Aircraft 1	Aircraft 2
Aircraft	Squirrel (AS350)	PA28
Operator	HQ Air (Trg)	Civ Trg
Airspace	Sleep ATZ	Sleep ATZ
Class	G	G
Rules	VFR	VFR
Service	A/G	A/G
Provider	Sleep	Sleep
Altitude/FL		
Transponder	A, C, S	A, C, S
Reported		
Colours	Black/yellow	White/dark blue/red
Lighting	Landing, HISLs, LED position	Strobes
Conditions	VMC	VMC
Visibility	20km	>10km
Altitude/FL	350ft	~300ft
Altimeter	QFE (1007hPa)	QFE (NK hPa)
Heading	100°	180°
Speed	70kt	85kt
ACAS/TAS	TAS	PowerFLARM
Alert	TA	None
Separation		
Reported	~75ft V/140m H	Not seen
Recorded	100ft V/<0.1nm H
