AIRPROX REPORT No 2015131

Date: 31 Jul 2015 Time: 1020Z Position: 5145N 00111W Location: Oxford

PART A: SUMMARY OF INFORMATION REPORTED TO UKAB

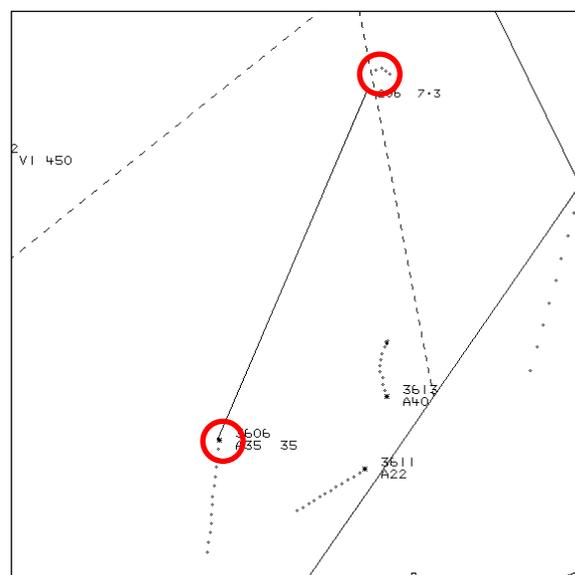
Figure 1: Traffic Information at 1017:21

The incident occurred on 31 Jul 15 at 1020, 5nm north of RAF Benson. The Airprox was between a DA42 and a glider; the DA42 was on handover between RAF Benson and RAF Brize Norton requesting a Traffic Service. The Radar Analysis Cell captured the incident at 1019:46 with 0.1nm horizontal separation based upon the London QNH of 1020 hPa. At 1016:57, Benson called Traffic Information on a non-Airprox Benson squawk and then provided more information at 1017:31 (Figure 1) as, "traffic right one o'clock six miles opposite direction, no height information."

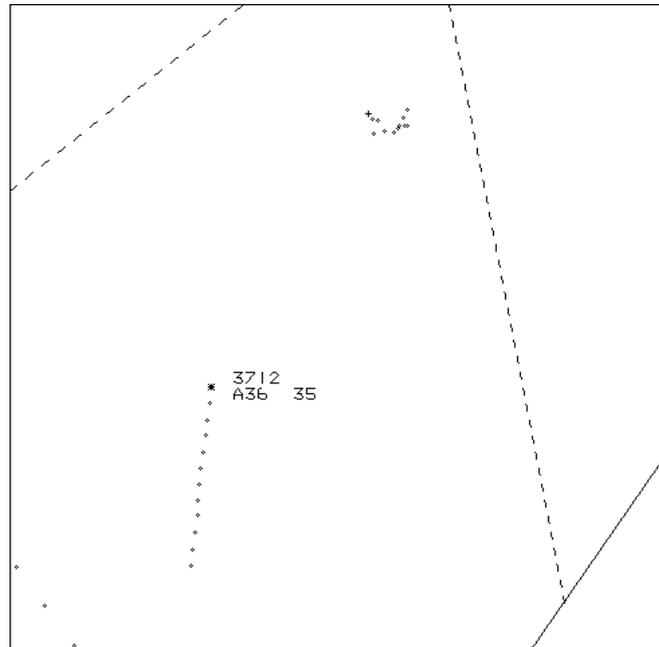
Figure 2: Geometry at 1018:43

At 1018:10, a squawk of 3712 was allocated to the DA42 for a radar handover to Brize and, at 1018:43 (Figure 2); the Brize frequency was passed to the crew, which was acknowledged correctly by the aircrew at 1018:54.

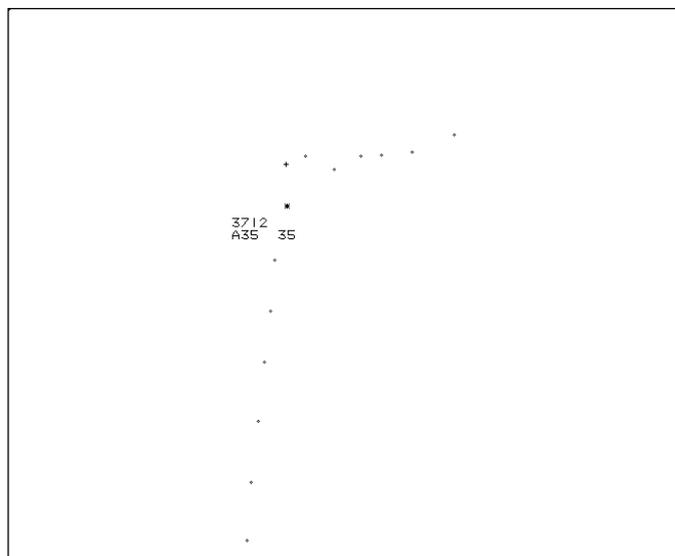
Figure 3: CPA at 1019:46

The CPA was at 1019:46 (Figure 3), however, the DA42 crew did not contact Brize Radar until 1021:36; they were immediately identified for a Traffic Service.

Benson ATC passed relevant and timely Traffic Information, as required under the conditions of a Traffic Service and for fulfilling the rules of a radar handover. The DA42 pilot was sent to Brize at 1018:43 but did not call the unit until 1021:36. The Airprox occurred after the Benson Traffic Service had terminated and before the DA42 pilot had agreed a Traffic Service with Brize radar. The delay in contacting Brize meant that the crew could not obtain an update on traffic. The DA42 crew had a TAS, but this did not provide information on the non-transponding glider. The crew became visual at a reported range of 0.25nm and, as the respective aircraft were not on a collision course, no avoiding action was taken.
