**AIRPROX REPORT No 2015140**

Date: 15 Aug 2015 (Saturday) Time: 1250Z Position: 5558N 00356W Location: Cumbernauld

**PART A: SUMMARY OF INFORMATION REPORTED TO UKAB**

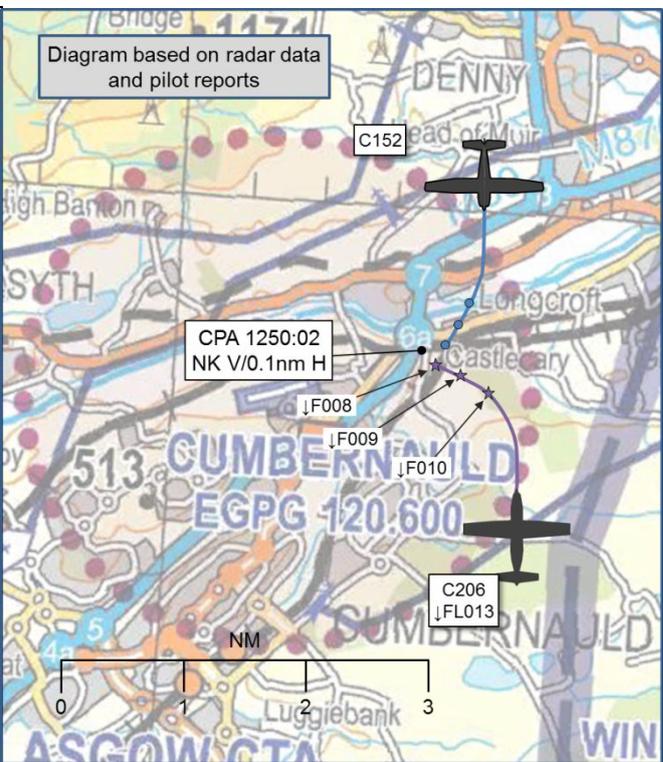
**THE C152 PILOT** reports that he was flying with a student in the Cumbernauld circuit using the active runway, RW26RH. Whilst on the crosswind leg, he heard the pilot of the C206 make a call to join from the south. He heard the airfield information being passed, including the runway in use, and that the C206 pilot stated that he would join downwind. The C206 pilot later changed this to a 'non-standard' left-base join. By this time, the C152 pilot was right base, having made the appropriate call, and was about to turn final when he saw the C206 on a reciprocal, closing heading. The other pilot then appeared to see the C152 and cut across in front of them to turn onto final. To avoid the potential collision the C152 pilot broke right.

**THE C206 PILOT** reports that the two aircraft involved were both in communication with each other on the radio and were visual with each other. Both arrived on finals at different levels and distances, and the C206 pilot elected to go around allowing the other aircraft to land first even though he was in front and faster. In his opinion flight safety was maintained at all times but, had the C152 pilot extended downwind for 30 seconds, both pilots could have achieved their aim. He also opined that overhead joins at Cumbernauld were not ideal for a number of reasons, 2000ft above Cumbernauld is often above cloud level, to avoid noise nuisance over the built-up area on the deadside, and for fuel efficiency.

In determining the cause of the Airprox, the Board quickly agreed that the C206 had flown into conflict with the C152, and that a contributory factor was that he had not complied with the promulgated Cumbernauld joining procedure. That being said, the C206 pilot had been visual with the C152 at all times; therefore, there was no likelihood of collision and, in determining the risk, the Board agreed that this was a Category C incident.

Cause: The C206 pilot flew into conflict with the C152.

Contributory Factor(s): The C206 pilot did not comply with the promulgated Cumbernauld joining procedure.

Degree of Risk: C.
