AIRPROX REPORT No 2015170

Date: 22 Sep 2015 Time: 16:35Z Position: 5153N 00126W Location: 6nm WNW of Oxford

PART A: SUMMARY OF INFORMATION REPORTED TO UKAB

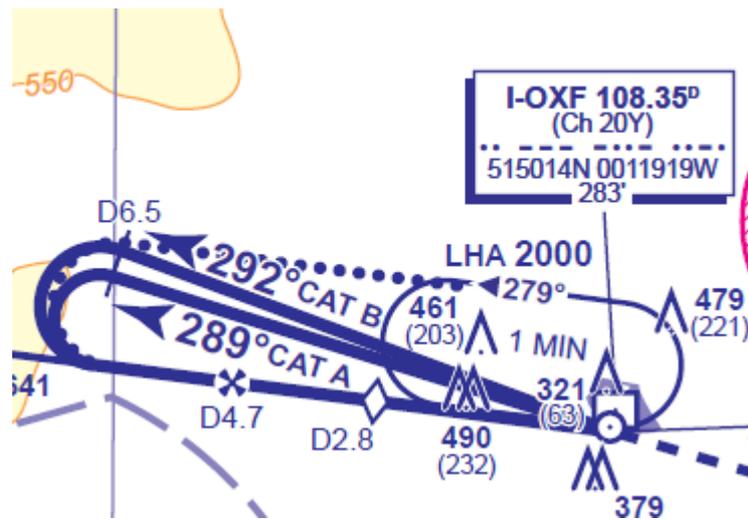
Figure 1: Oxford NDB (L) / DME 099° Procedure to Aerodrome

The DA42 (SSR code 0221) was operating on an instrument flight training detail and was in receipt of a Procedural Service from Oxford Approach. The DA42 was flying the Oxford NDB/DME 099° alternate procedure (the dotted track at Figure 1) to a missed approach. The runway in use at the time was RWY01. The DA42 pilot had commenced the approach by extending the outbound leg of the 'OX' hold; he reported beacon outbound at 1633:40, and reported the Airprox just before the end of the outbound leg. The procedure is a non-precision approach to the aerodrome, ending with a visual circling manoeuvre to Runway 01.

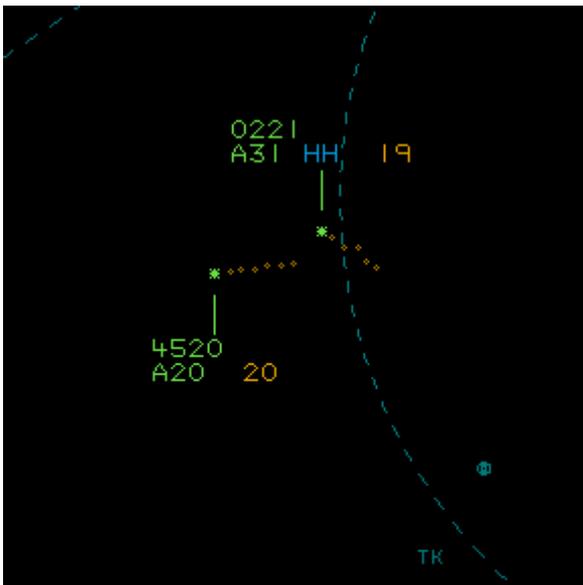
Figure 2: Swanwick MRT at 1634:19

The C182 had been tracking to the west (Figure 2), but tracked northbound (Figure 3) until just prior to CPA, which occurred at 1635:55 (Figure 4) when the DA42 passed astern of the C182 as this aircraft tracked away to the northwest.

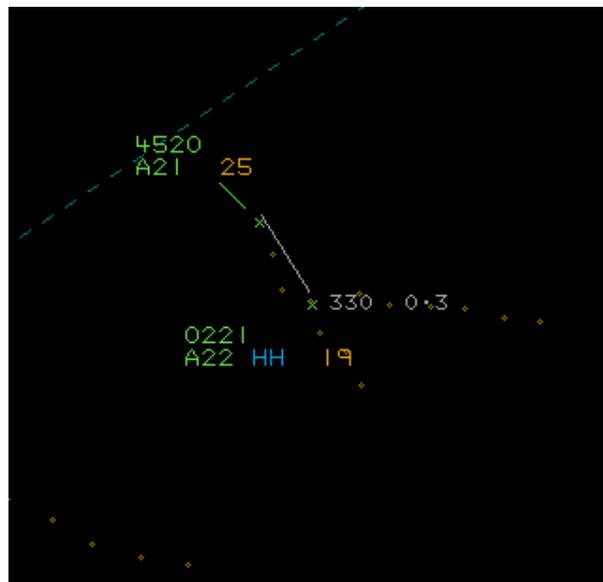
Figure 4: Swanwick MRT at 1635:55 (CPA)

In the end, the Board determined that although this incident had met the criteria for the reporting of an Airprox, the circumstances were such that normal safety parameters had pertained throughout given that the DA42 pilot had visually acquired the C182 at an early stage and had maintained it in sight at all times. They classified this incident as a sighting report and agreed that the risk was category E.

Cause: A sighting report.

Contributory Factor(s): No traffic information from the Air Traffic Controller.

Degree of Risk: E.

Recommendation(s): Oxford review their procedures to ensure they fully deconflict the Instrument Approach Procedures and VFR departures.
