AIRPROX REPORT No 2015175

Date: 2 Oct 2015 Time: 1055Z Position: 5316N 00052W Location: Headon Airfield

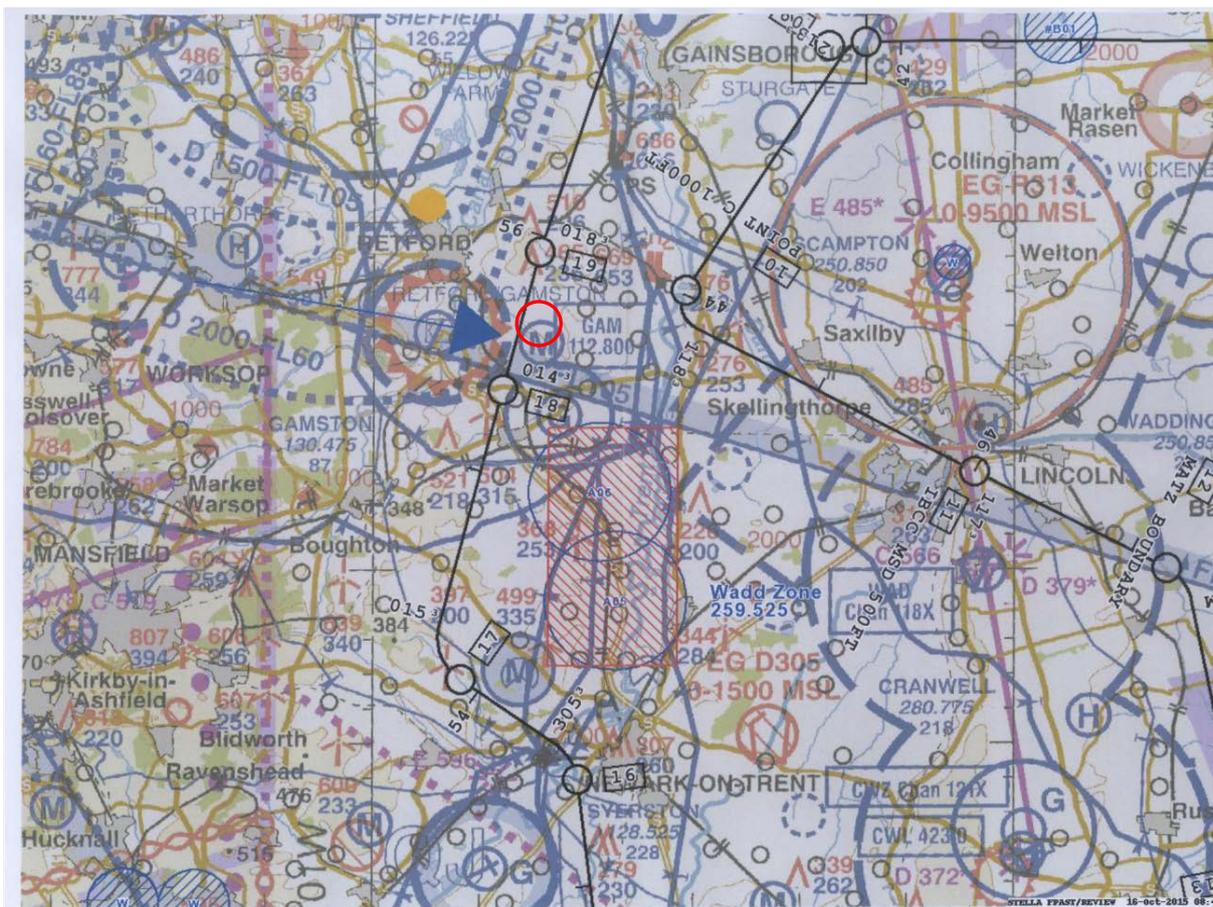
Figure 1

The unit involved conducted an Occurrence Safety Investigation (OSI) and noted that the coordinates given in the Mil AIP UKLFHB places the airfield approx. 0.5nm NNW of the depicted location, which contributed to the Tornado flying closer to the airfield than the pilot planned (Figure 1, the pilot's planned route with the site as annotated and the actual position of the microlight site shown in red). The OSI also considered a number of other factors, including: the suitability for low-level routing in the particular portion of the UK Low Flying System (LFS), the benefits of electronic conspicuity for GA, the importance of NOTAM'd and correctly plotted activity, a review of lookout procedures and a potential introduction of a VHF LL common frequency across the entire country. The incident was widely promulgated throughout the fast-jet community.
