**AIRPROX REPORT No 2015196**

Date: 30 Oct 2015 Time: 0619Z Position: 5117N 00023W Location: Ockham hold

**PART A: SUMMARY OF INFORMATION REPORTED TO UKAB**

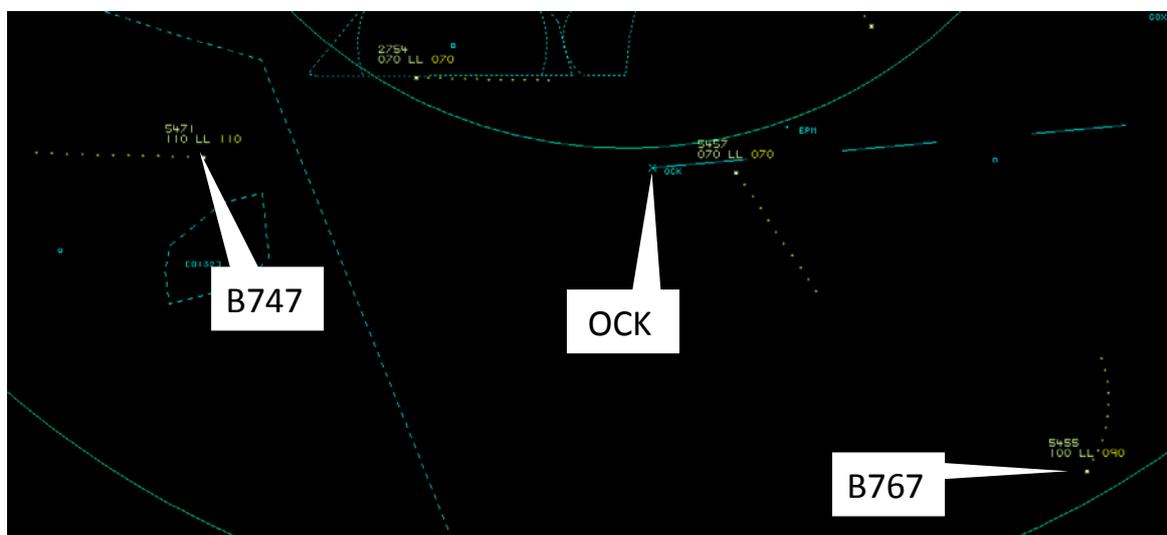
Figure 1 – 0616:15

At 0616:15, the B767 pilot (code 5455), who was established in the OCK Hold at FL100, was given descent clearance to FL90 by the Heathrow Intermediate (INT) controller. The B747 (code 5471) pilot was still with the TC South controller, routing towards the OCK Hold, maintaining FL110 (Figure 1).

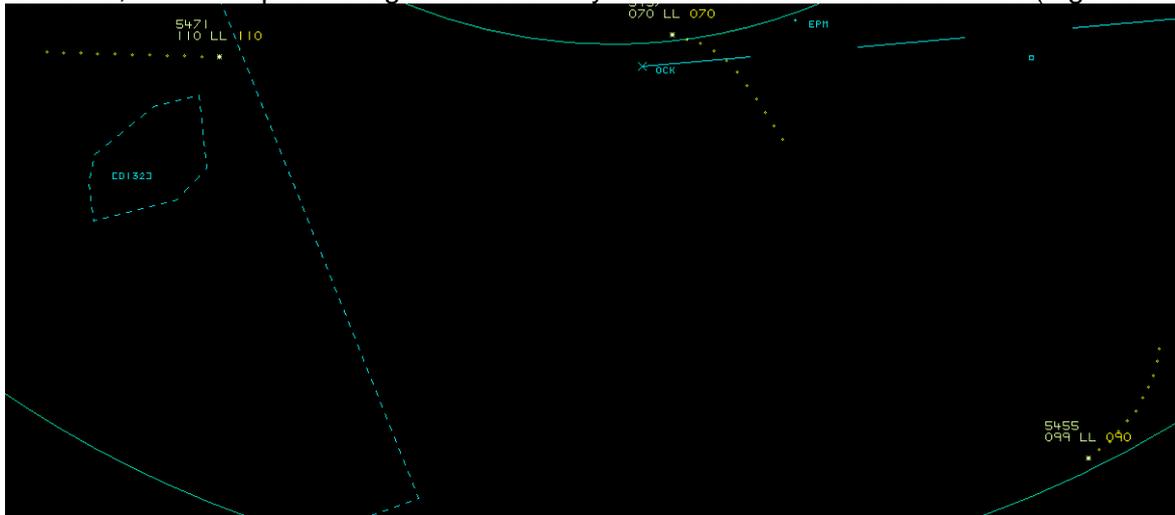
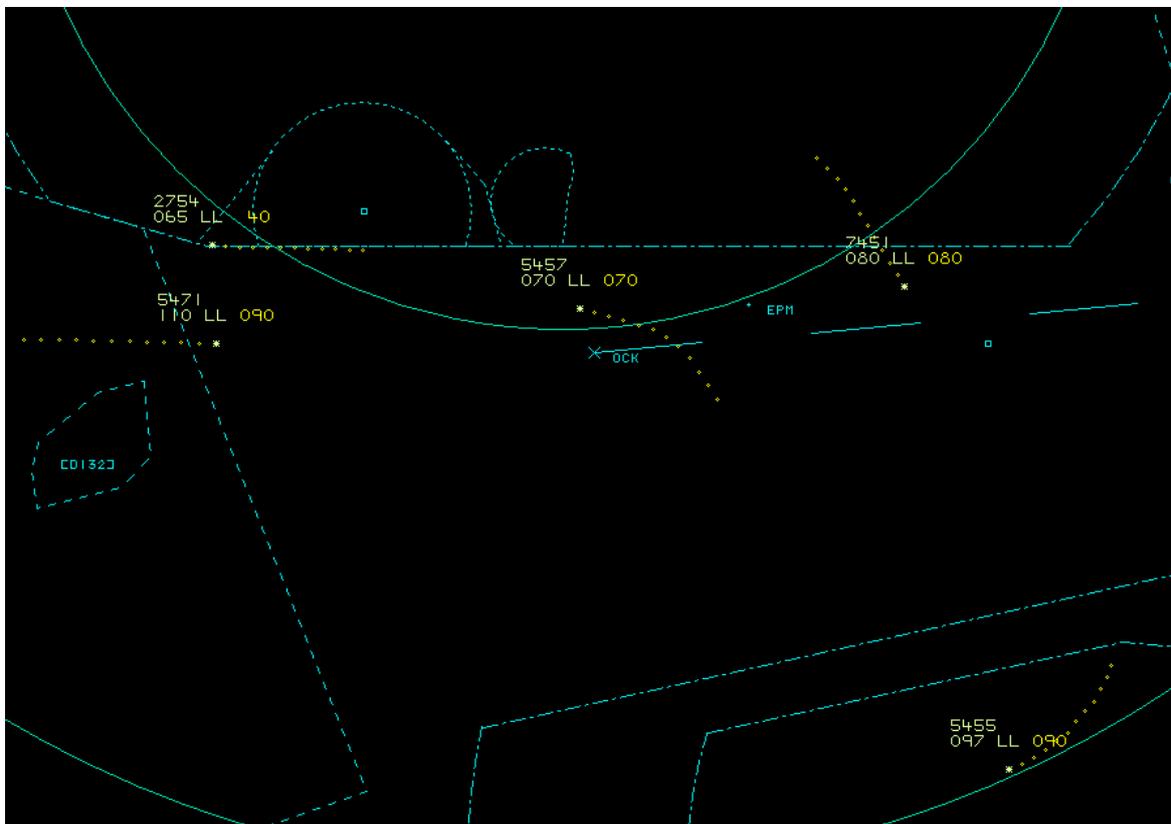
Figure 2 – 0616:45

At 0616:45, the B747 pilot was given descent by the TC South controller to FL90 (Figures 2 & 3).

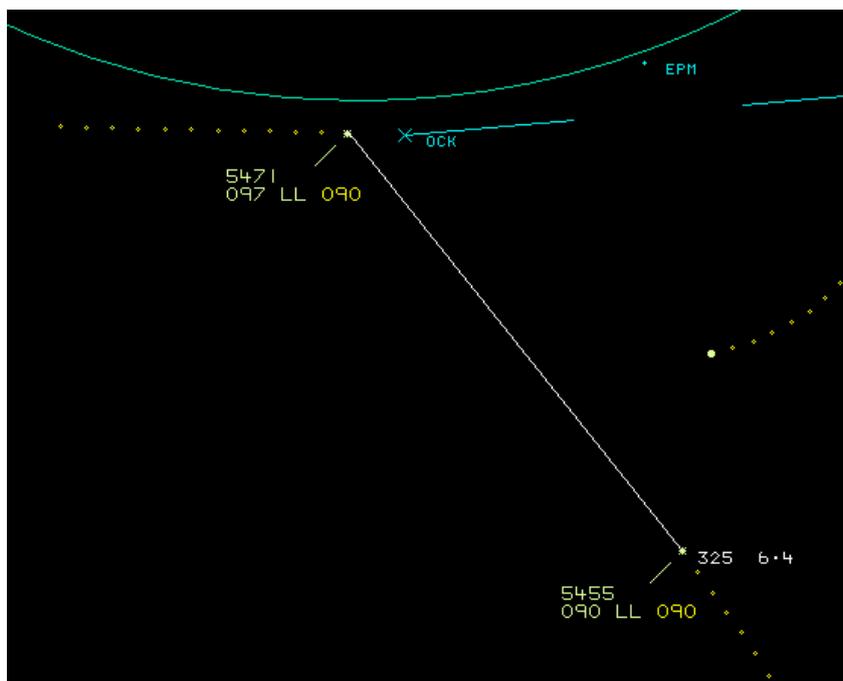
Figure 4 – 0618:35

At 0618:24, a Short Term Conflict Alert (STCA) was initiated, although it was cancelled at 0618:32, but at 0618:35, the Heathrow INT controller instructed the B747 pilot, then passing FL97 and just about to pass overhead the OCK VOR, to make a left turn onto heading 360°, advising him “that’s avoiding action”. The B747 pilot was informed about traffic south of him by 4nm. The B767 was 6.4nm southeast of the B747, maintaining FL90 (Figure 4).

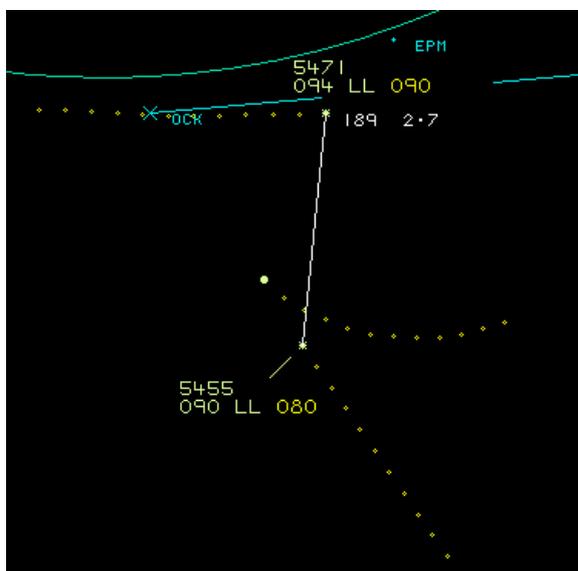
Figure 5 – 0618:45

At 0618:45, the Heathrow INT controller instructed the B767 pilot to expedite descent to FL080 (Figure 5).

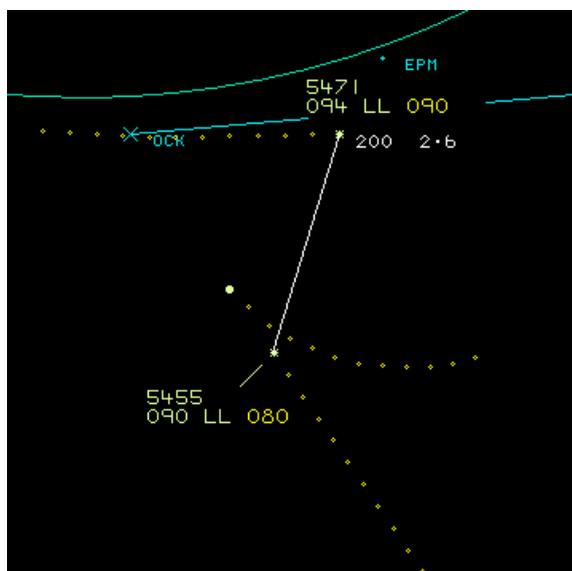
Figure 6 – 0618:56

CPA took place at 0618:56, with the aircraft separated by 2.6nm horizontally and 400ft vertically (Figure 6). [The B767 pilot was instructed to continue on his present heading at 0619:00.]
