AIRPROX REPORT No 2015215

Date: 31 Oct 2015 Time: 1149Z Position: 5154N 00210W Location: Gloucestershire Airport

PART A: SUMMARY OF INFORMATION REPORTED TO UKAB

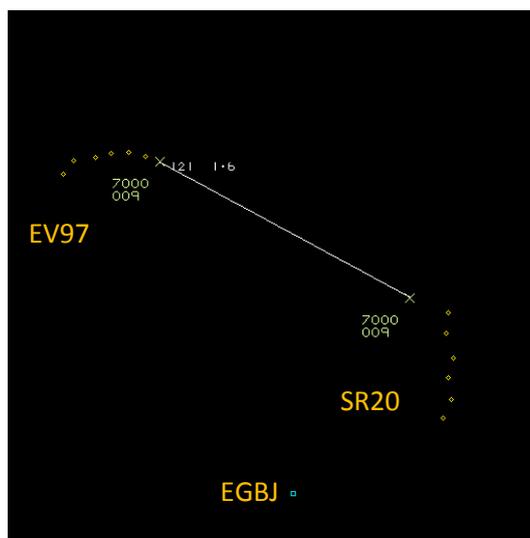
Figure 1: Swanwick MRT - 1148:10

At 1146:30, the Gloucestershire Tower controller asked the EV97 pilot if he was visual with the RF6, to which the EV97 pilot replied that he was. The controller then offered the EV97 pilot a right-hand orbit for spacing which was accepted by the pilot. The SR20 pilot had completed his go-around and, at 1148:10, as he turned downwind left-hand, the controller passed Traffic Information on the EV97, now midway through its orbit (Figure 1).

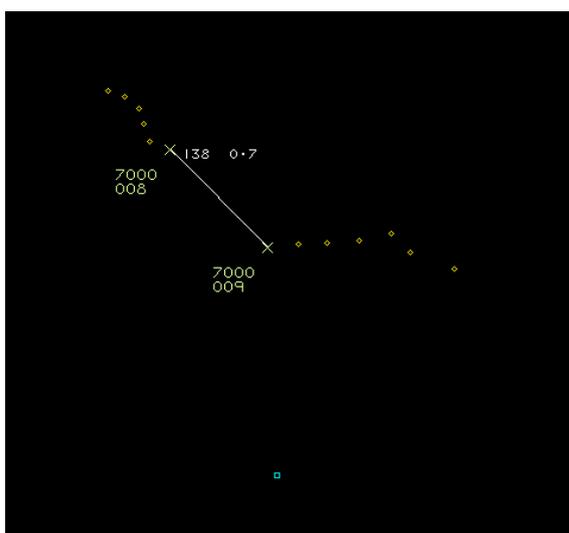
Figure 2: 1148:30

The SR20 pilot acknowledged this information and made his downwind call. The controller passed further Traffic Information on the EV97, offering the SR20 pilot the choice of widening out their circuit, or completing a right-hand orbit. The SR20 pilot elected to complete an orbit (Figure 2).

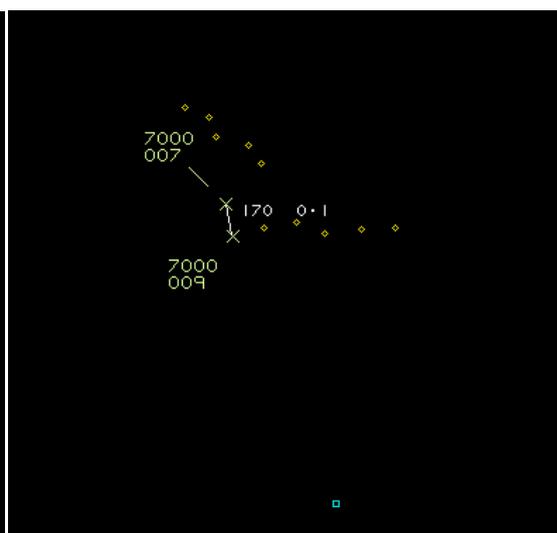
Figure 3: 1148:43

CPA was assessed as having taken place between 1148:43 and 1148:47. Figure 3, at 1148:43, shows a separation of 0.1nm horizontally and 200ft vertically.

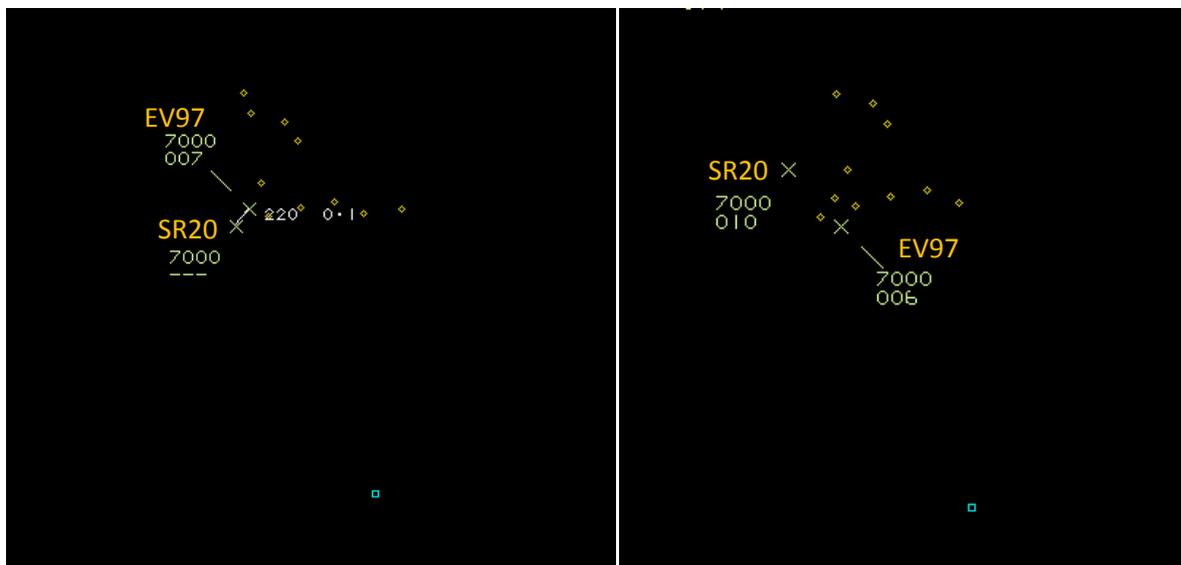
Figure 4: 1148:47

In Figure 4, at 1148:47, the horizontal distance was less than 0.1nm but there was no level information from the SR20 which had commenced the right-hand orbit. Figure 5 shows that the SR20 had climbed slightly.
