AIRPROX REPORT No 2015218

Date: 4 Dec 2015 Time: 1605Z Position: 5320N 00240W Location: 6.5nm E Liverpool Airport

PART A: SUMMARY OF INFORMATION REPORTED TO UKAB

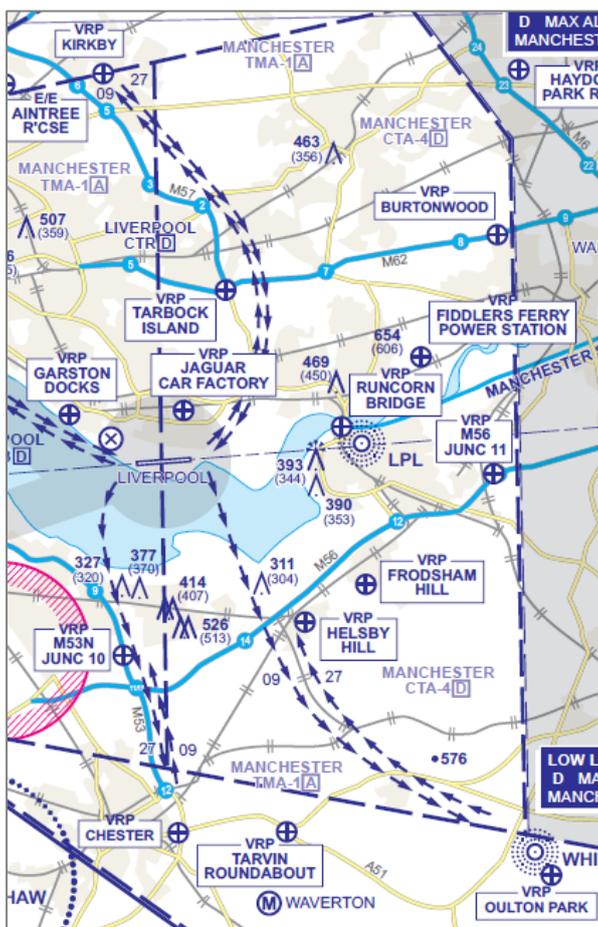
At 1558:27, the Liverpool Radar controller issued a clearance to the EC155 pilot to transit the Liverpool CTR (Figure 1) from south to north via the Oulton Park, Runcorn Bridge and Kirkby VRPs, VFR not above 2000ft.

Figure 1 – Control Zone and Control Area Chart (UK AIP AD 2-EGGP-4-1).

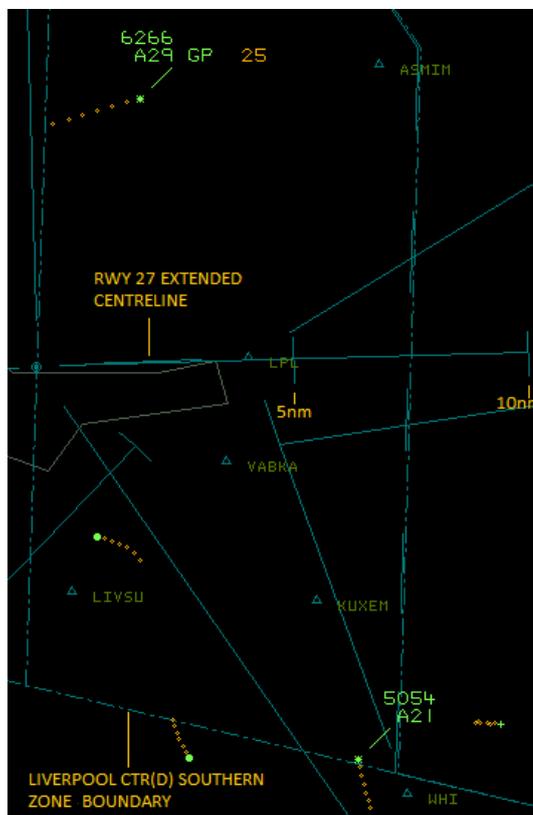
Figure 2 – Prestwick Centre MRT at 1601:47. A319 squawk 6266, EC155 squawk 5054.

At 1601:47 (Figure 2), the EC155 entered the Liverpool CTR and the Liverpool Radar controller placed the helicopter pilot under a Radar Control Service. He advised the pilot of the EC155 that an orbit to the south of the RW27 final approach might be required, in addition, he passed Traffic Information on the A319.

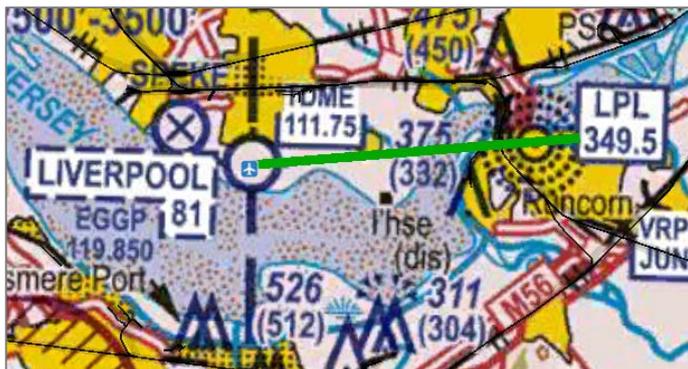
At 1603:34 (Figure 3) the Liverpool Radar controller issued the following instruction to the EC155 pilot, “(EC155 C/S) take up right-hand orbits just south of the M56, report when you have an (airline) Airbus in sight about to establish on a seven mile final”. Figure 4 shows the relative positions of the RW27 extended centreline (overlaid in green) and the M56 motorway (2.4nm to the south).

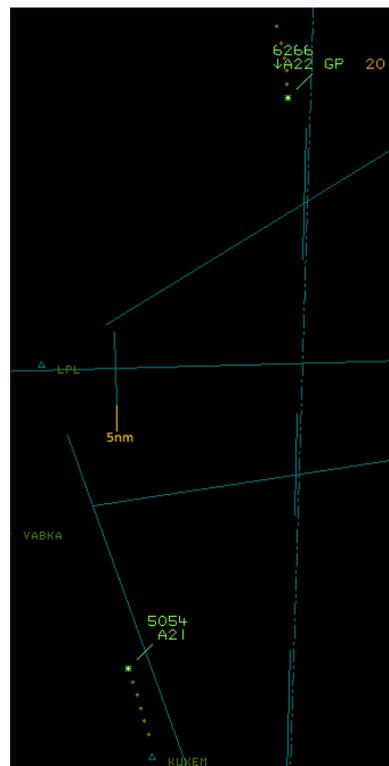
Figure 3
Prestwick Centre MRT at 1603:34.

At 1603:47, the pilot of the EC155 replied, “roger taking up right hand orbits remaining south of the M56 and we do have the traffic in sight...” At 1603:53, the Liverpool Radar controller instructed the EC155 pilot to “...arrange your flight to pass behind that traffic caution wake turbulence recommended distance 5 miles”.

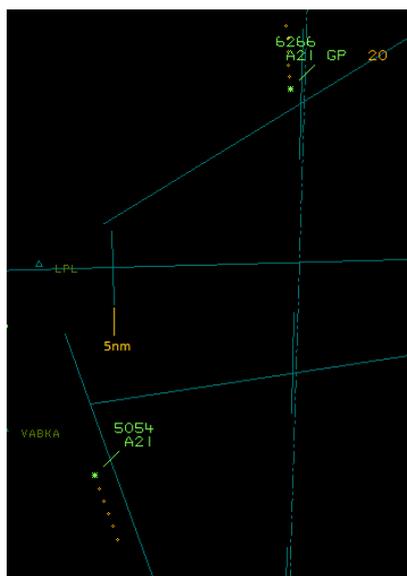
Figure 5
Prestwick Centre MRT at 1604:00.

At 1604:00 (Figure 5), the Liverpool Radar controller turned the A319 pilot onto a closing heading of 230° and cleared him for the ILS approach.

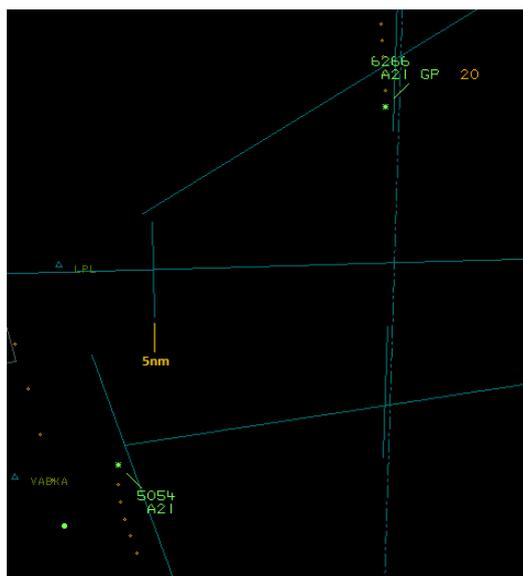
Figure 6
Prestwick Centre MRT at 1604:16.

At 1604:16 (Figure 6) the Liverpool Radar controller passed the following Traffic Information to the A319 pilot, "...traffic south-west of you by four miles just taking up orbits to pass behind you its EC155 helicopter 2000ft VFR".

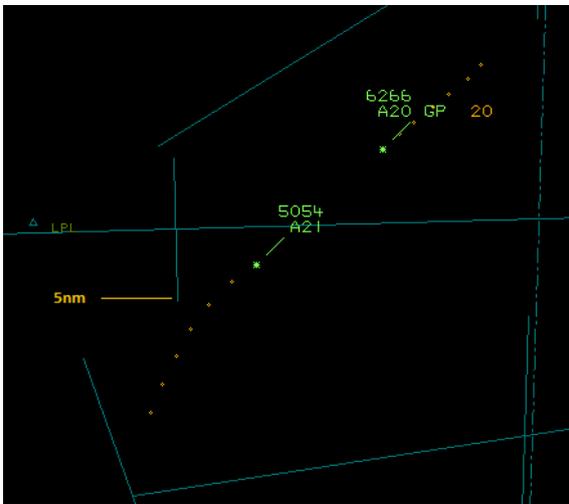
Figure 7
Prestwick Centre MRT at 1604:55.

At 1604:55 (Figure 7) the A319 pilot reported a TCAS descend RA.

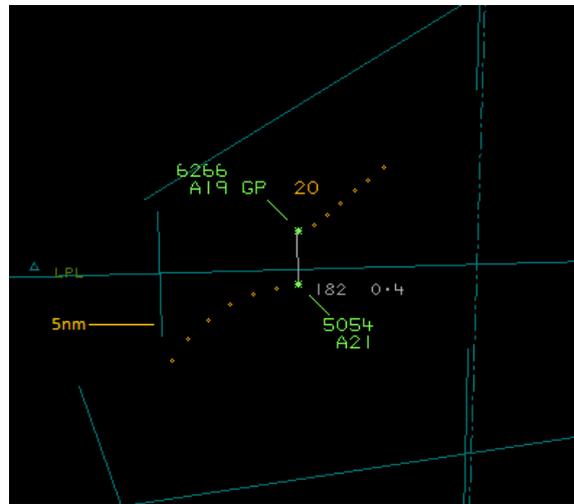
Figure 8
Prestwick Centre MRT at 1605:07 (CPA).

CPA occurred at 1605:07 (Figure 8) with a horizontal distance of 0.4nm and a vertical distance of 200ft.

At 1605:14 the A319 pilot reported clear of conflict and commented that, "... the helicopter was well north of the M56".
