**AIRPROX REPORT No 2016014**

Date: 11 Feb 2016 Time: 1536Z Position: 5130N 00019E Location: E of South Ockendon

**PART A: SUMMARY OF INFORMATION REPORTED TO UKAB**

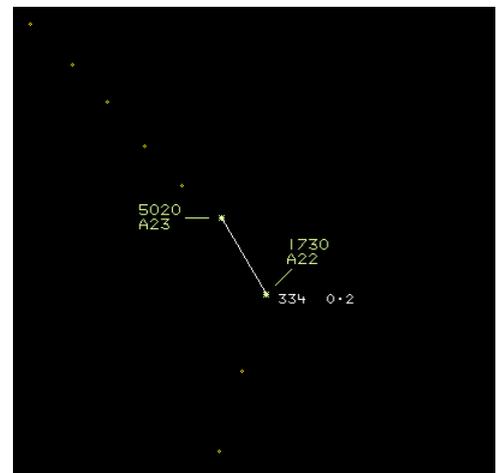
Figure 1 – Swanwick MRT – 1536:30

Figure 1 shows the relative positions of both the TB20 and the R200 at the time the TB20 reported seeing the first aircraft in their "9 or 10 o'clock". The Prentice was not observed on radar and it was not possible therefore to determine CPA. Neither the TB20, the R200 nor the Prentice made any reference to an Airprox whilst in communication with Farnborough Radar.
