**AIRPROX REPORT No 2016018**

Date: 16 Feb 2016 Time: 1555Z Position: 5145N 00100W Location: 10nm N Benson

**PART A: SUMMARY OF INFORMATION REPORTED TO UKAB**

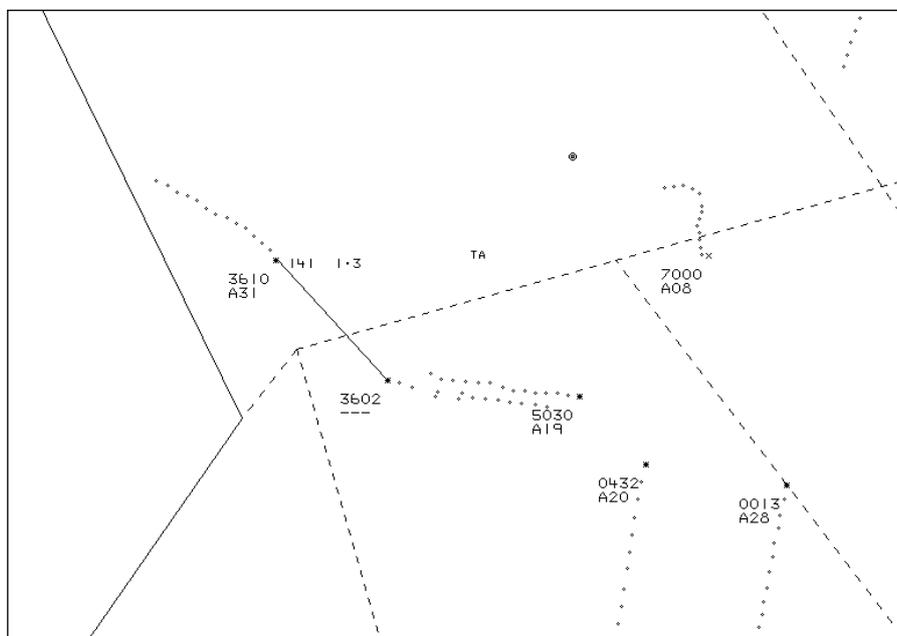
Figure 1: Merlin squawking 3610; Cessna 3602.

At 1552:48 (Figure 1), the Merlin is 1.3nm NW of the C152, no Traffic Information had been passed by the Approach Controller. At this time The Zone Controller was requesting altitude information from the C152. There is no Mode C showing on the C152 or the 4 tracks to the east of the C152.

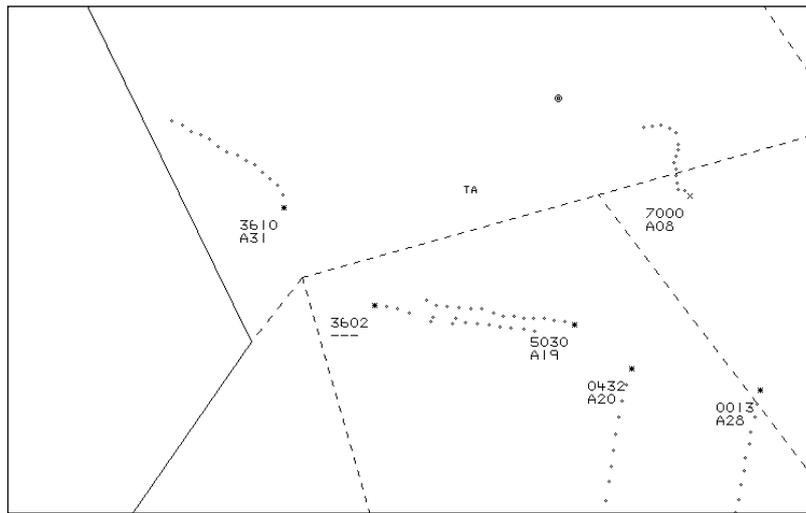
Figure 2: Geometry at 1552:52.

At 1552:52 (Figure 2), the Merlin is tracking south and the C152 west, one second before this the Approach controller passed Traffic Information to the Merlin on the C152.

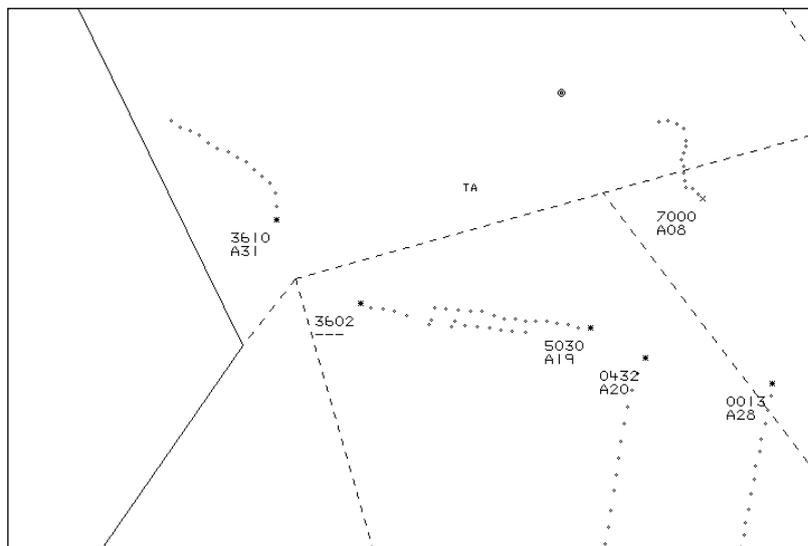
Figure 3: Geometry at 1552:55.

At 1552:55 (Figure 3), the C152 pilot reports his altitude to the Zone Controller, and 2 seconds later the Merlin reports that he is looking; the transcript appears to indicate surprise in his voice.

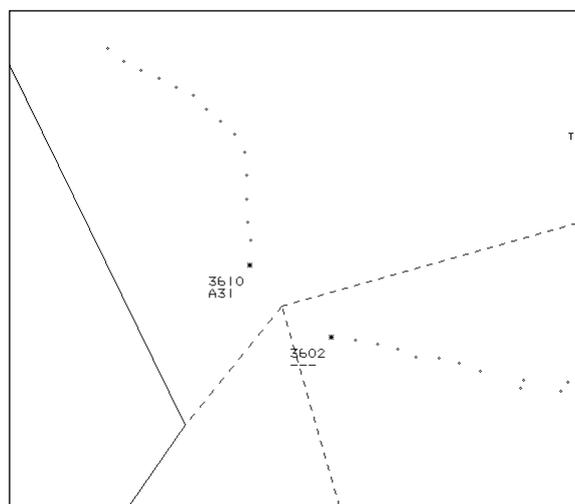
Figure 4: Geometry at 1553:07.

At 1553:07 (Figure 4), the Merlin pilot reports to Approach that he is visual with the C152.

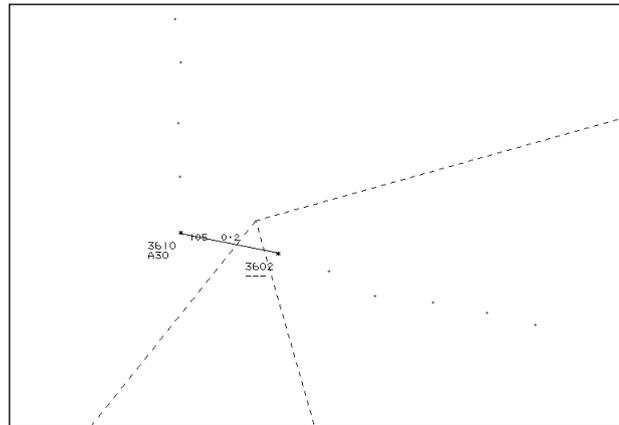
Figure 5: CPA at 1553:15.

The CPA was at 1553:17 (Figure 5, 1553:15) and estimated at 0.2nm horizontal separation.
