**AIRPROX REPORT No 2016025**

Date: 4 Mar 2016 Time: 1014Z Position: 5252N 00026W Location: 9nm S Cranwell

**PART A: SUMMARY OF INFORMATION REPORTED TO UKAB**

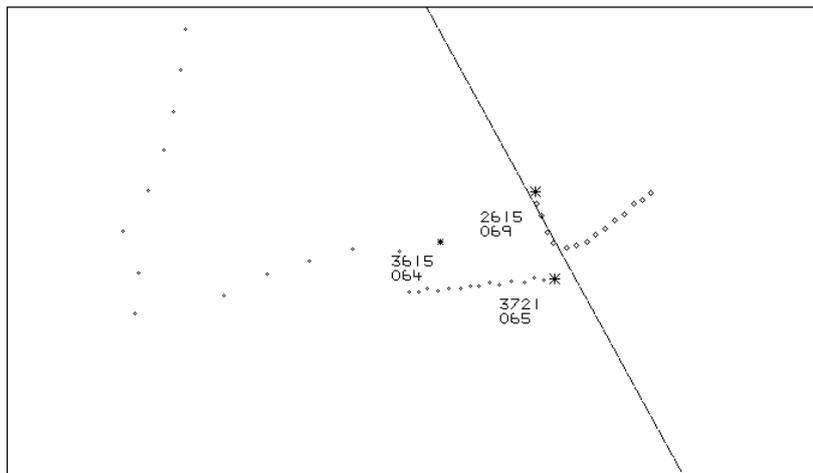
At 1013:55 (Figure 1), the respective tracks were in close proximity manoeuvring in the busy Lincolnshire airspace.

Figure 1: Geometry at 1013:55 (Tutor squawking 2615; Hawk(A) squawking 3615).

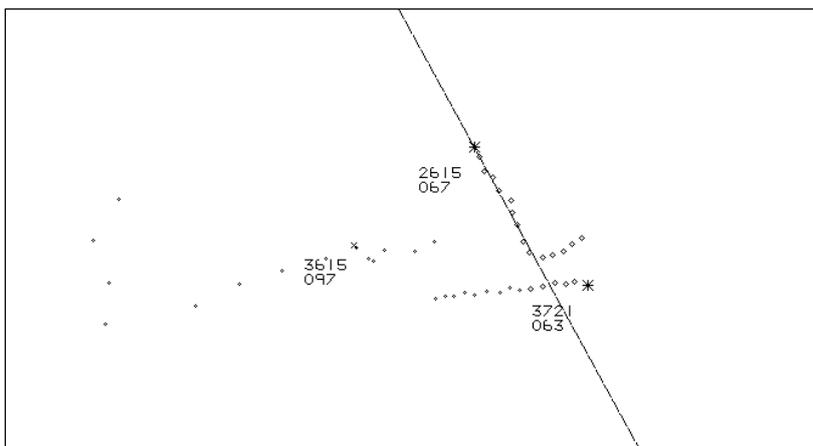
Waddington Approach first called Traffic Information to Hawk(A) at 1014:14 (Figure 2) as north-east, 1nm, 3000ft below.

Figure 2: Traffic Information at 1014:14.

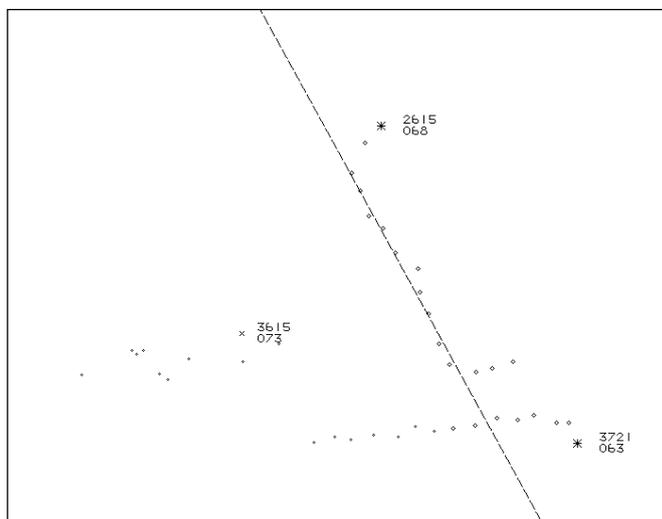
The Hawk(A) pilot confirmed that the Traffic Information was for his aircraft at 1014:23 (Figure 3).

Figure 3: Geometry at 1014:23 as Hawk(A) pilot confirms receipt of Traffic Information.

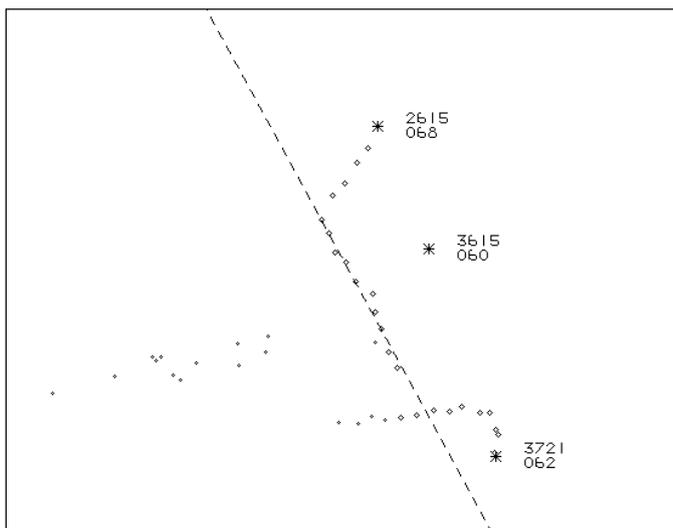
At 1014:35 (Figure 4), Cranwell Departures provided the first piece of Traffic Information to the Tutor as south, 0.5nm, 700 feet below, believed to be a Wittering Tutor (3721 squawk).

Figure 4: Traffic Information from Cranwell at 1014:35.

The accurate Traffic Information from Cranwell ATC to the Tutor was at 1nm and ideally would have been earlier as the crews had been in close proximity one minute prior to the CPA. However, there seemed to be an intensity of traffic in the area and an overlap of SSR codes. The Cranwell controller had 3 to 4 aircraft on frequency and had initially thought that the conflicting traffic was a Tutor from Wittering. The Hawk(A) squawk had momentarily disappeared from the radar screen as the pilot was conducting high energy manoeuvres. It appears that the Hawk(A) squawk overlapped with the non-Airprox Wittering Tutor squawk, leading the controller to believe that the conflicting track was another Tutor.

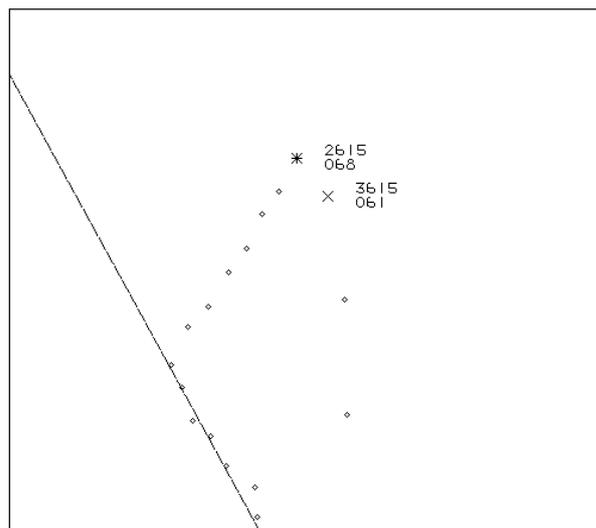
Figure 5: CPA at 1014:43.

The CPA at 1014:43 (Figure 5) with 800ft vertical and 0.1nm horizontal separation, coincided with the Tutor confirming that a Hawk was passing underneath by 300 feet.

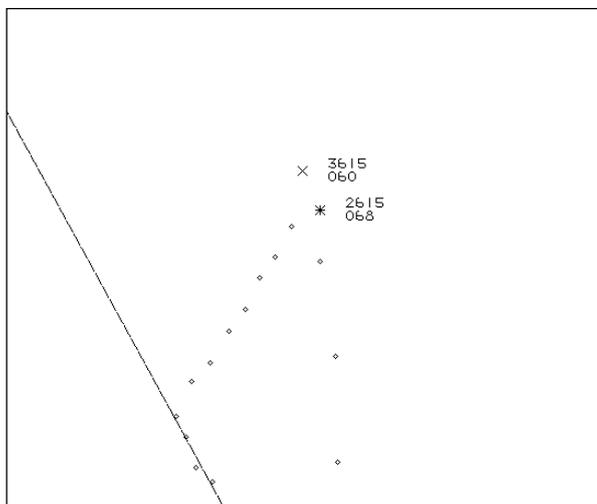
At 1014:46 (Figure 6), Waddington called further Traffic Information to the Hawk(A) pilot at 1000 feet above.

Figure 6: Traffic Information to the Hawk (A) pilot at 1014:46.
