AIRPROX REPORT No 2016061

Date: 28 Apr 2016 Time: 1135Z Position: 5049N 00321W Location: Exeter (EX) NDB hold

PART A: SUMMARY OF INFORMATION REPORTED TO UKAB

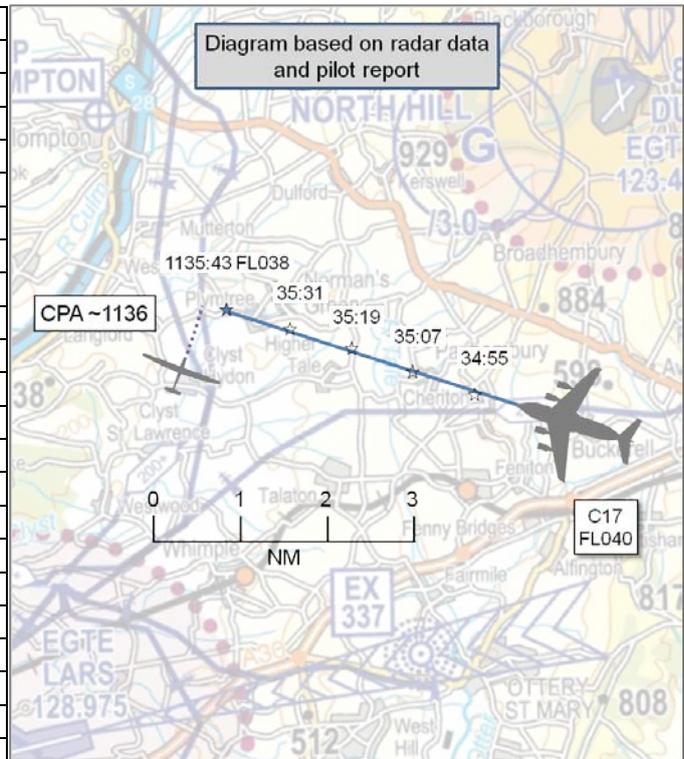
THE BOEING C17 PILOT reports being in the EX NDB hold at FL40 carrying out the hold portion of a procedural ILS approach for training. The Aircraft Commander was a flying instructor in the role of PM, and was sat in the left-hand seat. The PF was sat in the right-hand seat. The aircraft was at 230kt, in a clean configuration. Whilst flying the westbound leg of the hold, the PF was "Heads in" briefing the next portion of the procedure when the PM called "traffic ahead". On looking up, the PF observed a glider on the nose tracking, he recollected, right-to-left, level, about 1nm away and considered to be close enough for him to take manoeuvring action by descending approximately 400ft. The PM reported this to the controller at Exeter. The glider appeared to make no avoiding manoeuvres.

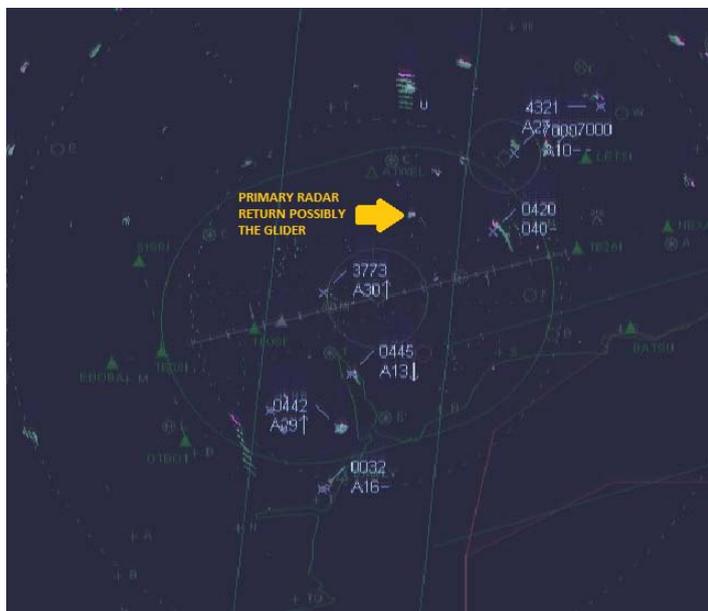
Figure 2 - Exeter Radar North display at 1134:34.

At 1134:34 (Figure 2) the C17 (code 0420) had turned westbound in the 'EX' hold. Coincident to this, and unseen by the Exeter Radar controller, a faint primary radar return was approximately 5nm north-east of Exeter airport, tracking north-east. Figure 2 is a magnified image taken from the recorded surveillance data. No Traffic Information was passed to the C17 on this return.

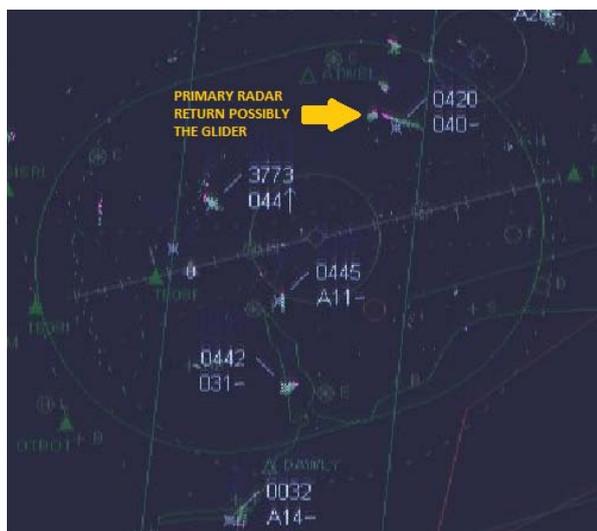
Figure 3 shows a further magnified image taken from the recorded surveillance data showing the traffic situation at 1135:28 with the C17 still tracking north-east and the primary radar return in its twelve o'clock position.

Figure 3 - Exeter Radar North display at 1135:28. Figure 4 - Exeter Radar North display at 1135:35.

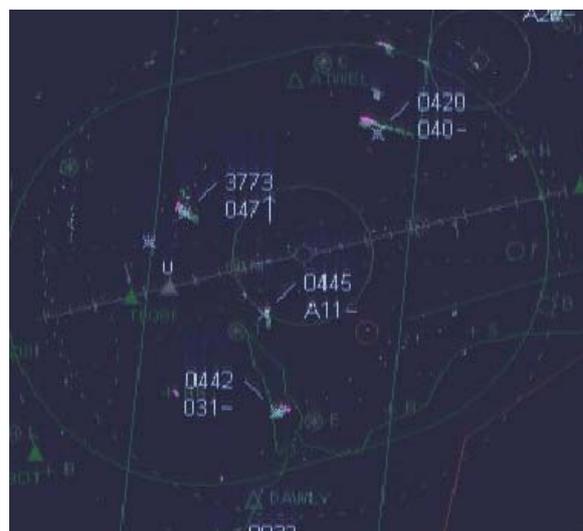
It was not possible to positively identify the glider involved in the Airprox. It was also not possible to accurately calculate the CPA due to the limitations of using the Exeter Radar recording which lacks the interactive functionality of the area radar recording. However, the recorded surveillance data suggests that the CPA is likely to have occurred circa 1135:35 (Figure 4) which shows the C17's radar return merging with the primary radar return. Once again, this screenshot has been magnified to illustrate the Airprox.
