AIRPROX REPORT No 2016066

Date: 09 Apr 2016 Time: 0929Z Position: 5136N 00013E Location: SSE LAM VOR/DME

PART A: SUMMARY OF INFORMATION REPORTED TO UKAB

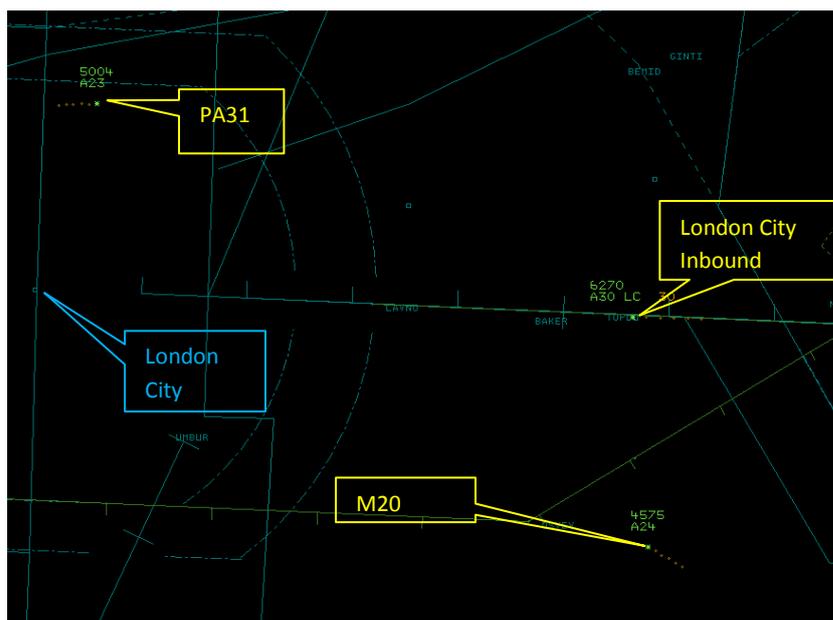
Figure 1

The traffic situation at 0924:11 (Figure 1) showed the PA31 effectively downwind right for London City (code 5004) and the M20 approaching from the southeast. There was traffic inbound to London City (code 6270) on approximately an 11nm final, which the PA31 pilot had been advised that he may have to hold for.

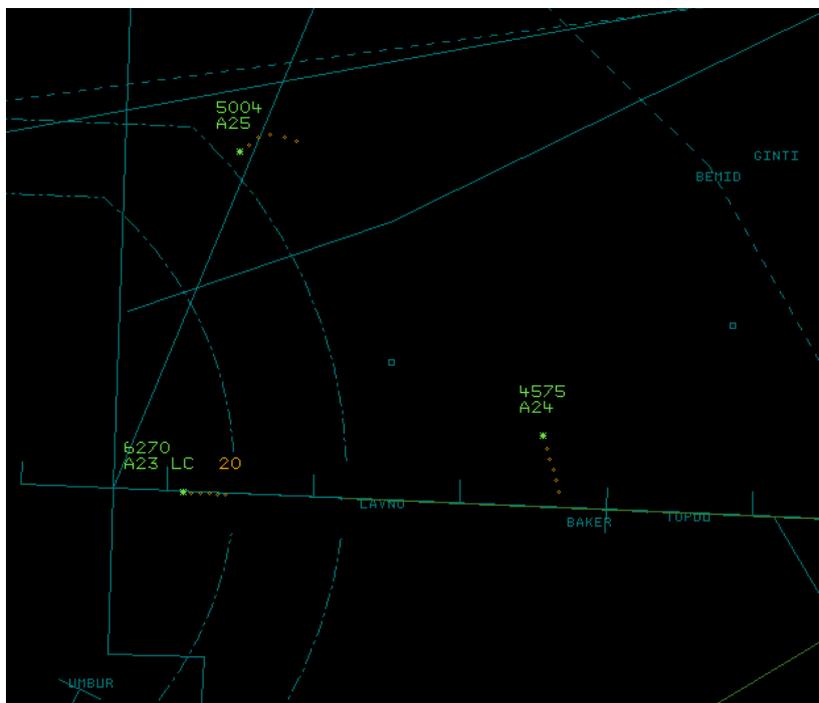
Figure 2

At 0926:50, (Figure 2), the Thames Radar controller issued Traffic Information about an unknown aircraft approaching from the Southeast.

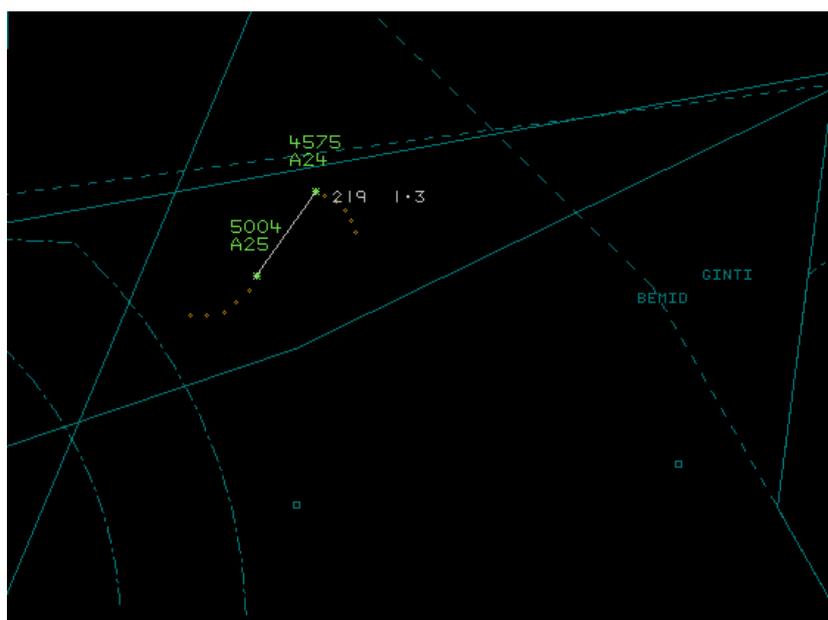
Figure 3

At 0929:11, (Figure 3), the Thames Radar controller updated the Traffic Information to the PA31 pilot and asked if he was visual. The PA31 pilot reported he was not visual and as he had a traffic warning from the TCAS elected to descend.

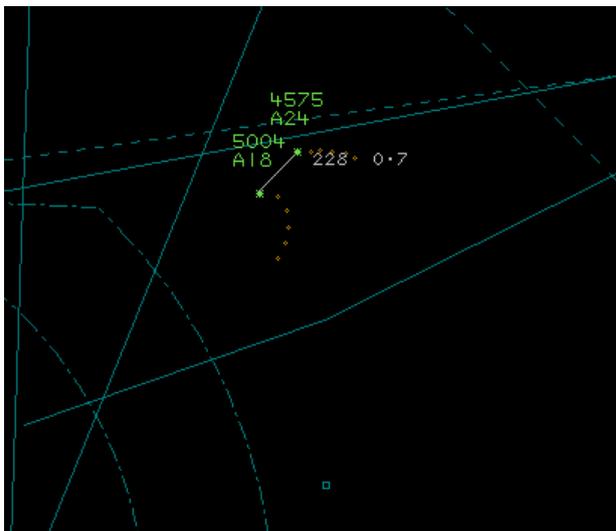
Figure 4

At 0929:30, (Figure 4), the Southend controller had opened the radar position and, although the M20 pilot was still under a Basic Service, provided Traffic Information about the aircraft orbiting to the south of their track. The M20 pilot had just made a left turn onto a westerly heading at this point and reported that he was IMC.

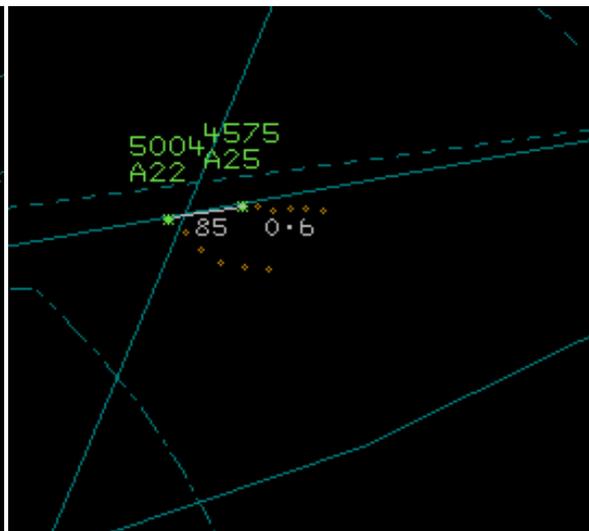
Figure 5

CPA occurred at 0929:46 (Figure 5), indicating 300ft and 0.6nm, although because of the relevant positions, speeds and routing of the two aircraft, this proximity continued for several seconds until, at 0929:50, the M20 pilot reported to Southend that he had the PA31 in sight and, at 0929:53, the PA31 pilot reported to Thames Radar that he was visual with the M20 and was climbing again.
