AIRPROX REPORT No 2016129

Date: 07 Jul 2016 Time: 1715Z Position: 5133N 00131W Location: 12 WSW Benson

PART A: SUMMARY OF INFORMATION REPORTED TO UKAB

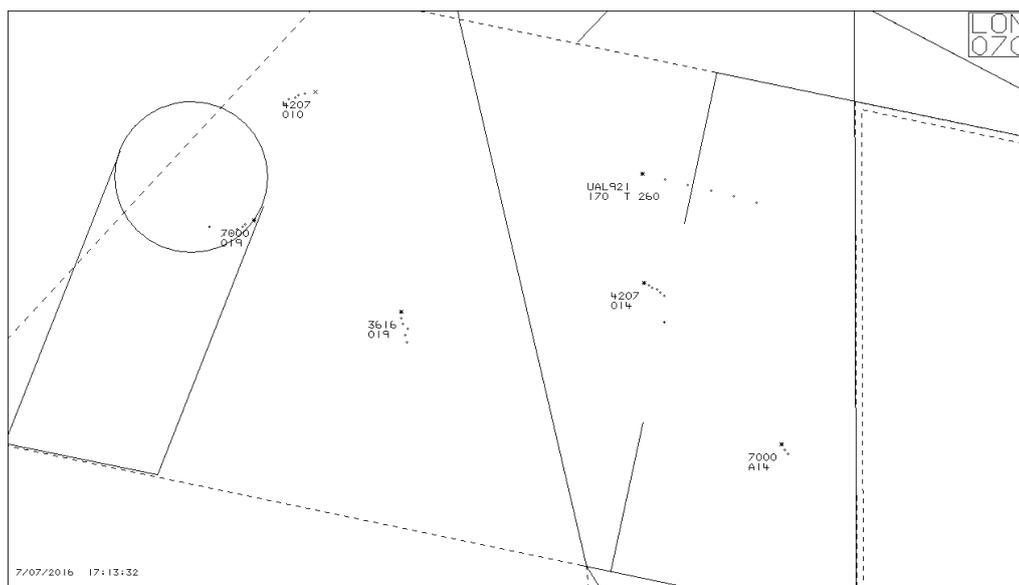
Figure 1: Geometry at 1713:32 (Chinook squawking 3616; Boeing Stearman formation squawking 4207, Mode C 014).

At 1713:32 (Figure 1), the Chinook is tracking north climbing to position for a PFL, the Boeing Stearman formation is to the east of the Chinook tracking north west in level flight enroute to Fairford. The controller has passed the Chinook Traffic Information on the 7000 squawk to the North West at a similar level. No Traffic Information was passed on the 4207 squawk directly to the north of the Chinook indicating 010 on Mode C or the Boeing Stearman formation to the east. This would suggest that it was not visible on the controller's radar screen as these would have been relevant calls at this point.

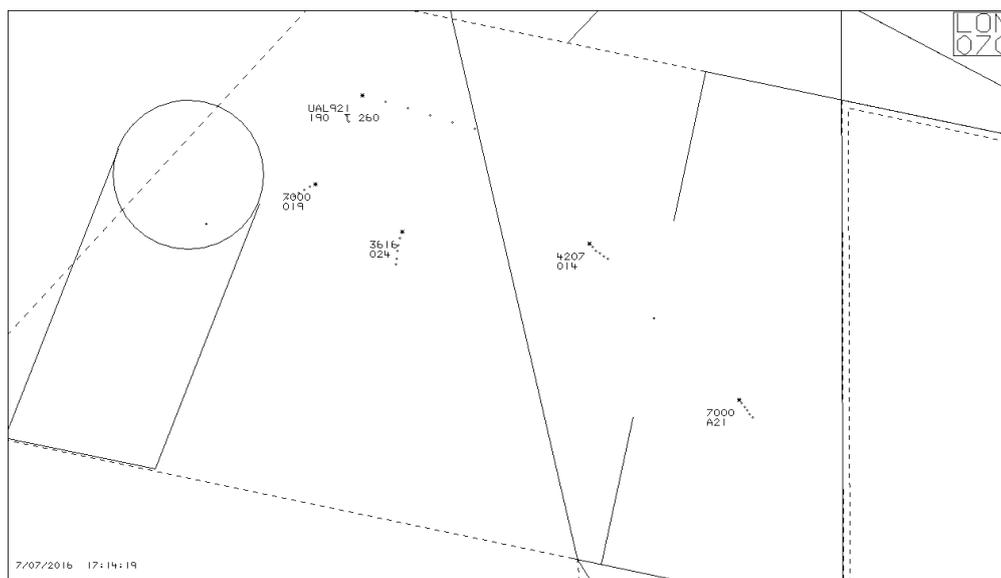
Figure 2: Geometry at 1714:19 (Chinook squawking 3616; Boeing Stearman formation squawking 4207, Mode C 014).

At 1714:19 (Figure 2), the Chinook is now visual with the aircraft squawking 7000 to the North West and begins to turn right and position to begin the PFL. The Boeing Stearman formation continues tracking northwest converging toward the Chinook.

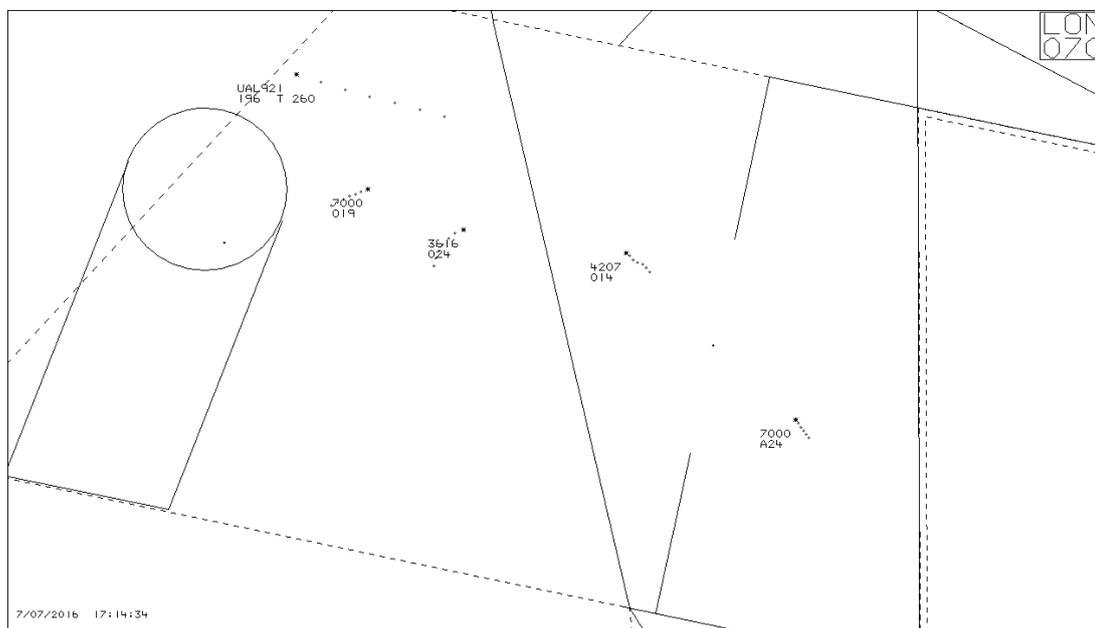
Figure 3: Geometry at 1714:19 (Chinook squawking 3616; Boeing Stearman formation squawking 4207, mode/C 014).

At 1714:34 (Figure 3), the controller passes the Chinook Traffic Information *[Chinook c/s] have further traffic east two and a half miles, tracking north west (pop up) on site, no height information, possibly a glider*. This traffic call would indicate that for a moment the Boeing Stearman formation created a small return on the controller’s radar screen.

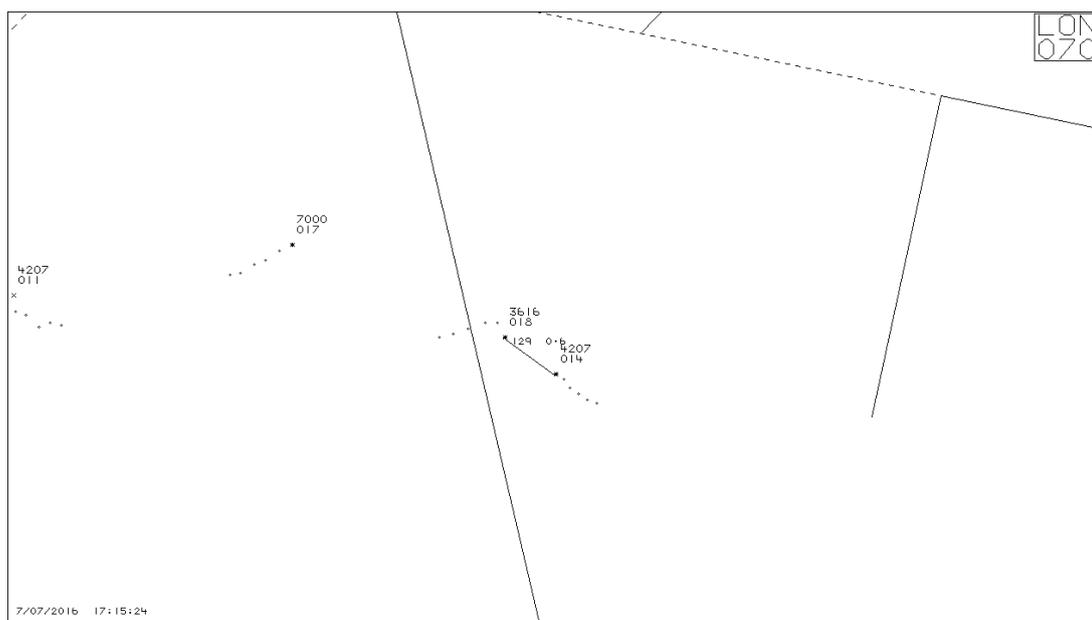
Figure 4: Geometry at 1715:24 (Chinook squawking 3616; Boeing Stearman formation squawking 4207, Mode C 014).

At 1715:24 (Figure 4), the Chinook is in the descent, passing 018 on Mode C, through the 12 o'clock of the Boeing Stearman formation. This correlates with the Boeing Stearman pilots report of becoming visual with the Chinook as it descended ‘out of cloud’ in their 11/12 o'clock in a right hand descending turn [UKAB Note: the Chinook crew report that they were VMC at all times]. Separation at this point it 0.6 nm and 400 ft.
