AIRPROX REPORT No 2016160

Date: 22 Jul 2016 Time: 1202Z Position: 5120N 00257W Location: Weston-Super-Mare

PART A: SUMMARY OF INFORMATION REPORTED TO UKAB

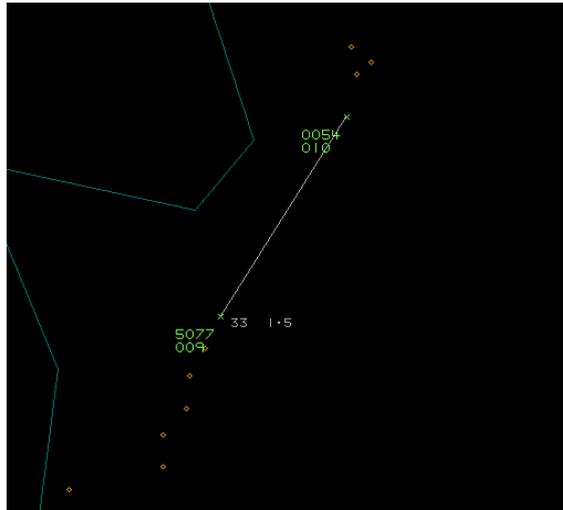
Swanwick MRT at 1201:37 EC135/0054 EV97/5077.

At 1201:37 (Figure 1) the EC135 (SSR code 0054) was visible as a Secondary Surveillance Radar contact indicating FL010. The EV97 (SSR code 5077) was also only visible as an SSR contact, and was 1.5nm south-south-west of the EC135, indicating FL009 tracking north-north-east. The EC135 then disappeared from SSR coverage. Due to the EC135 operating below the available SSR coverage it was not possible to determine the CPA using the area surveillance recordings.

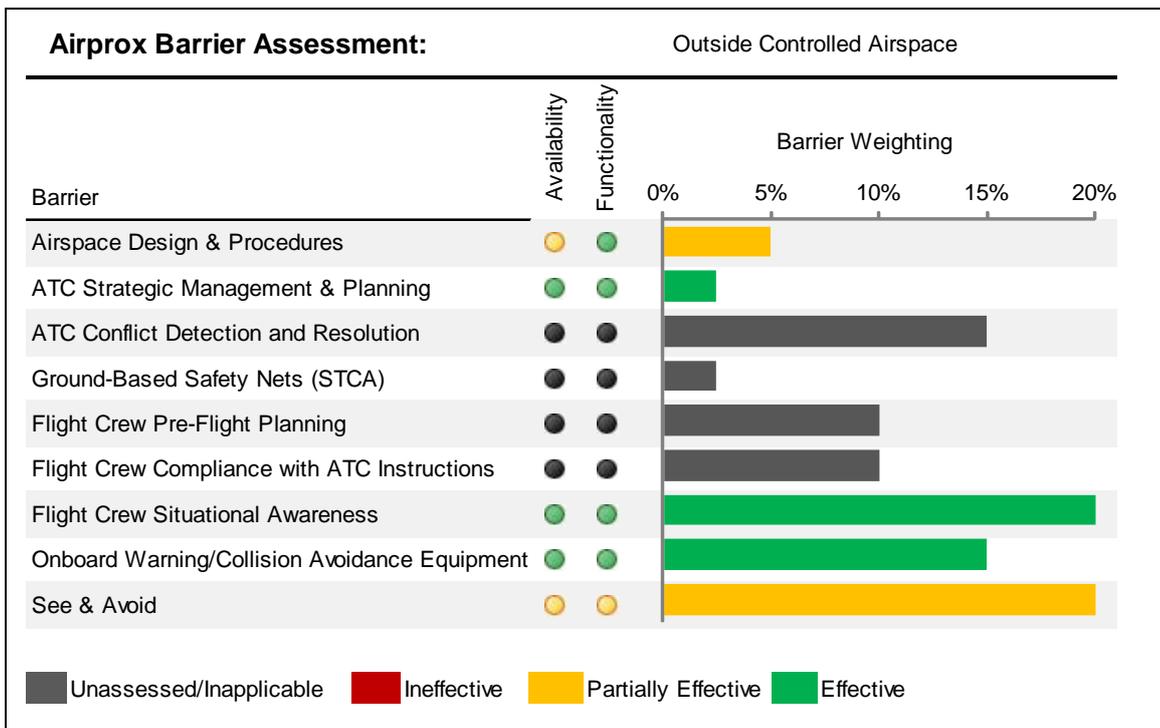
- **Airspace Design and Procedures** was considered only **partially effective** because radar cover at the normal operating levels for traffic in this area often resulted in only intermittent

radar returns; this meant the controllers may not be able to provide the best service to aircraft in the area.

- **Onboard Warning/Collision Avoidance Equipment** was **effective** because it gave warnings to the EC135 pilot of an aircraft that he had not seen or been informed about.
- **See and Avoid** was **partially effective** because although both pilots saw each other, the EV97 pilot did not act to avoid the EC135 by a sufficient margin.
