**AIRPROX REPORT No 2016174**

Date: 18 Aug 2016 Time: 1345Z Position: 5139N 00225W Location: Newport, Gloucestershire

**PART A: SUMMARY OF INFORMATION REPORTED TO UKAB**

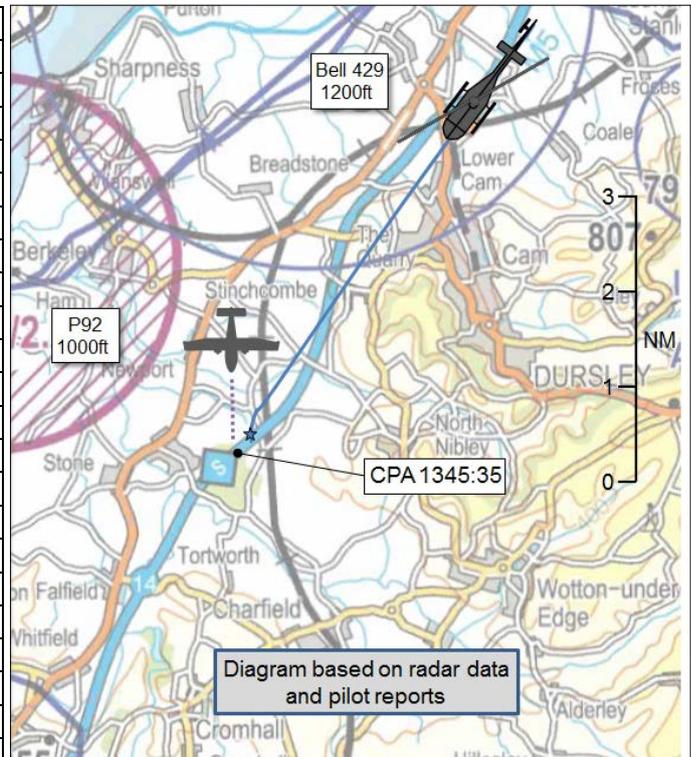
**THE B429 PILOT** reports that he was flying in southerly direction when he was alerted by the left-hand seat non-pilot crewman about traffic to the right; the right-hand door spar was obscuring the approaching aircraft. He made a left-hand descending turn, and the rear crew-member noted the registration of the other aircraft. There appeared to be no reaction from the other aircraft, so he believed that the other pilot had not seen him.

**THE TECNAM P92 MICROLIGHT PILOT** reports that she took off from a private strip, levelled at 500ft to improve vision, and then made a 90° turn on to a westerly heading and climbing further. She then turned onto a southerly heading, still climbing gently. Her first sighting of the helicopter was after it passed underneath from behind and climbed up ahead of her aircraft. She did not have to take avoiding action.

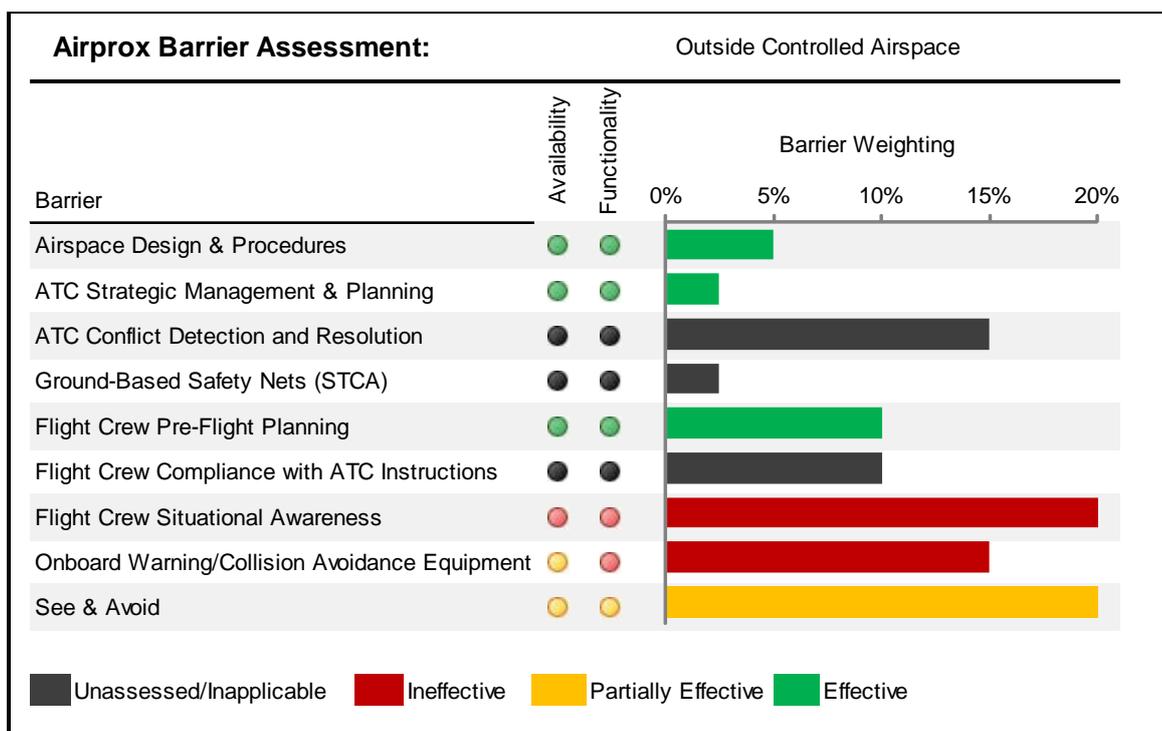
In considering the effectiveness of the barriers relevant to this incident, the Board concluded that the key factors had been that:

- **Situational awareness** had been **ineffective** because the Tecnam's lack of transponder or any calls to ATC had meant that the B429 pilot could not be specifically aware of the Tecnam's presence through either ATC or his TCAS.
- **Onboard warning/collision warning systems** were assessed as **ineffective** for the same reason – Tecnam lack of transponder.
- **See-and-avoid** was assessed as only **partially effective** due to the lateness of sighting by the B429 pilot as a result of cockpit obscuration.
