AIRPROX REPORT No 2016199

Date: 14 Sep 2016 Time: 1406Z Position: 5113N 00005W Location: 8nm ENE Gatwick airport

PART A: SUMMARY OF INFORMATION REPORTED TO UKAB

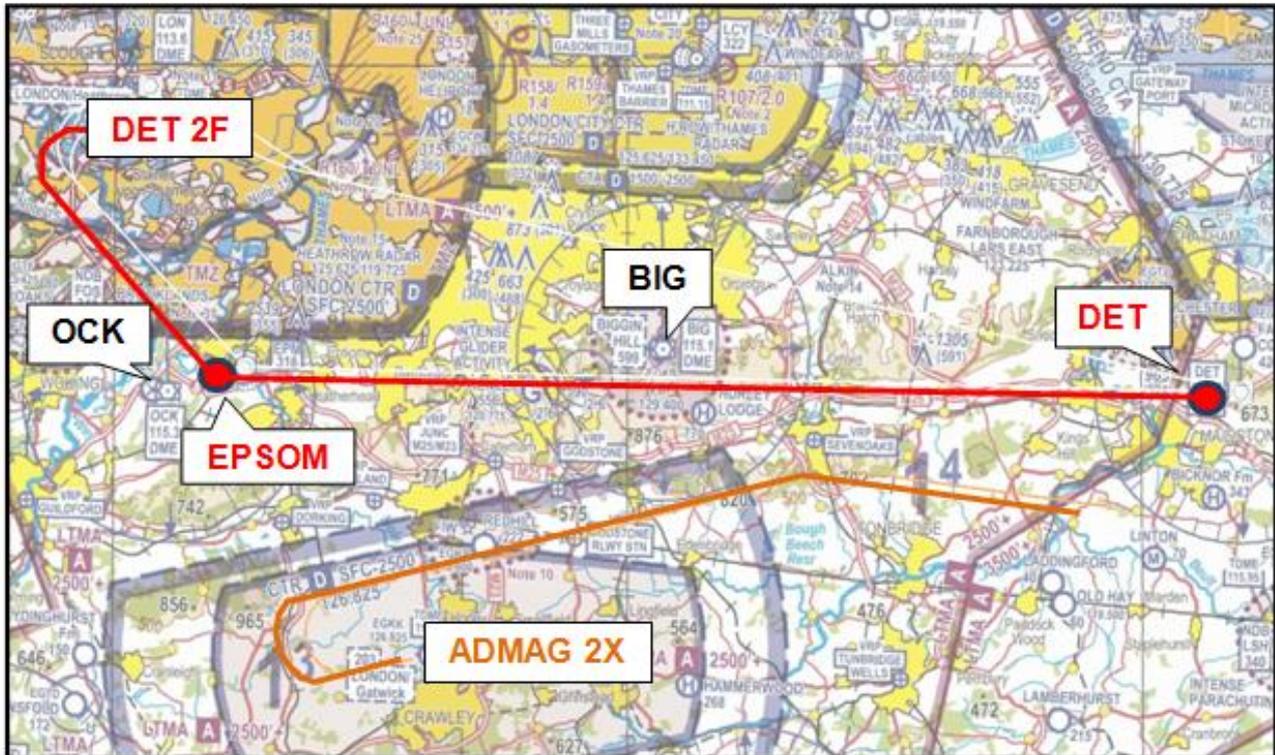
Figure 1 – DET 2F & ADMAG SIDs

The relative tracks of the Heathrow DET 2F and Gatwick ADMAG2X SIDs are shown at Figure 1.

The B787 pilot was taken off his SID by the controller and placed on a radar heading. This was considered to be common practice, because a continuous climb on this SID is restricted by its proximity to both the Ockham (OCK) and the Biggin (BIG) Holds. To provide further climb and to avoid potential conflicts with inbound traffic later, the heading is allocated after clearing the OCK Hold to take the departure clear to the south of the BIG Hold.

The SIDs being flown by the B787 and the A320 pilots were deemed separated, and although the B787 pilot had been taken off their SID onto a more south-easterly track, standard separation still existed against the A320, because the profile of the SID being flown by the A320 pilot would have provided vertical separation against the B787.

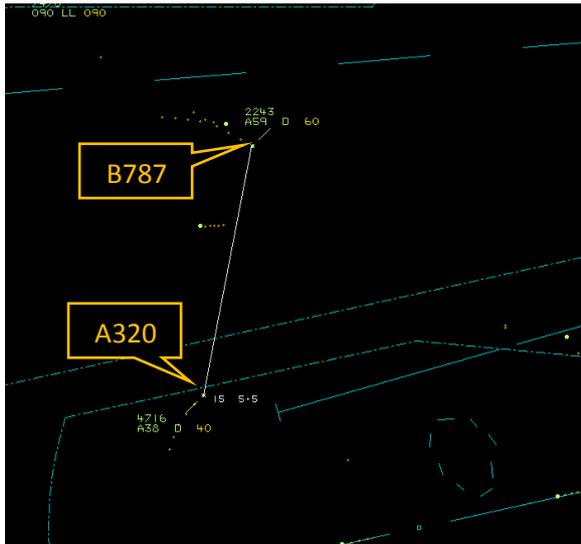
Figure 2 - Swanwick MRT – 1404:21

At 1404:21, the controller instructed the A320 pilot to climb to 6000ft (Figure 2).

It had been the controller’s intention to have the B787 pilot commence further climb first, with the A320 step-climbing beneath, as both aircraft were flight planned out of UK airspace via the same exit-point. The eventual loss of separation was as a direct result of the controller’s instruction to the A320 pilot to climb to 6000ft at 1404:21.

At interview, the controller commented that he had intended to climb the A320 pilot only to 5000ft, but said 6000ft without realising his mistake. This was evidenced by the flight progress strip (FPS) which showed climb instructions to “4A”, “5A” and “6A”, rather than just 4A and 6A. (The FPS did not show any of the avoiding action instructions).

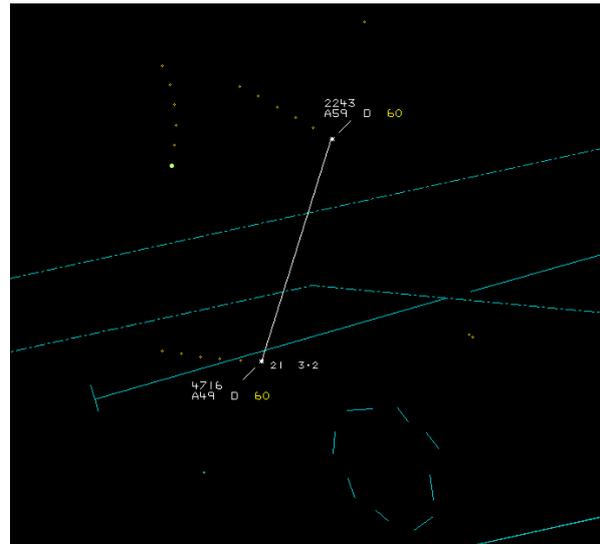
Figure 3 - Swanwick MRT – 1405:21.

The frequency was busy with almost continuous transmissions from other aircraft until at 1405:12, the B787 pilot was instructed to climb to FL100. However, this call was blocked by the transmission from another pilot and so had to be repeated. At 1405:21 a white Short Term Conflict Alert (STCA) was activated on the controller's radar display (Figure 3).

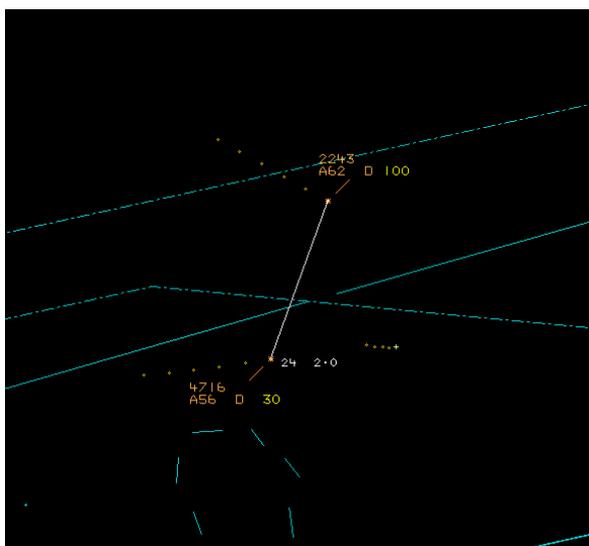
Figure 4 - Swanwick MRT – 1405:49.

At 1405:49 the STCA, having momentarily disappeared, reactivated with a red alert (Figure 4).

At 1405:47, the A320 Selected Flight Level (SFL) indicated 30, suggesting that the aircraft was descending to a level below that which had been instructed by the controller. This gave some cause for concern, as the aircraft’s track was taking it towards the Gatwick intermediate and final approach areas, at a level (potentially), that would bring it into conflict with Gatwick inbounds. A further enquiry was made of the aircrew of the A320, who subsequently stated that when they had received the instruction to descend again to 5000ft they had queried it with the controller. From the recording of the R/T it is believed that this enquiry was stepped on by the controller’s subsequent avoiding action turn instruction to the B787. The A320 pilot stated that *“whilst this was happening I saw the conflicting aircraft very close to us. I therefore wound the Altitude selector down and I incorrectly set 3000 in the FCU Altitude select window, I just wanted the aircraft to start descending (the Auto Pilot was engaged) and I was then planning to reset the altitude in the FCU window to the instructed 5000”*.

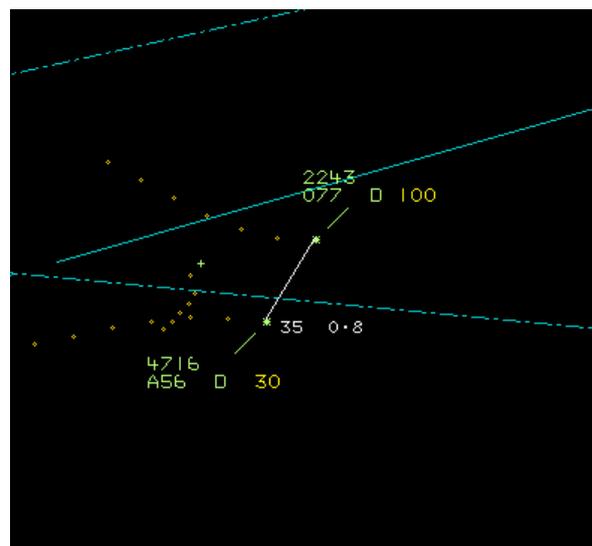
Figure 5 - Swanwick MRT – 1406:18

The lateral CPA occurred at 1406:18 with the aircraft separated by 0.8nm laterally and 2100ft vertically (Figure 5).

Vertical separation reduced to 600ft whilst the aircraft were still 1.8nm apart laterally. At the minimum distance laterally (0.8nm), the aircraft were separated by >2000ft vertically.

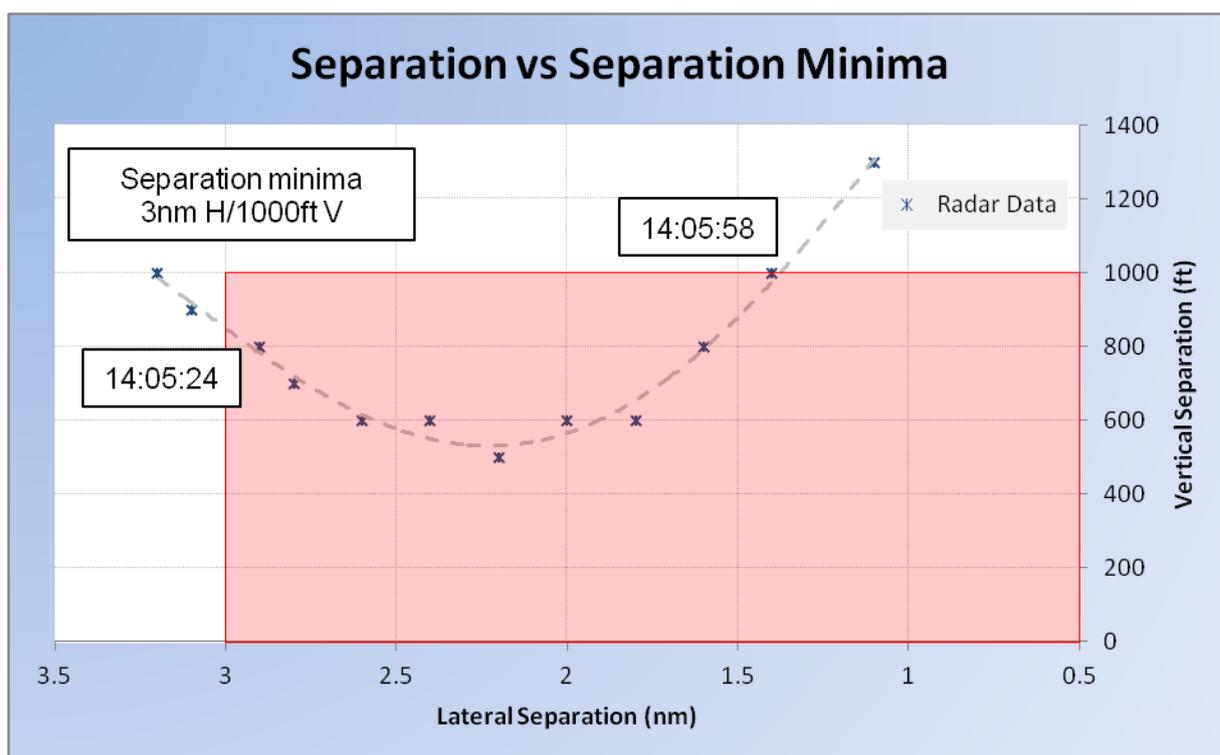
The A320 and B787 pilots shared an equal responsibility for collision avoidance and not to operate in such proximity to other aircraft as to create a collision hazard¹. Notwithstanding that, in Class A airspace, ATC were required to separate the aircraft. The minimum slant range between aircraft occurred at 14:06:10 (CPA). Separation minima were lost at about 14:05:24 as the aircraft were within 1000ft as the lateral separation reduced through 3nm. Separation minima were regained at 14:05:58 as the vertical separation increased through 1000ft with a lateral separation of approximately 1.4nm, just less than half the required 3nm.

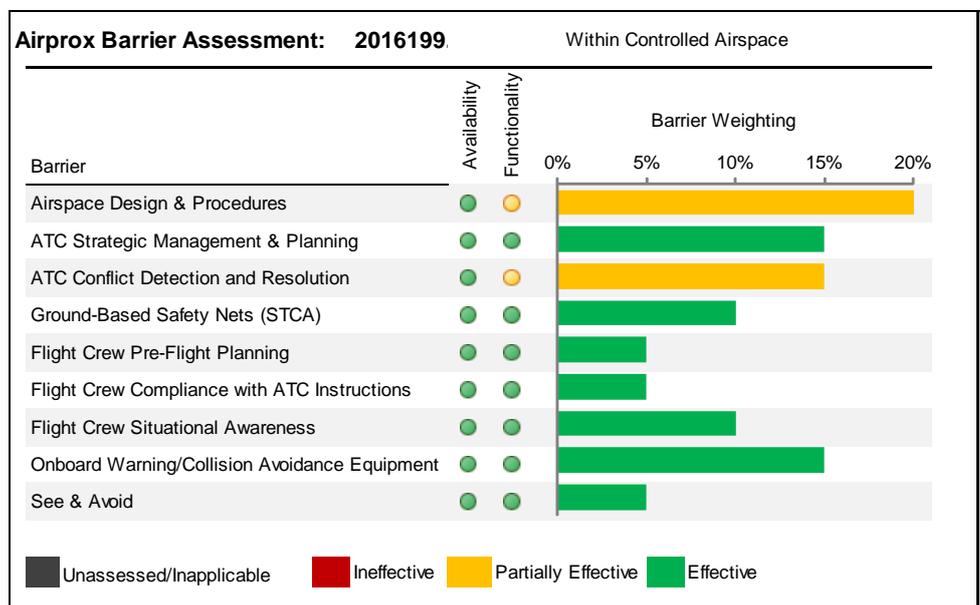
- **Airspace Design and Procedures** was considered to be only **partially effective** because the TC controllers necessarily have to take aircraft off SIDs, which are designed to separate different departures from each other, in order to ensure an expeditious flow of air traffic.

- **ATS Conflict Detection and Resolution** was only **partially effective** because the controller had not realised that he had climbed the A320 pilot to an incorrect level. Additionally, the frequency was blocked by another pilot, which had prevented timely conflict resolution.

Modern safety management processes employ the concept of safety barriers that prevent contributory factors or human errors from developing into accidents. Based on work by EASA, CAA, MAA and UKAB, the following table depicts the barriers associated with preventing mid-air-collisions. The length of each bar represents the barrier's weighting or importance (out of a total of 100%) for the type of airspace in which the Airprox occurred (i.e. Controlled Airspace or Uncontrolled Airspace).³ The colour of each bar represents the Board's assessment of the effectiveness of the associated barrier in this incident (either Fully Effective, Partially Effective, Ineffective, or Unassessable/Absent). The chart thus illustrates which barriers were effective and how important they were in contributing to collision avoidance in this incident.
