AIRPROX REPORT No 2016201

Date: 11 Sep 2016 Time: 1517Z Position: 5115N 00036W Location: 0.5nm W Guildford

PART A: SUMMARY OF INFORMATION REPORTED TO UKAB

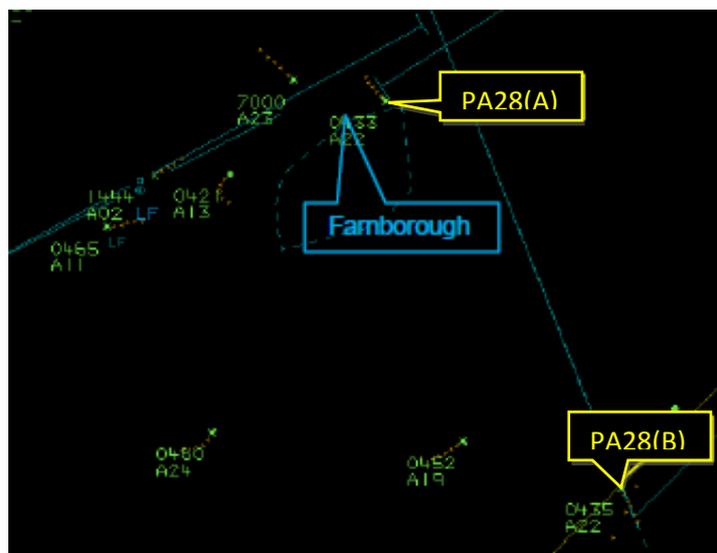
Figure 1 – 1514:55

At 1514:55 (Figure 1) the pilot of the PA28(A) reported south of the final approach track for RWY24 and advised that they intended to change SSR code and frequency.

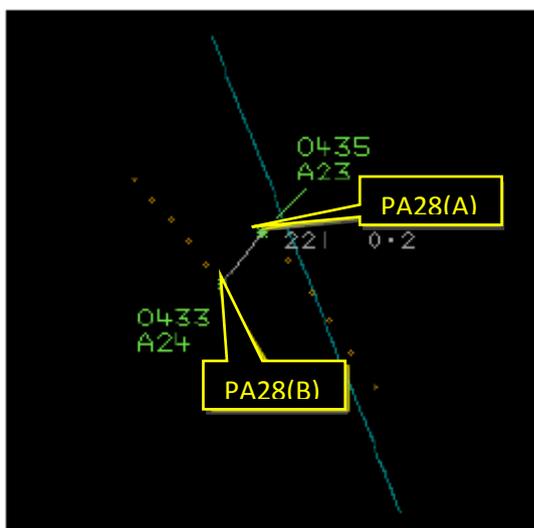
Figure 2 - 1517:10

CPA occurred between 1517:04 and 1517:10 (Figure 2) with the minimum measurable distance indicating 0.2nm and 100ft. Neither aircraft mentioned the Airprox or reported sighting the other traffic on the frequency.

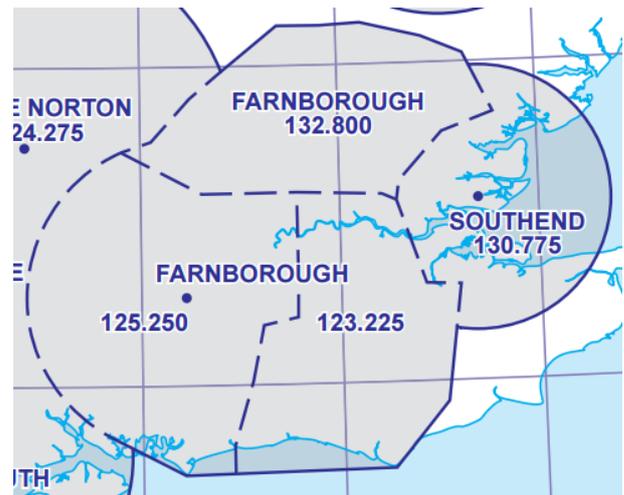
Figure 3: Farnborough LARS 02/02/2017

Post meeting note. The UKAB Secretariat confirmed that the Farnborough LARS airspace is currently comprised of three areas; Farnborough West, North and East. The Farnborough LARS boundary changed near the Southend CTR on 3rd March 2016 to enable a better division of traffic as shown in Figure 3.

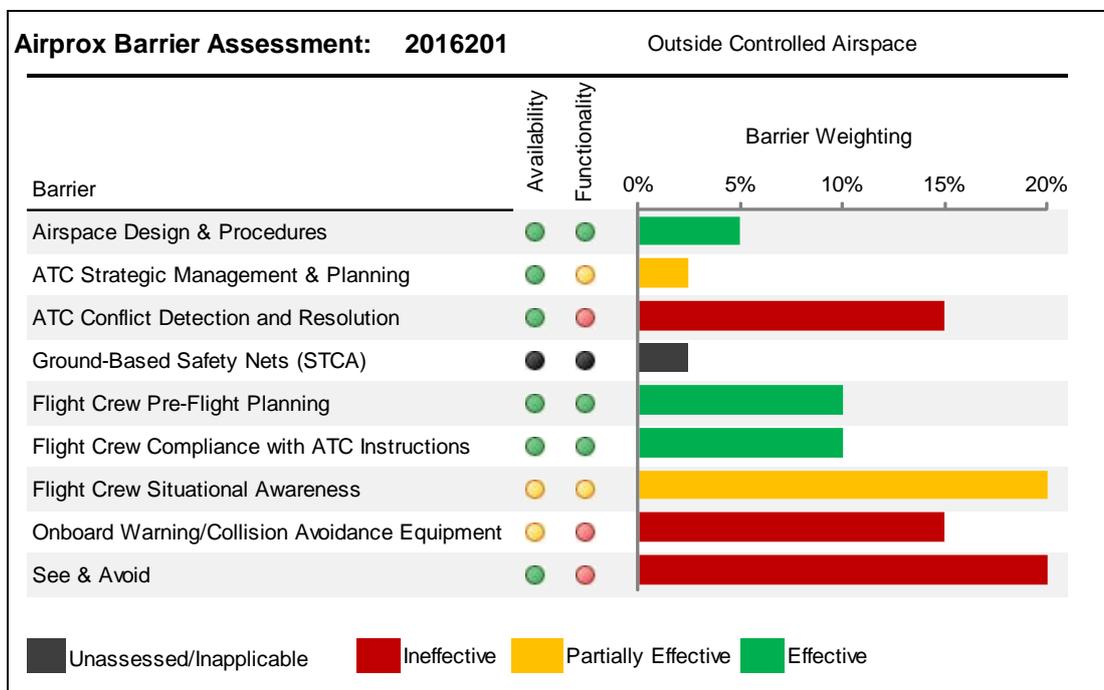
- **ATC Strategic Management and Planning** was considered **Partially Effective** because the level of service available at Farnborough West to participating aircraft was reduced due to the workload of the Farnborough West controller, in this instance this resulted in the Traffic Information not being passed to the pilot of PA28(A).

- **ATC Conflict Detection and Resolution** was considered **ineffective** because the Farnborough West controllers high workload resulted in him not recognising the confliction in time to pass the relevant traffic information to the PA28(A) pilot; notwithstanding the PA28(A) was under a reduced Traffic Service which may result in less accurate, late or absent traffic information; in these circumstances pilots should note the warning and conduct their flight accordingly.

- **Flight Crew Situational Awareness** was considered **partially effective** because although the PA28(A) pilot was in receipt of a reduced Traffic Service, he was only given generic traffic information. Whilst this is normal practice in instances of high controller workload it limits the information available to a pilot due to a reduction in timely traffic information as a result of a controller prioritising other services.

- **Onboard Warning/Collision Avoidance Equipment** was assessed as being partially available because only one aircraft had the system fitted; however it was assessed as being **ineffective** because, even though the PA28(B) was transponding, PA28(A)'s TAS did not alert the PA28(A) pilot to the presence of the other aircraft.

- **See and Avoid** was considered **ineffective** because the PA28(B) pilot did not see PA28(A) at all, and the PA28(A) pilot only saw PA28(B) as it passed by, effectively a non-sighting.
