AIRPROX REPORT No 2016238

Date: 14 Nov 2016 Time: 1038Z Position: 5420N 00109W Location: 18nm E RAF Leeming

PART A: SUMMARY OF INFORMATION REPORTED TO UKAB

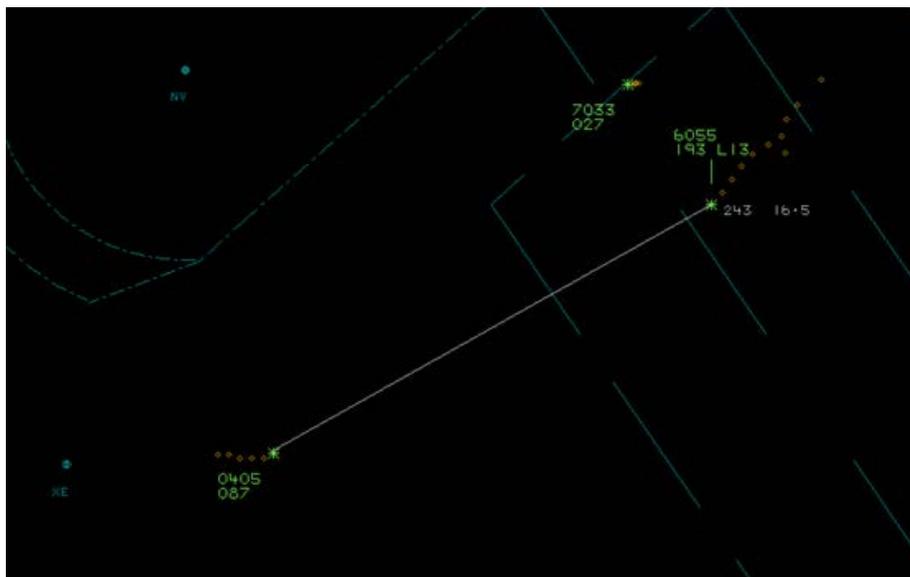
Figure 1: Geometry at 10:38:06 (Hawk SSR 0405; F15 SSR 6055/6)

At 10:38:06 (Figure 1), the Hawk had just been handed over from Leeming Approach to Leeming Zone. The traffic operating 16nm NE was not mentioned during the radar handover but Traffic Information was passed by Leeming Approach prior to transferring the aircraft to Leeming Zone.

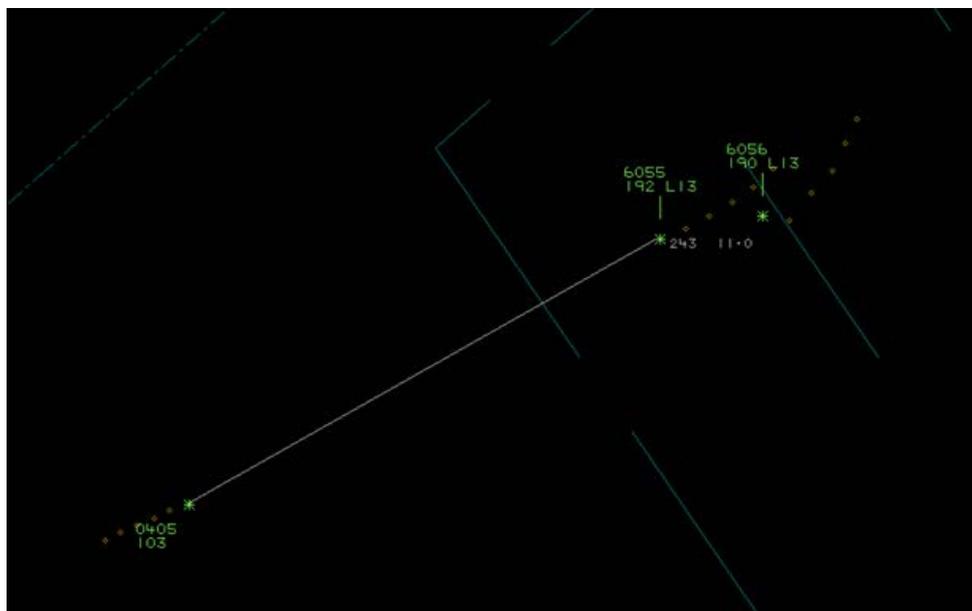
Figure 2: Geometry at 10:38:30 (Hawk SSR 0405; F15 SSR 6055/6)

At 10:38:30 (Figure 2), the Hawk checked in on frequency with Leeming Zone and Traffic Service was agreed. No Traffic Information was passed at this time, though Leeming Approach had passed Traffic Information on a pair of F15s prior to handing over the Hawk to Leeming Zone.

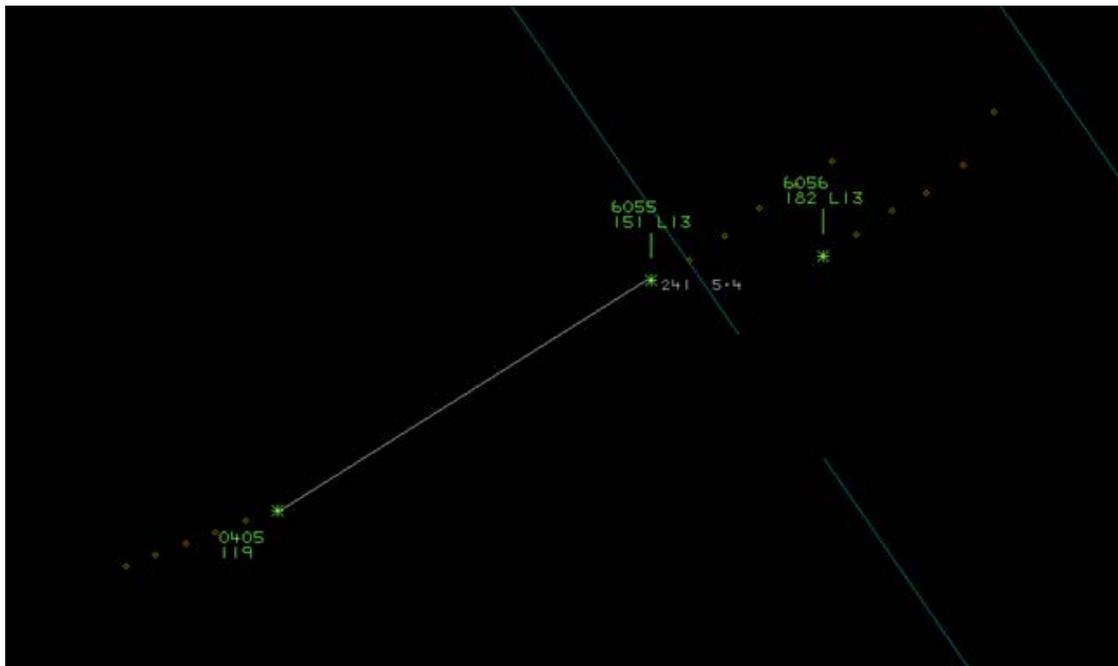
Figure 3: Geometry at 10:38:54 (Hawk SSR 0405; F15 SSR 6055/6)

At 10:38:54 (Figure 3), the Leeming Zone controller passed Traffic Information on the 'previously called traffic', described as NE, 5nm, tracking SW, indicating 500ft above, descending. There was no statement about the conflicting traffic being a pair. The Hawk pilot replied that he was looking but did not call visual. At the same time, the Swanwick NE Tac controller passed Traffic Information on the Hawk to the F15s as SW, 5nm, opposite direction, indicating FL120. The lead F15 replied that he was searching but did not call visual or systems contact.

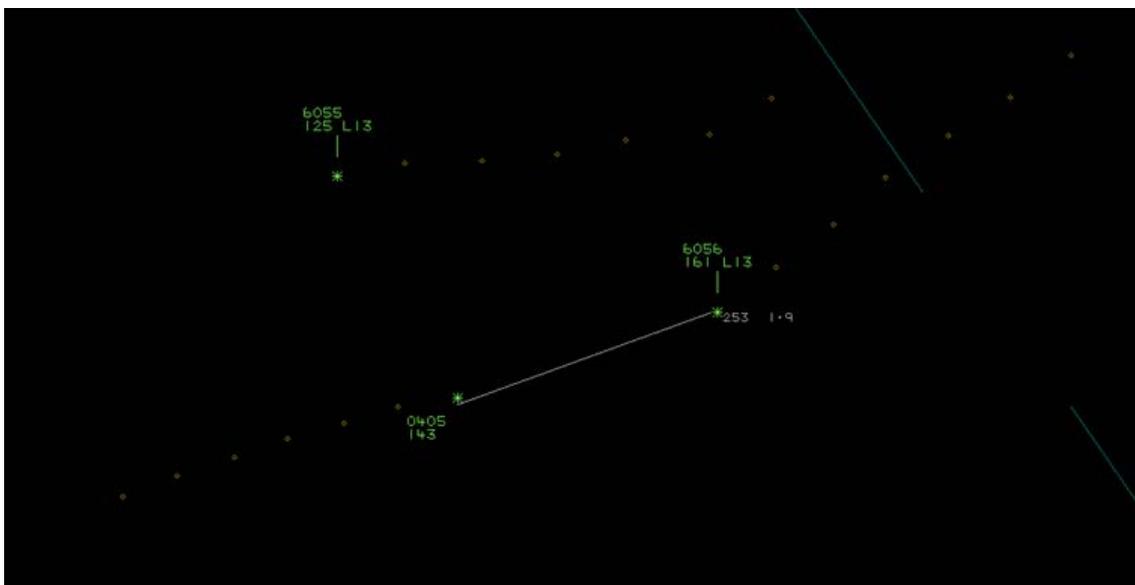
Figure 4: Geometry at 10:39:15 (Hawk SSR 0405; F15 SSR 6056)

At 10:39:15 (Figure 4), the Leeming Zone controller passed updated Traffic Information on 'further traffic', meaning the second aircraft in the pair of F15s. It was described as E, 1nm, tracking SW, indicating 1000ft above. Simultaneously, the Swanwick NE Tac controller provided updated Traffic Information to the second F15 as W, 1nm, tracking E at FL140 climbing. The pilot responded but still did not call visual.

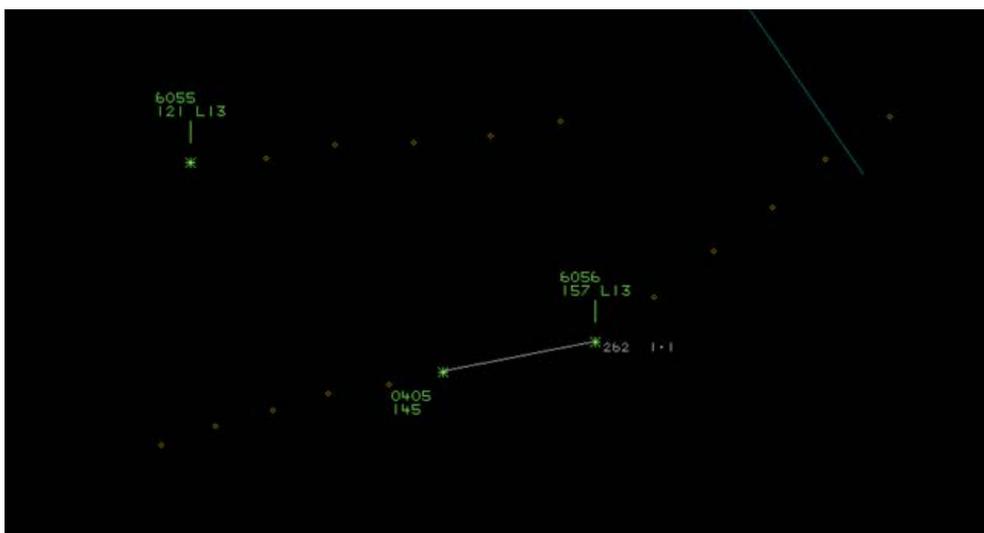
Figure 5: Geometry at 10:39:21 (Hawk SSR 0405; F15 SSR 6056)

At 10:39:21 (Figure 5), the Hawk pilot reported visual with the pair of F15s, followed by a declaration of Airprox with the second aircraft in the pair.

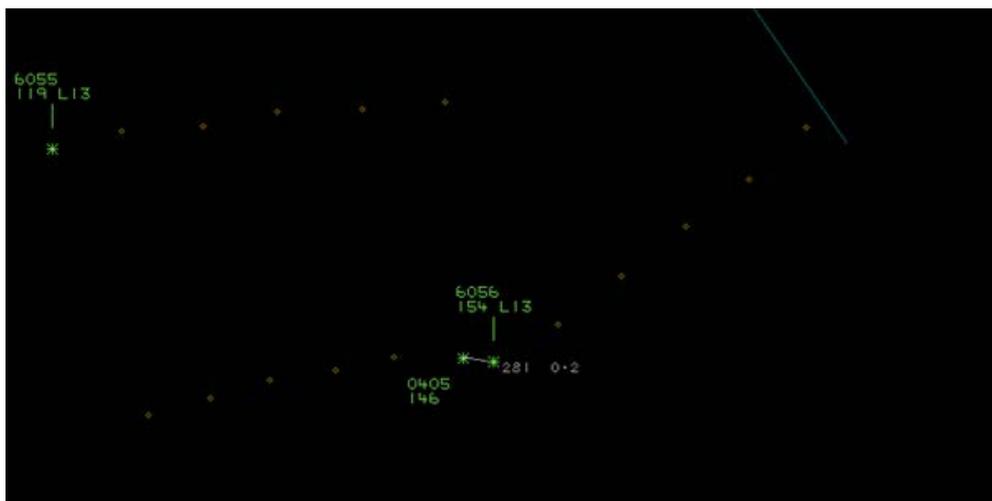
Figure 6: Geometry at 10:39:24 (Hawk SSR 0405; F15 SSR 6056)

At 10:39:24 (Figure 6), the 2 aircraft were at their CPA (crossing tracks) with an indicated vertical separation of 800ft.

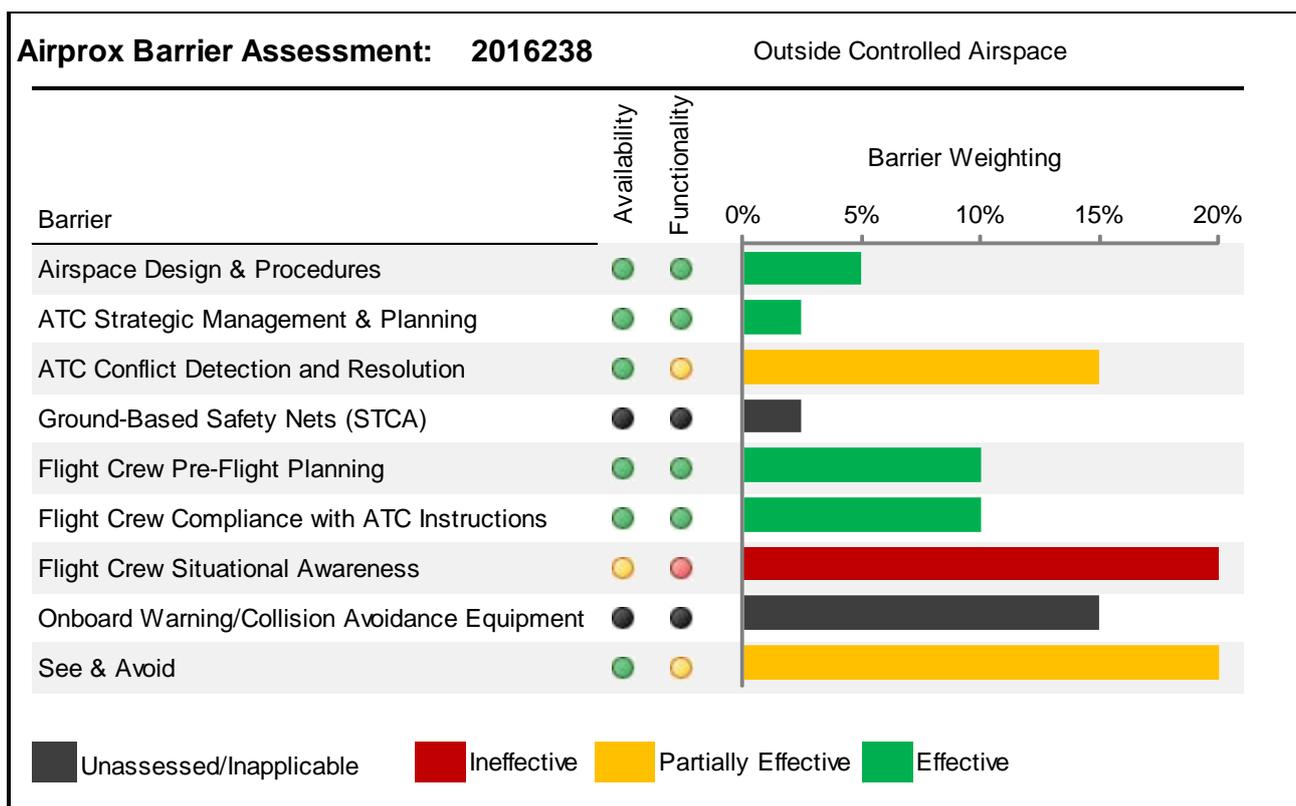
- **ATC Conflict Detection and Resolution** was only **partially effective** because, for different reasons, Traffic Information was passed late to both pilots and was not complete as far as the Hawk pilot was concerned.
- **Flight Crew Situational Awareness** was assessed as **ineffective** because the Hawk pilot was not told about the No2 F15 until it was too late, and the No2 F15 pilot did not assimilate that the vertical separation between the 2 aircraft was eroding rapidly as the Hawk climbed and he descended.
- **On Board Warning/ Collision Avoidance System** was assessed as **inapplicable** because neither aircraft was fitted with one.
- **See and Avoid** was assessed as **partially effective** because although the No2 F15 pilot saw the Hawk he did not avoid it sufficiently, and the Hawk pilot did not see the No2 F15 until the last minute.

Modern safety management processes employ the concept of safety barriers that prevent contributory factors or human errors from developing into accidents. Based on work by EASA, CAA, MAA and UKAB, the following table depicts the barriers associated with preventing mid-air-collisions. The length of each bar represents the barrier's weighting or importance (out of a total of 100%) for the type of airspace in which the Airprox occurred (i.e. Controlled Airspace or Uncontrolled Airspace).⁶ The colour of each bar represents the Board's assessment of the effectiveness of the associated barrier in this incident (either Fully Effective, Partially Effective, Ineffective, or Unassessable/Absent). The chart thus illustrates which barriers were effective and how important they were in contributing to collision avoidance in this incident.
