**AIRPROX REPORT No 2016002**

Date: 8 Jan 2016 Time: 1441Z Position: 5134N 00015E Location: 6nm E London City

**PART A: SUMMARY OF INFORMATION REPORTED TO UKAB**

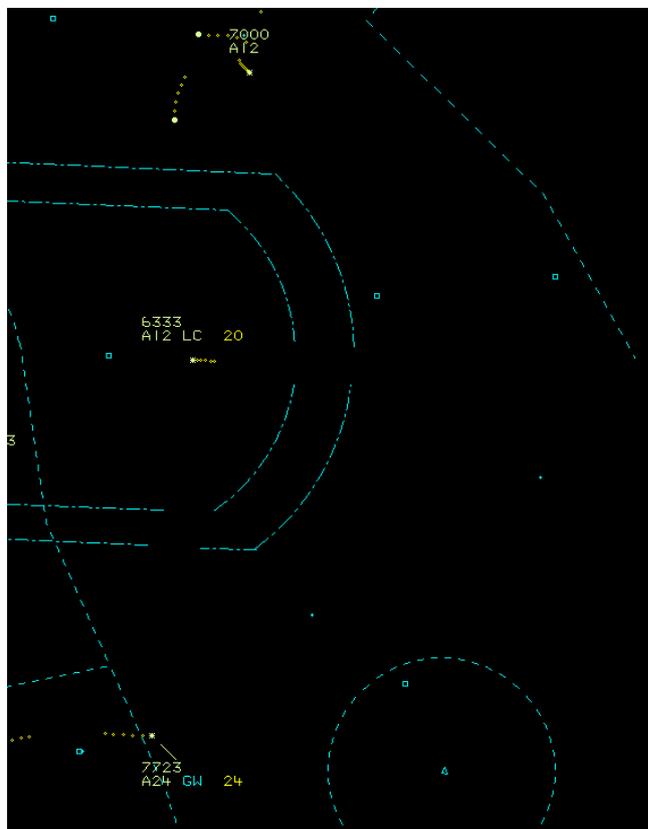
Figure 2 - 1437:40 (LJ75 code 7723).

At 1437:40 the LJ75 pilot was turned left on to a heading of 025° and he was advised by the controller that due to London City traffic he would provide vectors to take the aircraft outside the London City Control Zone (CTR) and around to the north (Figure 2).

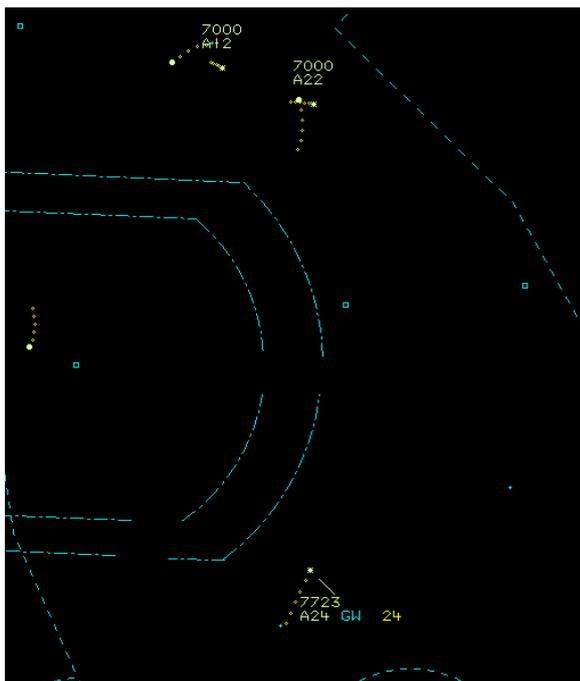
Figure 3 – 1439:26.

At 1439:26 the LJ75 pilot was turned left on to a heading of 010° (Figure 3).

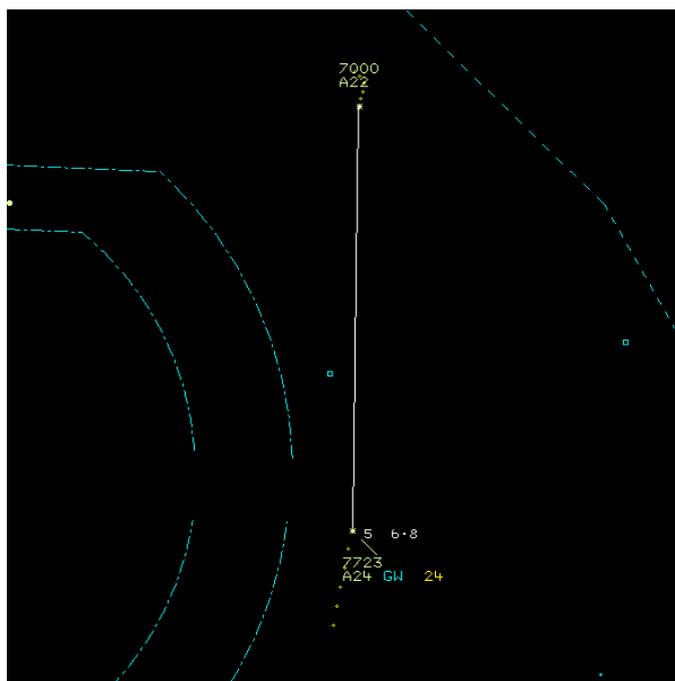
Figure 4 – 1440:25.

At 1440:25 the Thames controller contacted London City Tower to coordinate a transit of the north-eastern corner of their CTR with the LJ75, which was agreed. The LJ75 was passing underneath the London City final approach and the PA28 was 6.8nm north of the LJ75 tracking south (Figure 4).

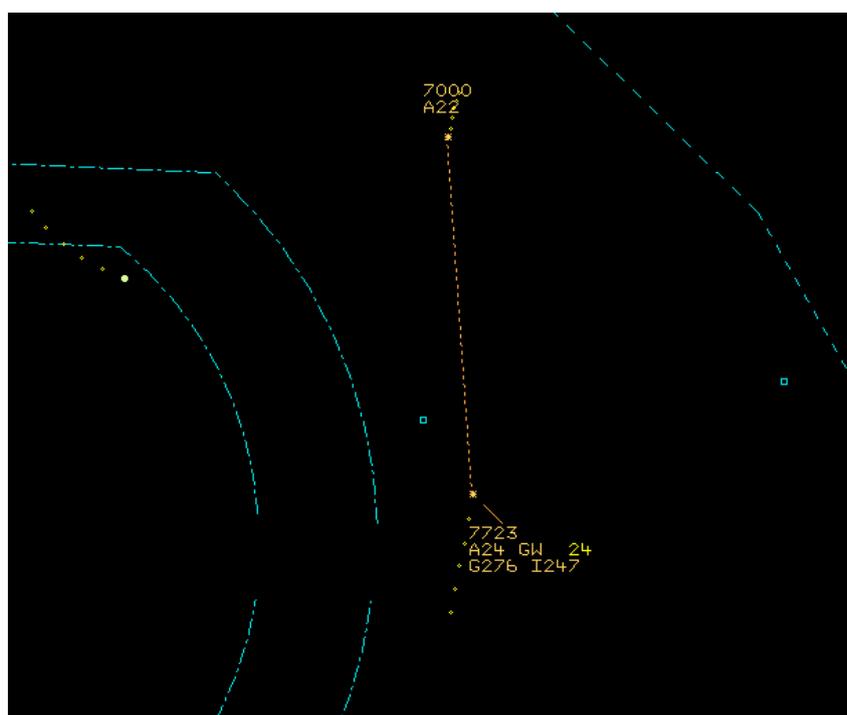
Figure 5 – 1440:45 – with LJ75's Ground & Indicated Air Speeds annotated.

At 1440:44 an Amber STCA was initiated and at 1440:45 the controller instructed the LJ75 pilot to turn left on to a heading of 300° degrees and passed Traffic Information on the PA28. The pilot of the LJ75 confirmed that he could see the PA28 on TCAS (Figure 5).

The coordination was initiated at 1440:20, but just as the telephone-call was being terminated, the Amber STCA was initiated on the controller's radar display. In accordance with the original plan, the controller then turned the LJ75 pilot left but this effectively turned the aircraft into direct conflict with the PA28.

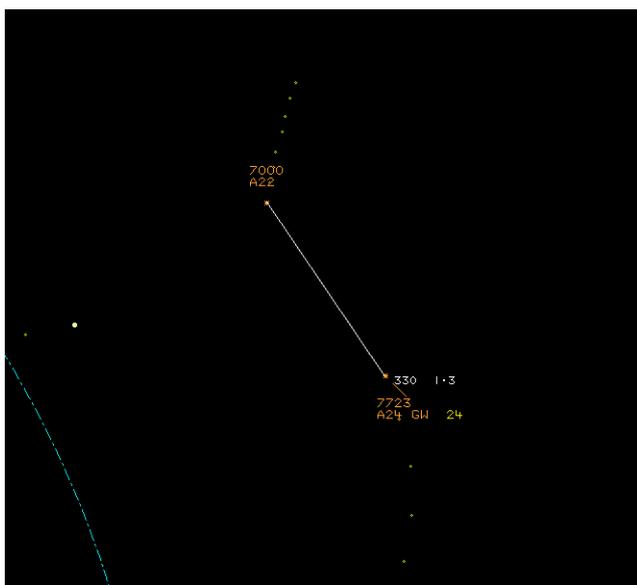
Figure 6 – 1441:20.

At 1441:20 the controller asked the LJ75 pilot if he was visual with the traffic to which the LJ75 pilot responded by reporting a TCAS RA (Figure 6).

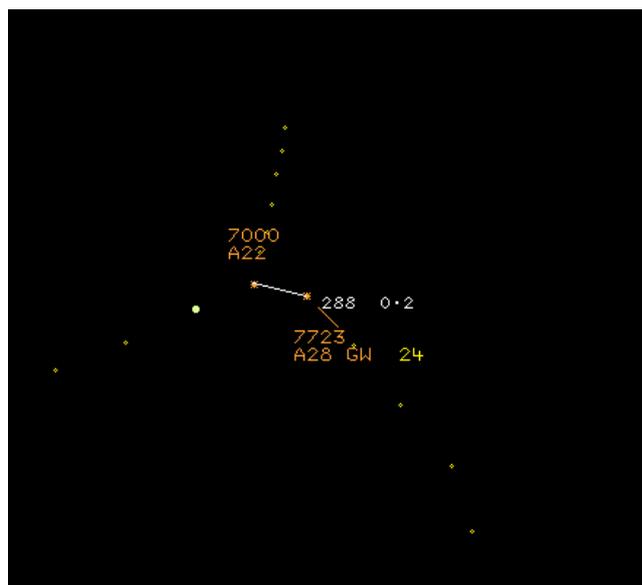
Figure 7 – 1441:31.

CPA was assessed to be at 1441:31 with the aircraft separated by 600ft vertically and 0.2nm horizontally (Figure 7). The LJ75 was observed in a climb to 3000ft although then descended almost immediately to 2800ft after the CPA.

Cause: The Thames controller vectored the LJ75 into conflict.

Degree of Risk: C.
