**AIRPROX REPORT No 2016012**

Date: 4 Feb 2016 Time: 1050Z Position: 5154N 00213W Location: Gloucestershire ATZ

**PART A: SUMMARY OF INFORMATION REPORTED TO UKAB**

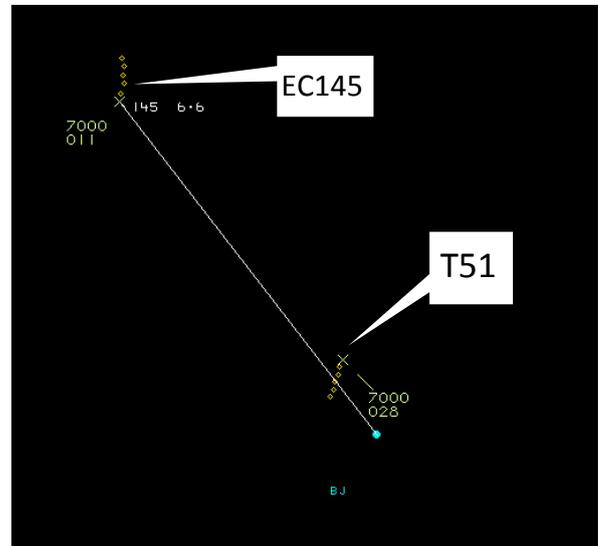
Figure 1 – 1047:00.

At 1047:00, the EC145 pilot, 6.6nm north-west of Gloucestershire Airport, contacted Gloster Approach and requested a downwind join at 2000ft for an autorotation. This was approved at 1048:00, Traffic Information was passed on traffic in the Gloucestershire overhead at 3000ft, and the helicopter pilot was then transferred to Gloster Tower at 1048:28. (The traffic in the overhead was a Titan T51 operating up to 3000ft with Gloster Tower) (Figure 1).

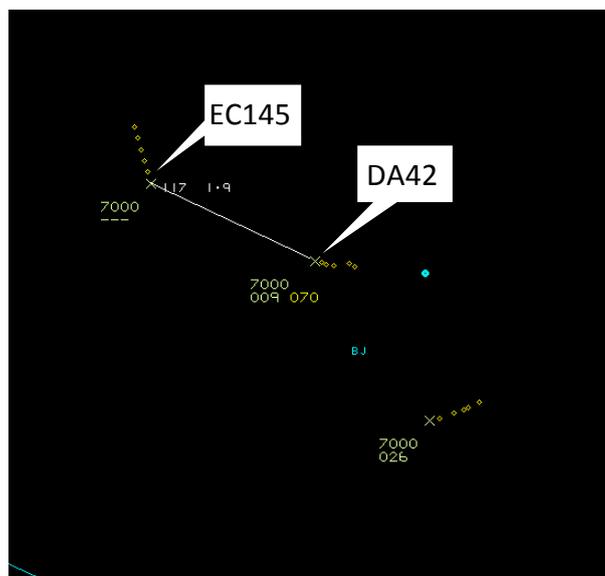
Figure 2 – 1049:30.

At 1049:30 (Figure 2), the DA42 pilot was transferred to Gloster Approach (but did not report on frequency until 1050:00).

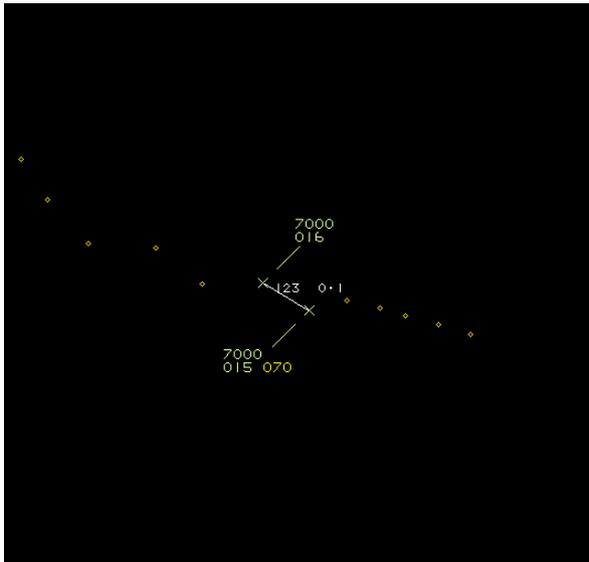
Due to the area radar update rate, CPA was assessed to have taken place between 1050:07 and 1050:10 (Figures 3 & 4), with the aircraft separated by less than 0.1nm horizontal and 100ft vertical.

Figure 3 – 1050:07  
Aircraft approaching each other

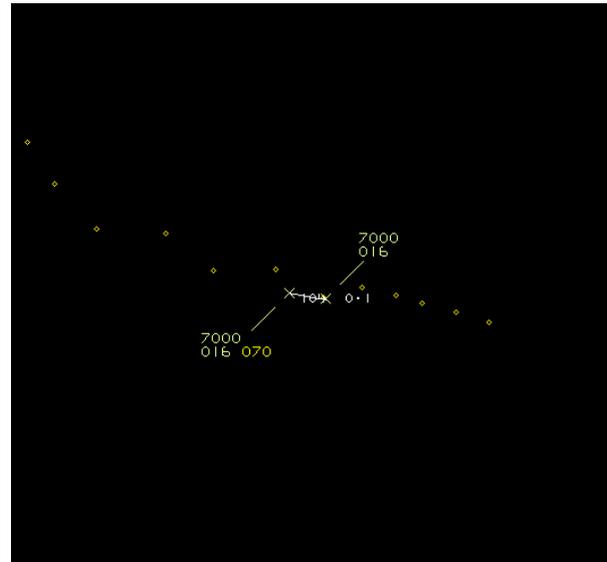
Figure 4 – 1050:10  
Both aircraft having passed each other.

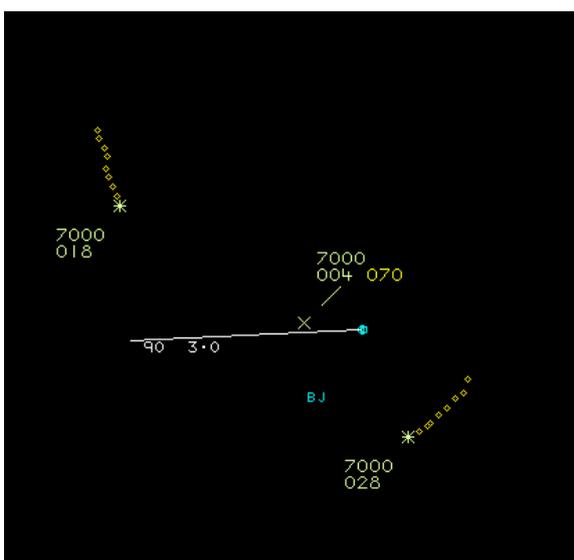
In the unit investigation report, and confirmed by the Aerodrome controller at interview, the routing of the inbound EC145 came as a surprise, because, although the EC145 pilot had requested a "downwind" join, the Aerodrome controller had not expected the EC145 pilot to commence the join as far west downwind as he did (Figures 5 & 6).

Figure 5 – 1049:12  
With cursor set to RW27 centreline – 3nm.

*That Gloucestershire ATC and the based helicopter operators agree what is considered as a standard "downwind" join and that this is published and available to all parties.*

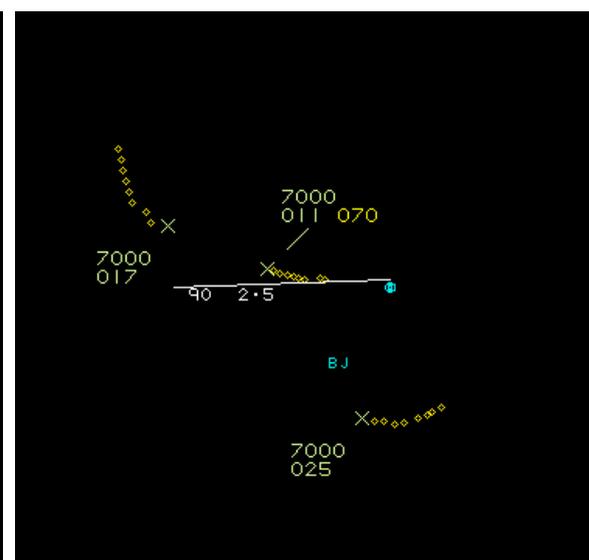
Figure 6 – 1049:44  
EC145 commenced turn 2.5nm WNW of airport
