**AIRPROX REPORT No 2016065**

Date: 03 May 2016 Time: 1239Z Position: 5236N 00006W Location: SSW Fenland

**PART A: SUMMARY OF INFORMATION REPORTED TO UKAB**

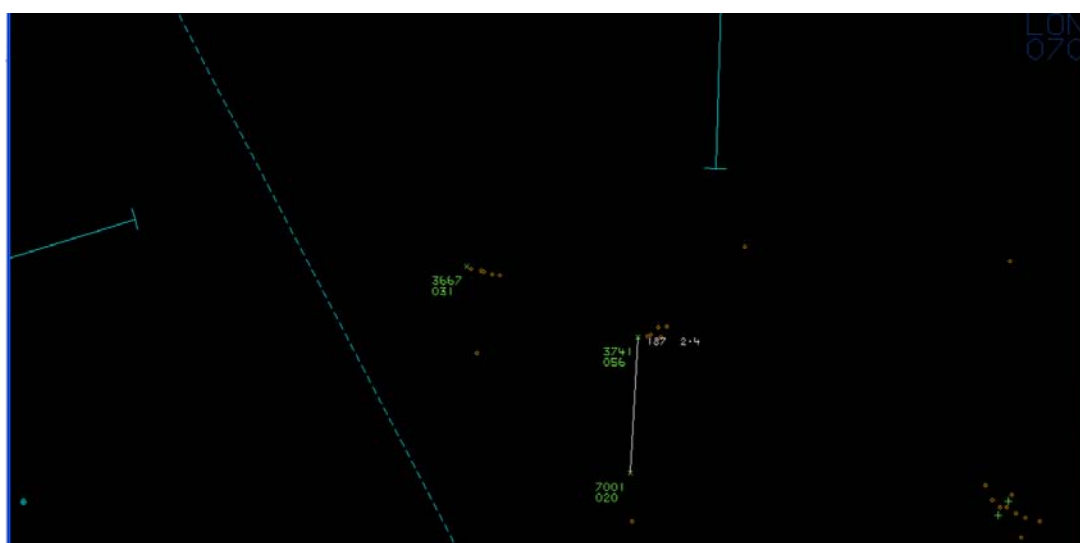
Figure 1: Geometry at 1239:26Z (Hawk squawking 7001: Tutor Squawking 3741)

At 1239:26Z (Figure 1), the Hawk is 2.4nm to the south of the Tutor and transiting North, North West about to pull out of low level. The Tutor is transiting west.

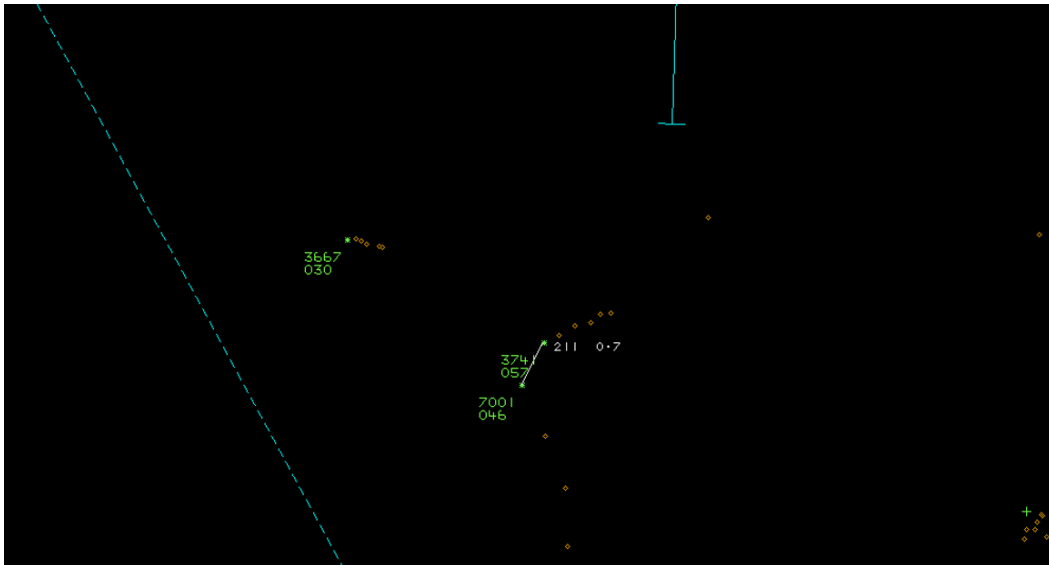
Figure 2: Geometry at 1239:40Z (Hawk Squawking 7001; Tutor Squawking 3741)

At 1239:40Z (Figure 2), the Hawk is 0.7nm to the south west of the Tutor and transiting north-north-west climbing out of low-level. The Tutor is transiting west in level flight. At this time traffic information had been passed by Wittering ATC to the Tutor, and the pilot had reported visual.
