AIRPROX REPORT No 2016076

Date: 15 May 2016 Time: 1300Z Position: 5159N 00210W Location: 1nm W Tewkesbury

PART A: SUMMARY OF INFORMATION REPORTED TO UKAB

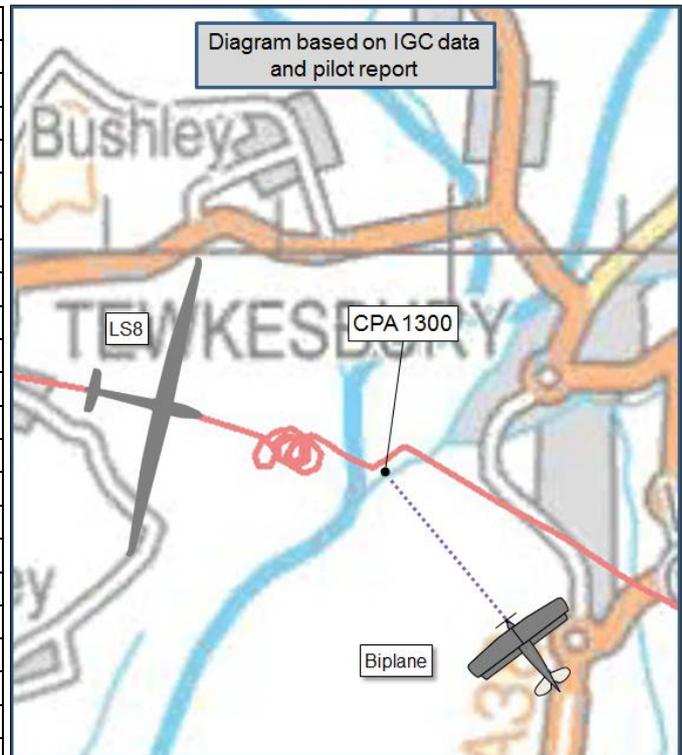
THE LS8 PILOT reports that he was about 1km west of Tewkesbury. He had been circling right hand in a thermal and straightened up to continue en-route. About 15 seconds later, while looking down and to his right, he saw another aircraft heading straight for him and assessed that it would hit him if they both continued on their current trajectories. He wasn't sure whether the other aircraft was in the first part of a loop manoeuvre or in a straight climb. He hoped that by turning to his left and climbing it would pass behind him provided that it did not then turn to its right. Whilst turning, he lost sight of the other aircraft but heard it pass behind him. Then he turned back on track and caught a glimpse of the other aircraft behind and on his right. Thinking that the pilot may still have been unaware of his presence whilst performing aerobatics he thought it best to continue on track to increase the separation.

Cause: A late sighting by the LS8 pilot and a probable non-sighting by the Biplane pilot.
