AIRPROX REPORT No 2016088

Date: 23 May 2016 Time: 1148Z Position: 5109N 00134W Location: Middle Wallop airfield
Elevation 297ft.

PART A: SUMMARY OF INFORMATION REPORTED TO UKAB

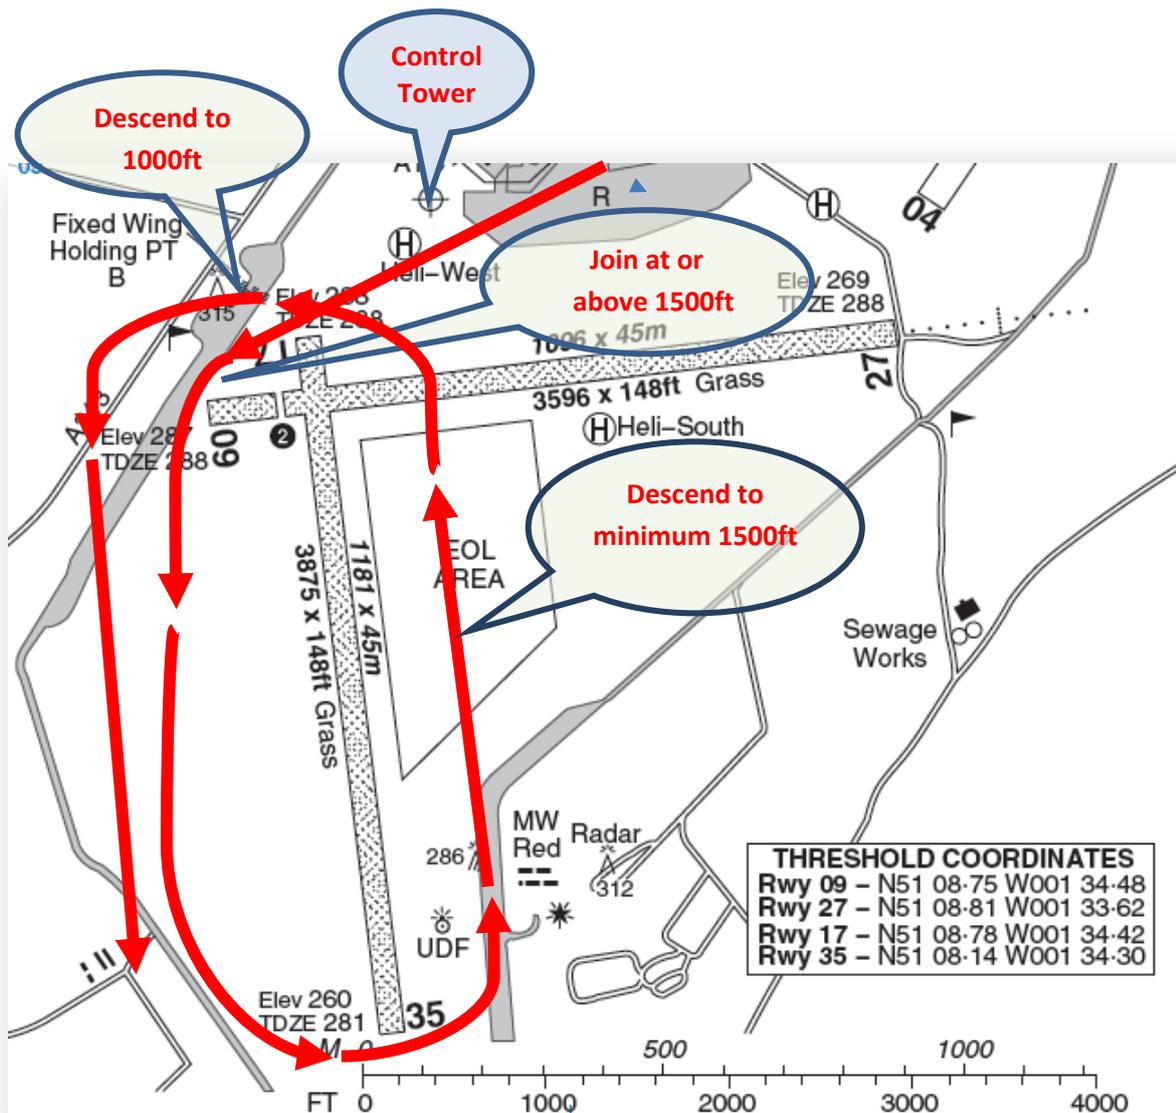
Figure 2.

The Wallop Aerodrome controller had a pending flight progress strip on the DA40 so, when the pilot called at 1147:42, he was able to issue a joining instruction to join overhead for RW35. Figure 2 indicates the expected circuit join that the DA40 pilot would make. Traffic Information about the departing aircraft was passed. The controller reported that the DA40 was approximately 2.5nm from Middle Wallop at this time.

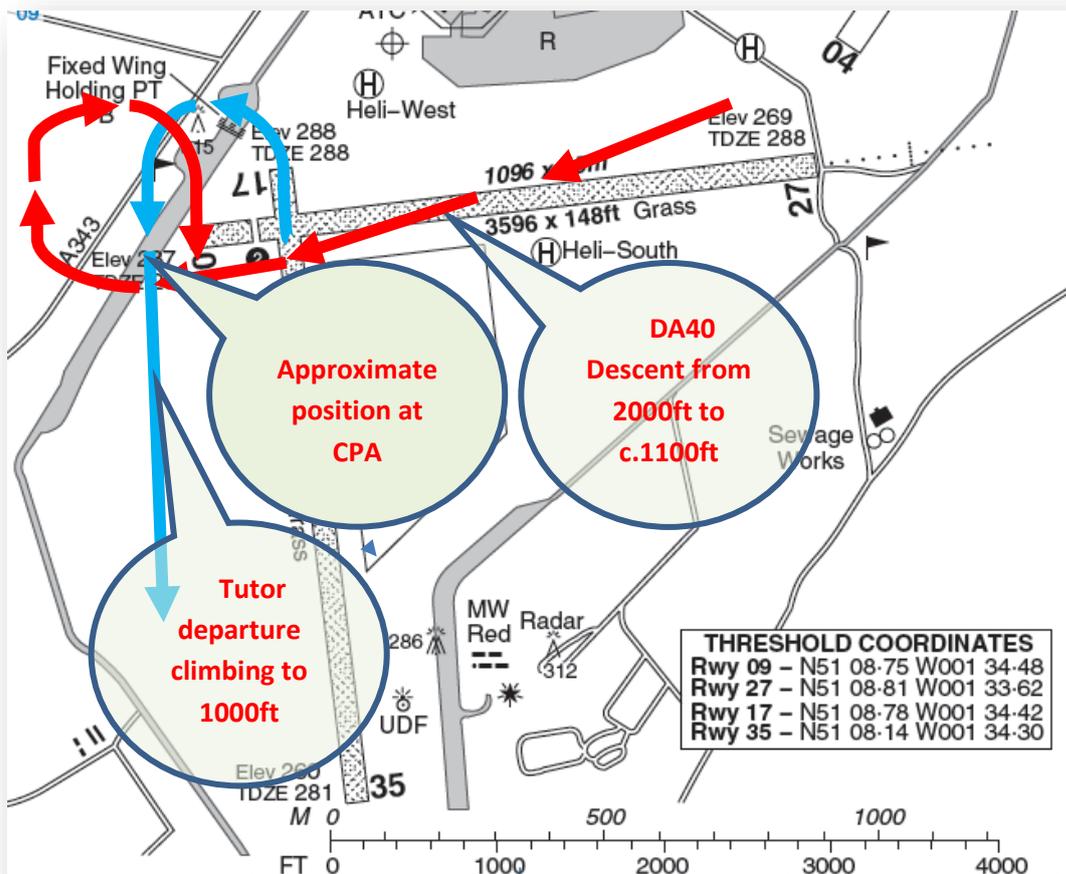
Figure 3-Approximate position of CPA.

At 1149:30 the DA40 pilot reported “just joining overhead and I’ve just noticed an aircraft downwind...I’m actually going to turn in to the right behind him”. The controller immediately asked the Tutor pilot if he could see the DA40 joining behind them to which he reported “Yeah, he was cutting in front of me at about eleven hundred feet, not sure why he was doing that”. The DA40 pilot, although reporting turning right to go behind the Tutor, had meant that an orbit to the right was being executed to bring the DA40 in behind the Tutor downwind. The DA40 pilot had descended to approximately circuit height prior to passing in front of the Tutor. Figure 3 shows the probable track the inbound DA40 took (in red) with the Tutor track (in blue).

The controller had observed the departing Tutor turning downwind and was surprised to see the DA40 appear at a lower level and not heading in the expected direction. No 'dead-side' join was flown by the DA40, who appeared not to have complied with the standard overhead join procedures. The controller stated that although the DA40 was civilian registered, they expected the pilot to be complying with the FOB procedures as the operator was known, and as such issued instructions using phraseology in accordance with Chapter 10 of CAP413.

On seeing the proximity of the two aircraft west of the tower, the controller considered that the safety of the two aircraft had been compromised and had submitted the Airprox report. Both aircraft were operating VFR in class G airspace and as such the pilots were responsible for their own collision avoidance.
