AIRPROX REPORT No 2016096

Date: 02 Jun 2016 Time: 1200Z Position: 5111N 00101W Location: Lasham Airfield

PART A: SUMMARY OF INFORMATION REPORTED TO UKAB

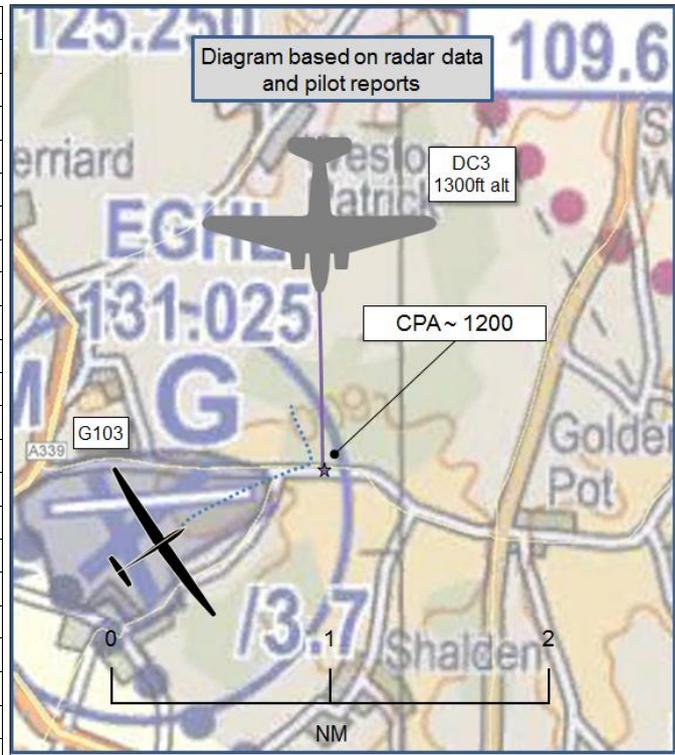
THE G103 GLIDER PILOT reports that he was P1 in the rear seat of a G103 on an instructional flight with a pre-solo student pilot. They launched by winch on bearing 050° with a 15 – 17kt wind from the north, the P2 was handling. There was significant correction to the left on the launch such that release took place on a line directly above the winch or slightly to the NW of it. A height of 1300ft AGL was achieved from the launch and, at that time, the cloud base was about 1400 - 1500ft AGL. After release from the cable, they continued briefly on a NE heading, descending gradually to about 1200ft and the student appeared to prepare for a turn to the right which, in his view would not have positioned them well for making a judgement about where to start a properly planned circuit. As he prompted the student to consider a turn to the left (into wind) he looked back over the nose of the glider and immediately said “There’s an aircraft ahead” at which point a DC3 Dakota came into his sight from a position under the nose of the glider. The DC3 was on a southerly heading, about 200ft below, and approx 200 yards distant to the right. The student began a gentle turn to the left which brought them parallel reciprocal to the DC3 and increased their rate of separation from it. Due to the difference in altitude, there was no immediate risk of collision but, had they turned right as the student intended, loss of height in the turn and rapid reduction of the separation between the aircraft would have presented a serious risk of very unsafe proximity between the two aircraft. The DC3 made no alteration of course, and continued straight-and-level to the south. He estimated that the DC3 flew over the Avenue Nurseries premises, which are situated about 400 yards east of the threshold to runway 27 at Lasham.

THE LASHAM GROUND INSTRUCTOR reports that the G103 was manoeuvring over the NE boundary of the airfield; the other aircraft passed below and appeared to be within the traffic circuit of the gliding operation heading south. At the time of the Airprox, the glider had just released and the winch cable was still being wound in by the winch with the drogue chute still airborne.

The DC3 passed within 0.7nm to the east of Lasham at 1600ft. Lasham is notified as a gliding site with tow and winch launches up to an upper limit of 3000ft agl.
