AIRPROX REPORT No 2016124

Date: 30 Jun 2016 Time: 1108Z Position: 5115N 00109W Location: 7nm NW Odiham

PART A: SUMMARY OF INFORMATION REPORTED TO UKAB

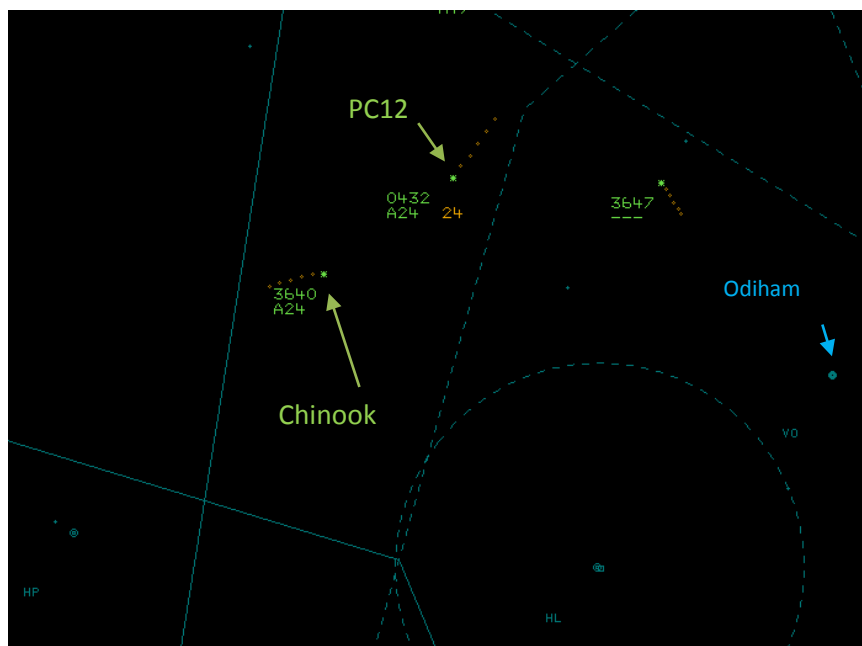
Figure 1 at 1107:01

At 1107:01 (Figure 1) on observing the potential conflict of the PC12 and the Chinook, the Farnborough Controller provided Traffic Information to the PC12 about the unknown aircraft (Chinook) which was crossing right to left at the same level. The pilot reported turning to the right to avoid, but did not state whether or not they had the traffic in sight.

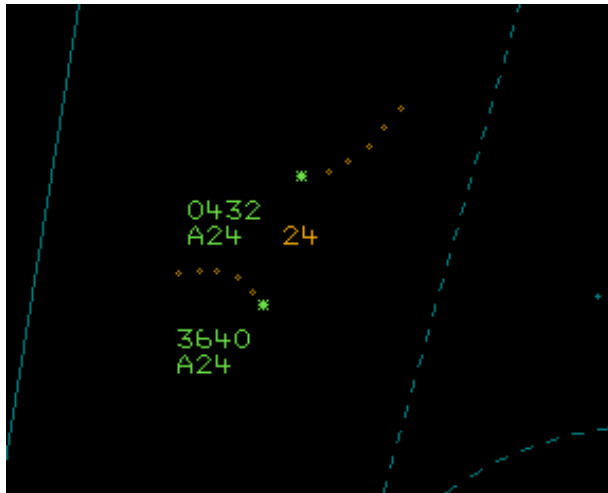
Figure 2 at 1107:19

At 1107:19 the radar indicated that the PC12 had turned onto a westerly heading and the Chinook was turning onto a southerly heading. At 1107:52 (Figure 3) the PC12 had turned left again routing towards Southampton. The Chinook was now heading west.

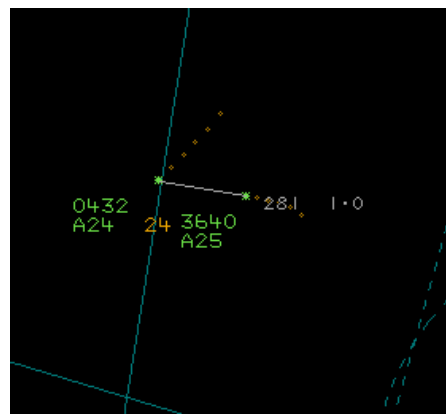
Figure 4 at 1108:20 - CPA

CPA occurred at 1108:20 – co-incident with the conversation taking place between the Farnborough and Odiham controllers – minimum horizontal distance of 1nm and minimum vertical distance of 100ft.

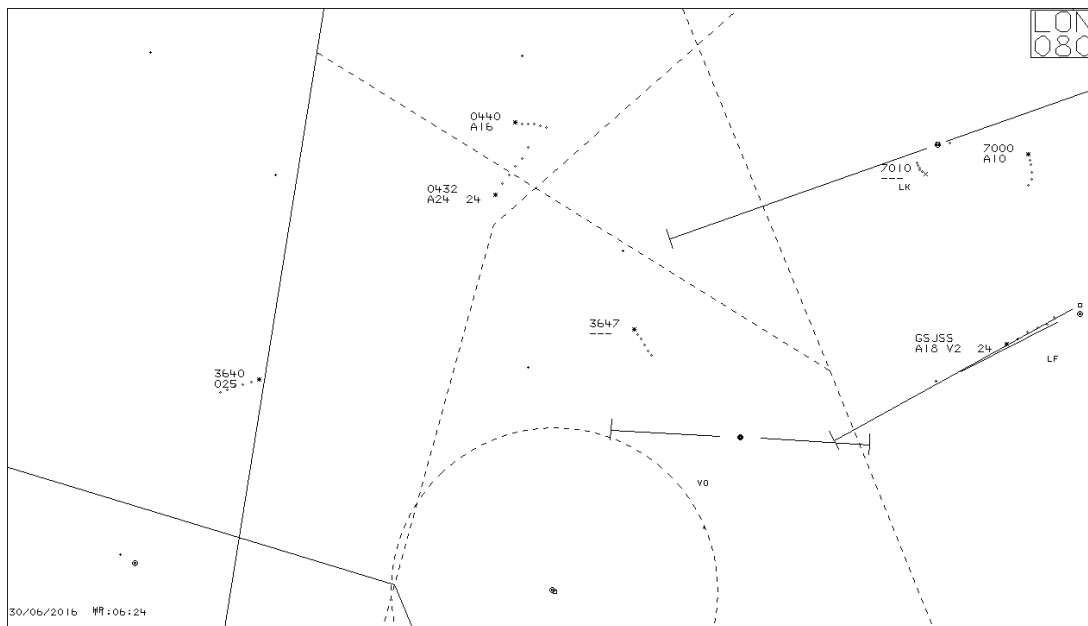
Figure 5: Geometry at 1106:24 (Chinook squawking 3640; PC12 squawking 0432).

At 1106:24 (Figure 5), The Chinook was to the West of Odiham and being positioned for a PAR for RW09 on a Traffic Service. The Odiham controller had spoken with Farnborough ATC to inform them of the approach to RW09 as per procedures. The PC12 is to the North West of Odiham tracking South West; the radar replay shows the aircraft on a converging heading at the same height.

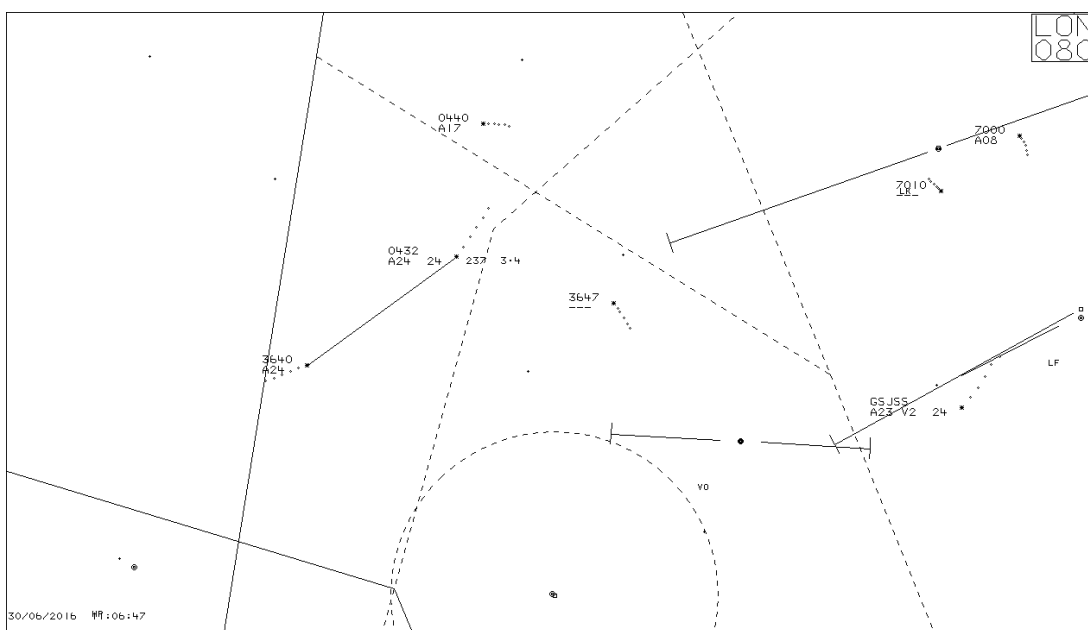
Figure 6: Geometry at 1106:47 (Chinook squawking 3640; PC12 squawking 0432).

At 1106:47 (Figure 6), the Odiham Approach controller passes Traffic Information to the Chinook pilot on the PC12, *'traffic left 10 o'clock, 2 miles, crossing left right, indicating similar altitude, are you visual'*. The Chinook pilot reported not visual, and the controller issued a turn to the right and an orbit in order to resolve the conflict. At this time there is 3.4nm separation and the aircraft are at the same height.

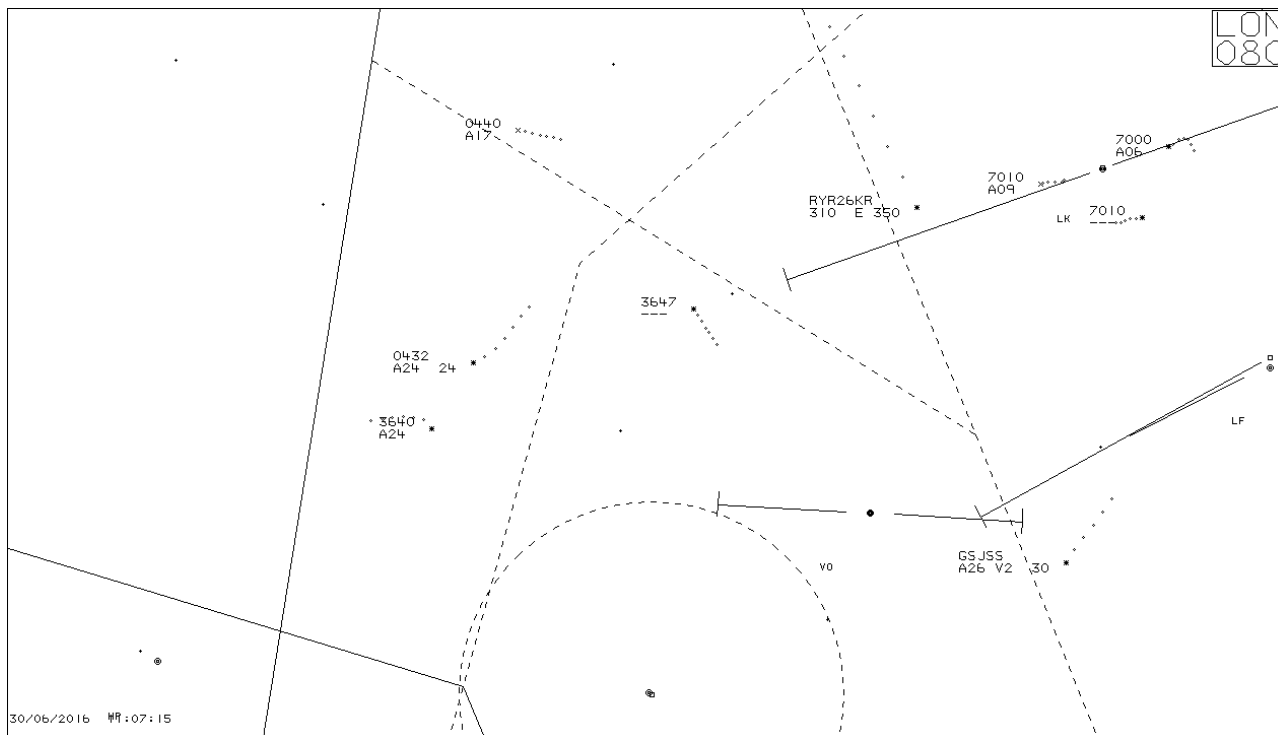
Figure 7: Geometry at 1107:15 (Chinook squawking 3640; PC12 squawking 0432).

At 1107:15 (Figure 7), the Chinook was in a right hand turn and the PC12 also initiated a right hand turn onto a more westerly heading.

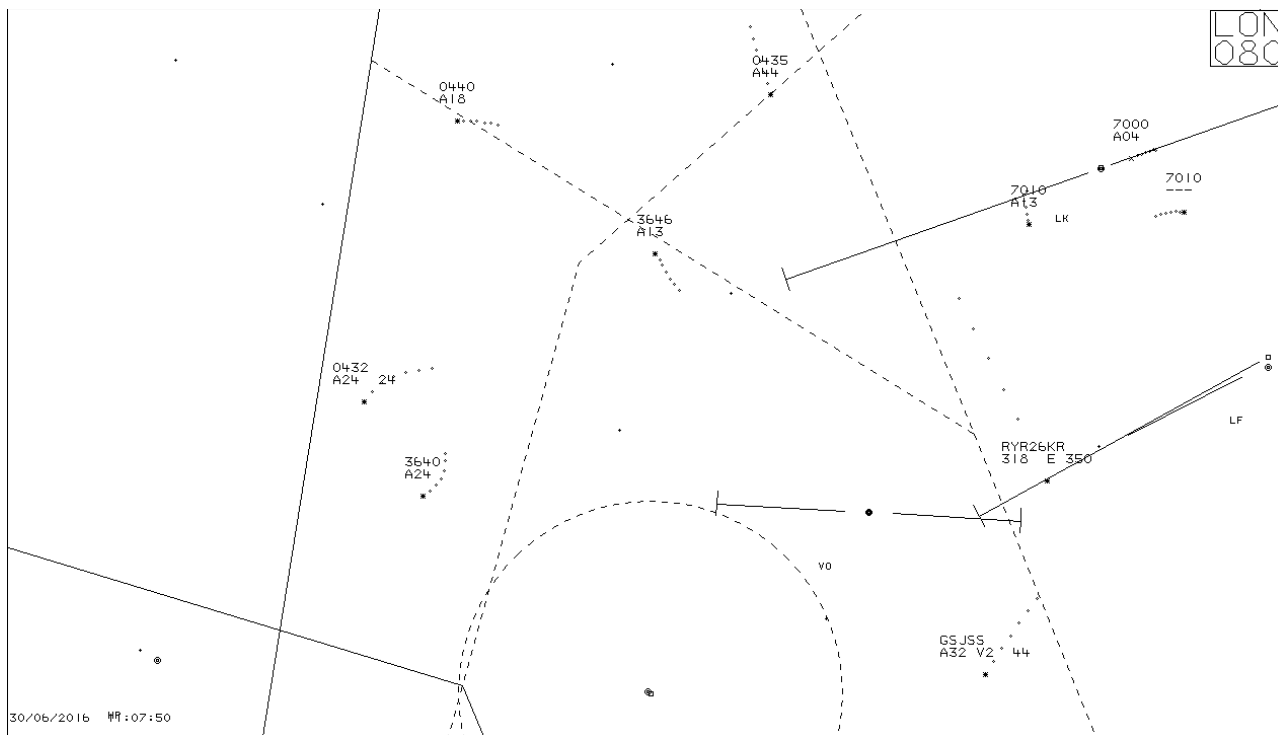
Figure 8: Geometry at 1107:50 (Chinook squawking 3640; PC 12 squawking 0432).

At 1107:50 (Figure 8), the PC12 again changes course, turning left onto a more southerly heading back towards the Chinook. The controller recognises this and stops the turn of the Chinook at 180°; it is evident from the replay that the Chinook has already turned through 180°.

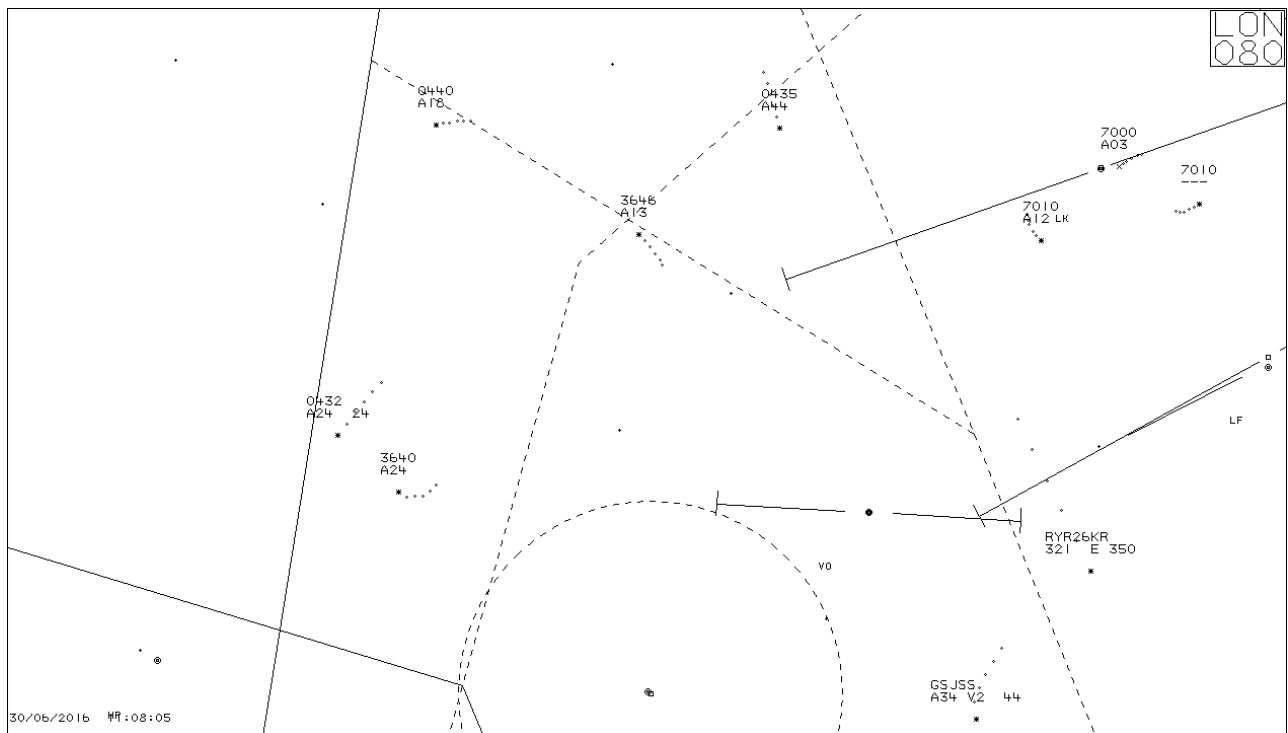
Figure 9: Geometry at 1108:05 (Chinook squawking 3640; PC12 squawking 0432).

At 1108:05 (Figure 9), the Chinook pilot saw the PC12 visually and, to avoid going into cloud, continued a right hand turn.

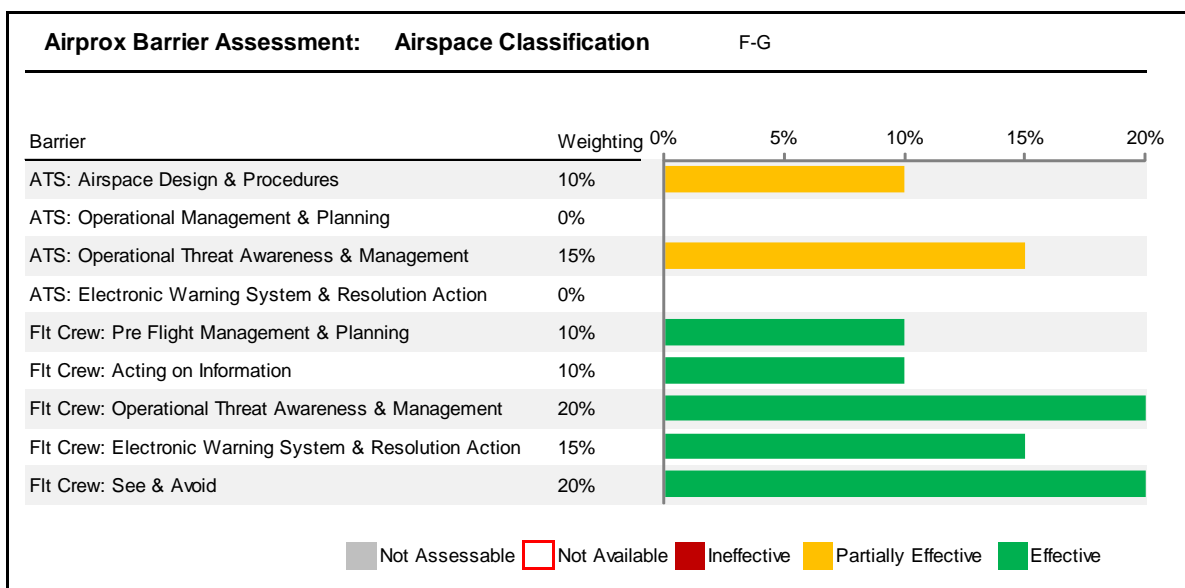
In assessing the barriers that were available in this incident, the Board first noted that the ATS procedure between the two ATC units had broken down and, although the MATZ still existed for protection, they therefore assessed that airspace design and procedures were only partially effective. They also thought that ATC actions in identifying and resolving the conflict were only partially effective given that liaison between the 2 controllers had not been effectively conducted. However, on the positive side, members noted that the PC12 had received Traffic Information on his TAS and, ultimately, see-and-avoid had been an effective barrier.

Modern safety management processes employ the concept of safety barriers that prevent contributory factors or human errors from developing into accidents. Based on work by EASA, CAA, MAA and UKAB, the following table depicts the barriers associated with preventing mid-air-collisions. The length of each bar represents the barrier's weighting or importance (out of a total of 100%) for the type of airspace in which the Airprox occurred (i.e. Controlled Airspace or Uncontrolled Airspace).⁴ The colour of each bar represents the Board's assessment of the effectiveness of the associated barrier in this incident (either Fully Effective, Partially Effective, Ineffective, Not Available, or Not Assessable). The chart thus illustrates which barriers were effective and how important they were in contributing to collision avoidance in this incident.
