AIRPROX REPORT No 2016156

Date: 28 Jul 2016 Time: 1211Z Position: 5146N 00003E Location: Lambourne hold

PART A: SUMMARY OF INFORMATION REPORTED TO UKAB

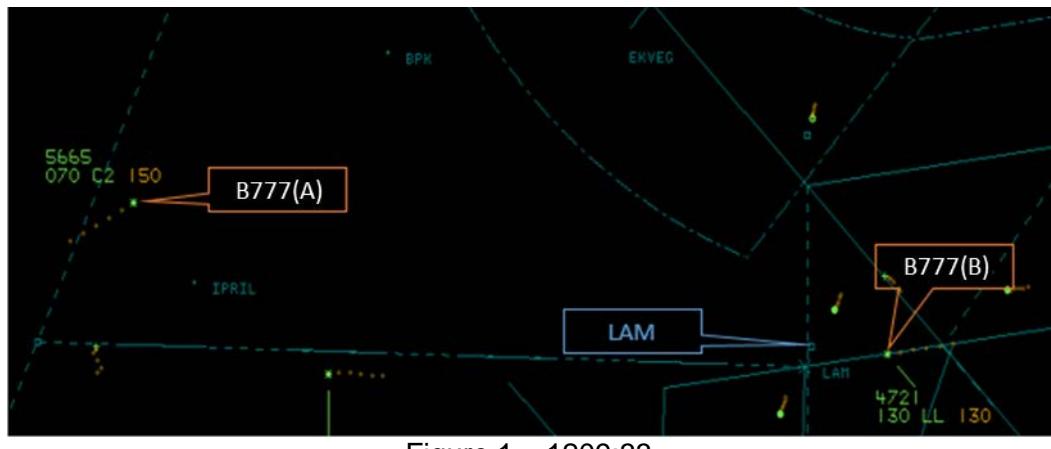
At 1209:33 (Figure 1) the B777(B) pilot was instructed to descend to FL120 and then transferred to Heathrow Director (LL INT N).

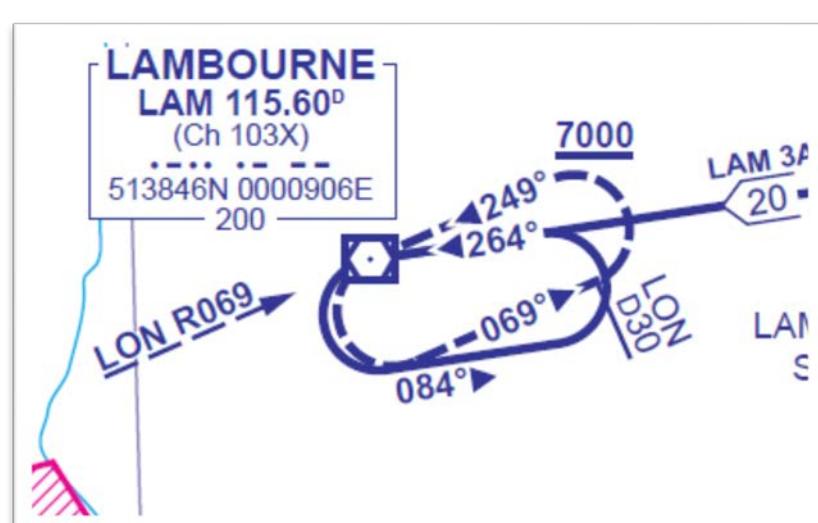
The LAM hold is a left-hand holding pattern as depicted in Figure 2 below.

The B777(B) flew over LAM at 1209:54 and commenced a right turn.

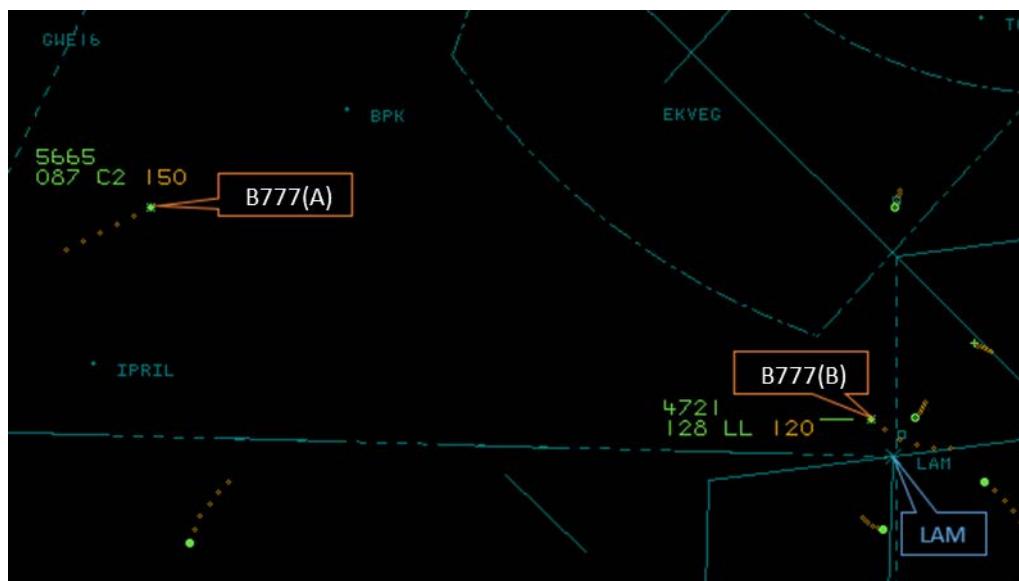
Figure 3 at 1210:40.

At 1210:40 (Figure 3) the TC East controller issued an avoiding action turn to the B777(A) pilot onto a heading of 040°. At the same time the LL INT controller issued a turn to the B777(B) pilot onto a westerly heading. Both controllers issued Traffic Information to their respective aircraft.

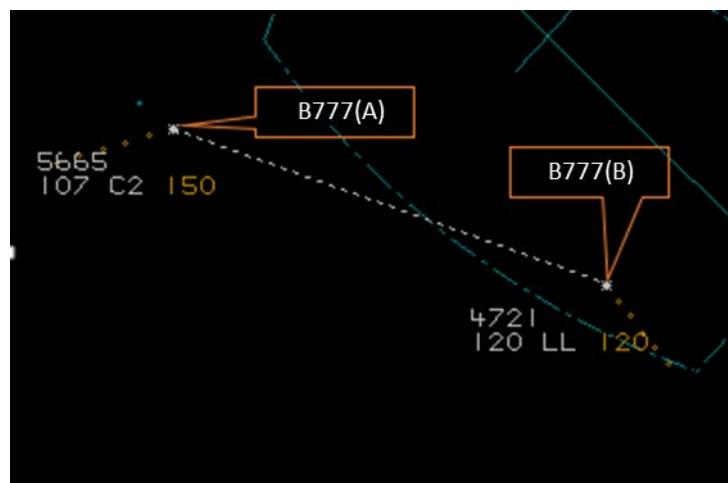
Figure 4 – 1210:52.

At 1210:52 (Figure 4) the Short Term Conflict Alert activated.

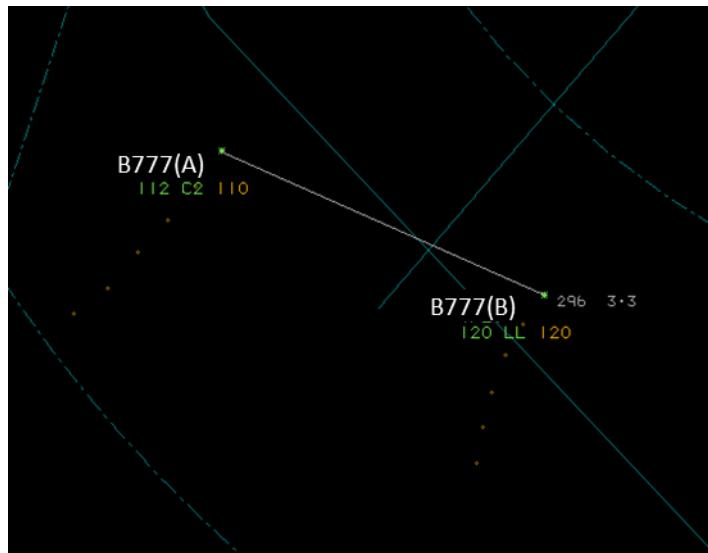
Figure 5 at 1211:34 – CPA.

CPA occurred at 1211:34 (Figure 5) when the aircraft were 800ft vertically and 3.3nm horizontally apart. The pilot of the B777(A) reported visual with B777(B) and later filed an Airprox report. Standard Radar separation was maintained. [3nm]

According to the unit report, the pilot of B777(B) reported that a discrepancy between the charts and the programming of the FMS had caused the error, which he had not become aware of until the aircraft began a right turn. The aircraft were operating in Class A airspace where ATC are responsible for separating the aircraft. Separation was maintained due to the timely action taken by the controllers involved.

Cause: The B777(B) pilots incorrectly programmed their FMS and turned towards the B777(A).
