AIRPROX REPORT No 2016170

Date: 10 Aug 2016 Time: 0956Z Position: 5437N 00252W Location: SW Penrith

PART A: SUMMARY OF INFORMATION REPORTED TO UKAB

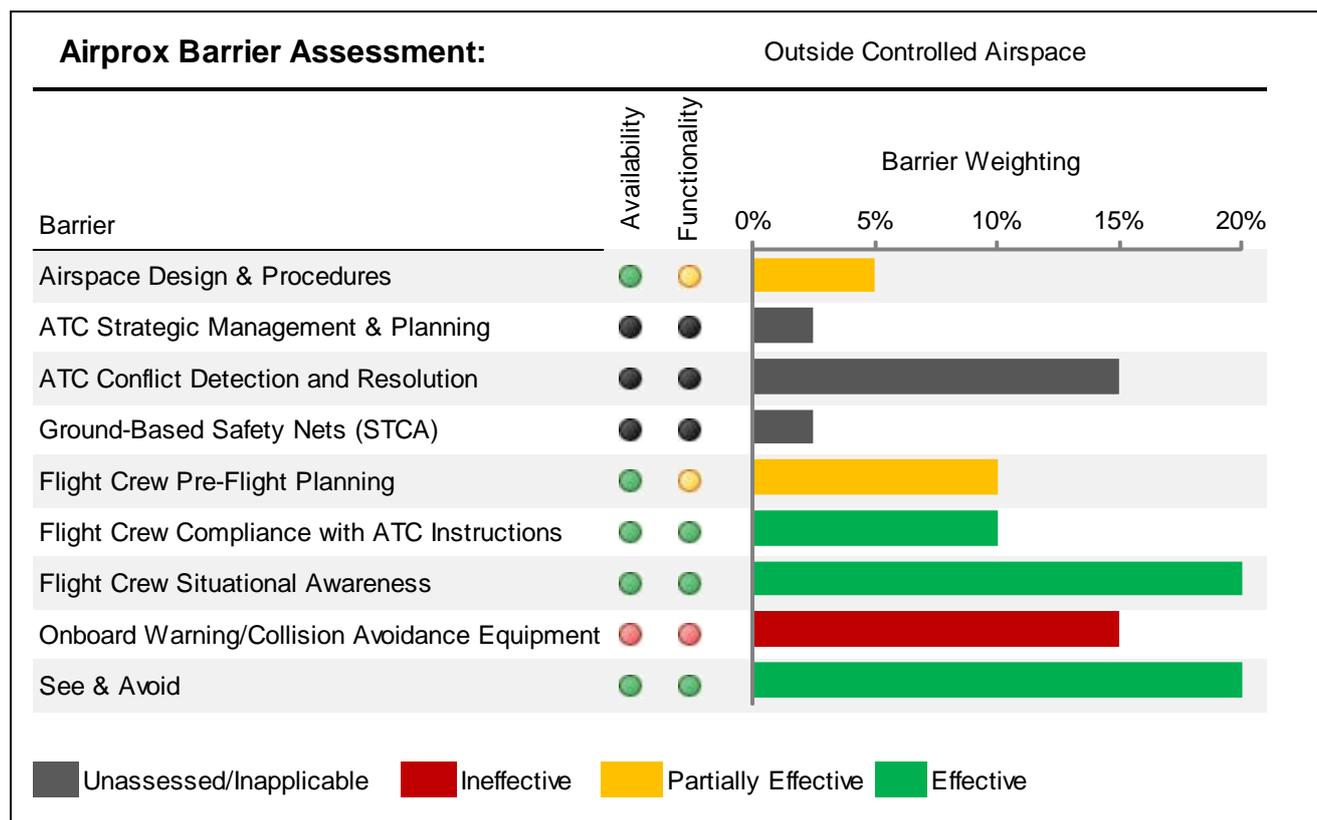
Barrier Assessment:

- **Airspace Design & Procedures** was considered **partially effective** overall because of the lack of a VHF LL Common frequency.
- **Flight Crew Pre-Flight Planning** was considered **fully available** in its present guise but only **partially effective** because the pilots were on different frequencies. Whilst this can often be the case, the Board felt that the availability and use of a VHF common frequency for low-level flights and transits in areas where air traffic services are limited would have increased the information available to both pilots regarding the other's presence.
- **Onboard Warning/Collision Avoidance Equipment** was assessed as being **ineffective** because although the Tucano had TAS fitted, the Gyrocopter was not fitted with a transponder therefore the TAS could not identify the Gyrocopter and rendered the equipment ineffective.
