AIRPROX REPORT No 2016177

Date: 16 Aug 2016 Time: 1039Z Position: 5154N 00218W Location: 7nm W Gloucestershire airport

PART A: SUMMARY OF INFORMATION REPORTED TO UKAB

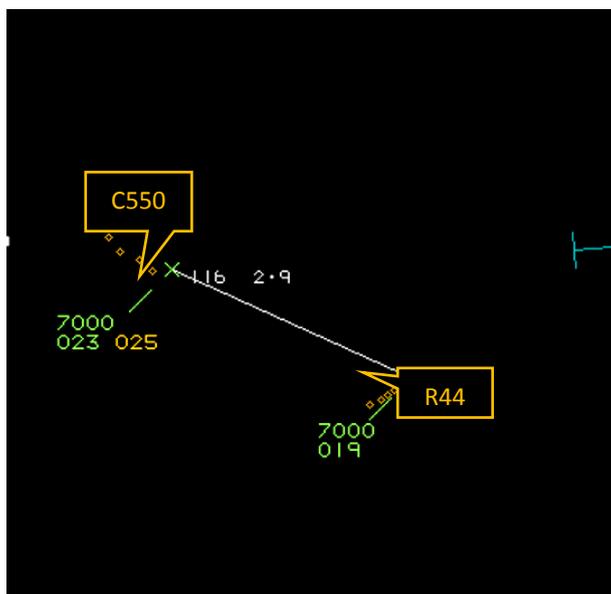
Figure 1 – 1037:33.

At 1037:37 the C550 pilot, based on TCAS information available to him, reported traffic 500ft below and asked the Gloucestershire controller if they were speaking to that traffic (Figure 1).

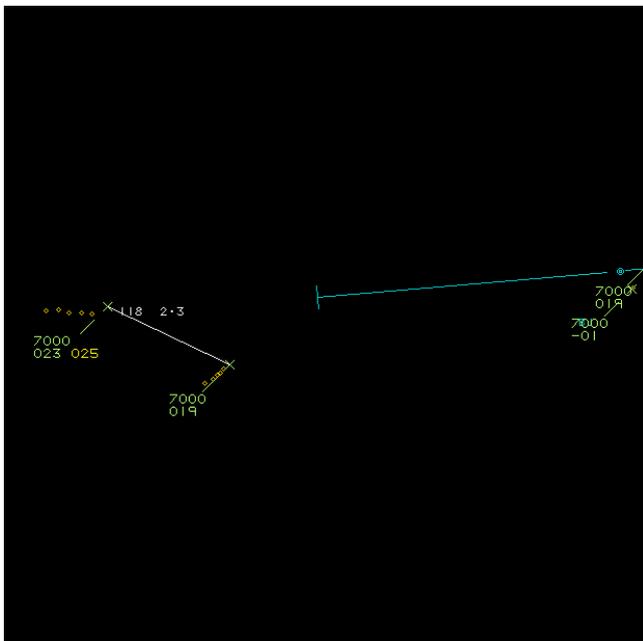
Figure 2 – 1038:05.

At 1038:05 the C550 pilot reported the other aircraft was now 300ft beneath them and that they, (the C550) were turning to the north and then back on track. The controller again tried a broadcast call but received no response (Figure 2).

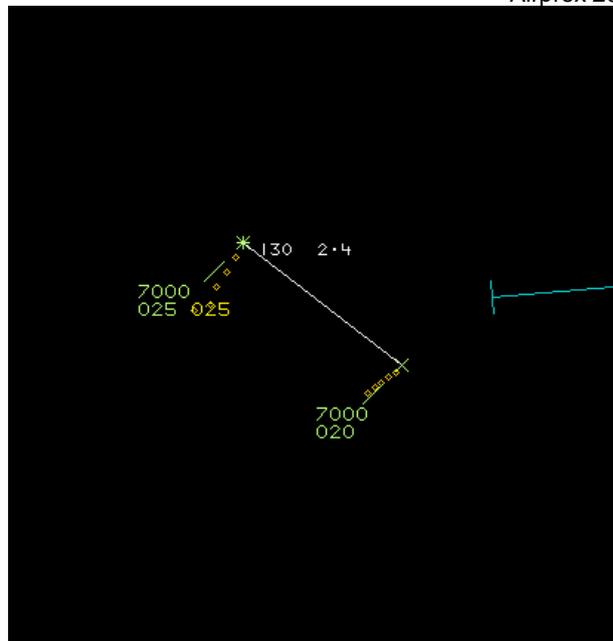
Figure 3– 1038:24.

At 1038:25 the C550 pilot reported visual with the other aircraft and the Gloucestershire controller then cleared them for a visual approach (Figure 3).

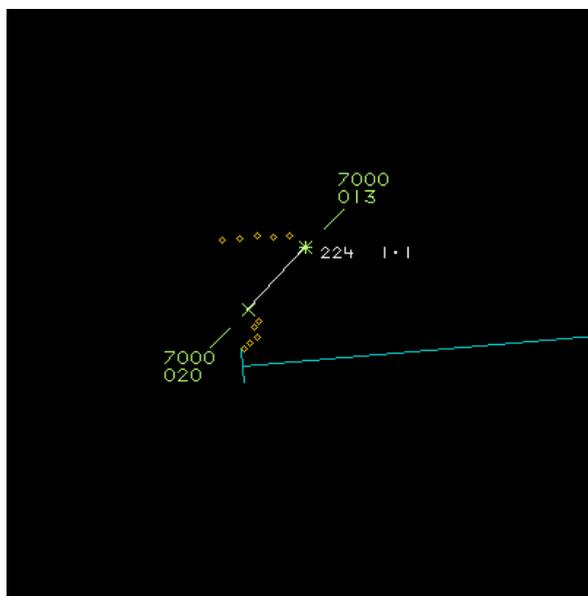
Figure 4 – 1039:38.

At 1039:38 the C550 pilot reported the colour of the other aircraft and confirmed that it was an R44. This was coincident with CPA, with the aircraft separated by 1.1nm laterally and 700ft vertically (Figure 4).

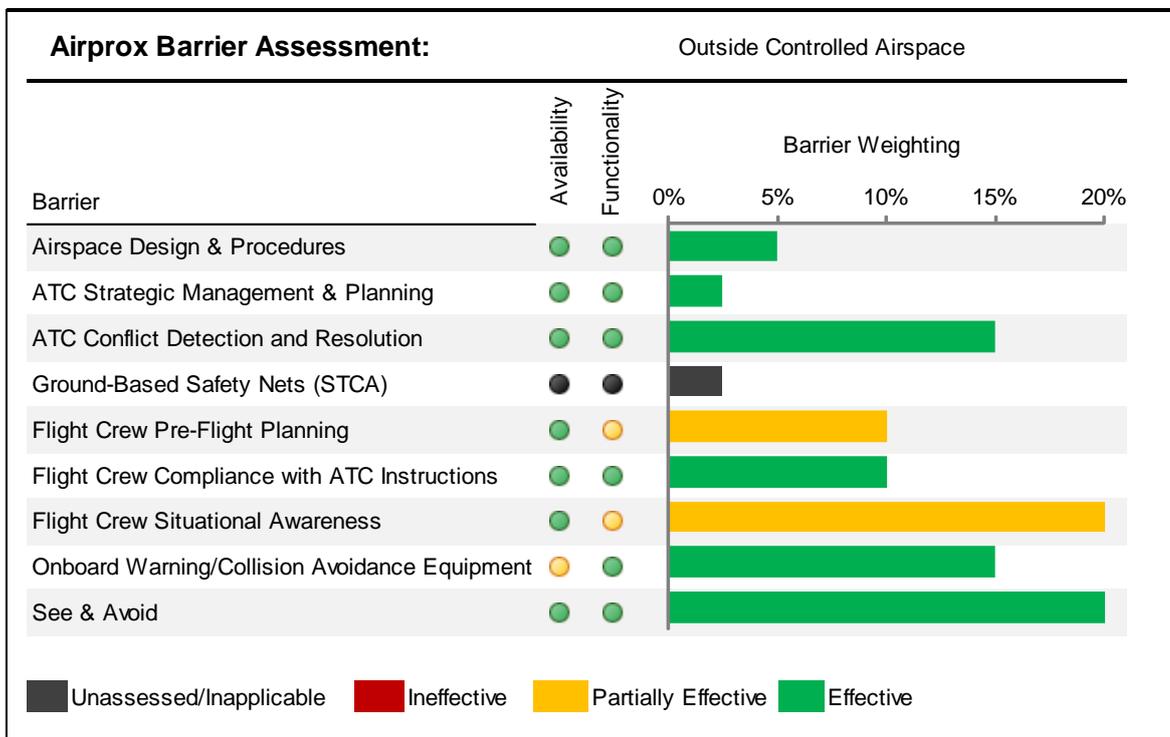
- **Flight Crew Pre-flight Planning** was assessed as **partially effective** because the R44 pilot had not sufficiently taken into account the impact of his flight on aircraft conducting approaches to RWY09 at Gloucester.
- **Flight Crew Situational Awareness** was also only **partially effective** because the R44 pilot did not hear ATC's calls to him as they tried to establish his intentions and potentially provide him with Traffic Information.

represents the barrier's weighting or importance (out of a total of 100%) for the type of airspace in which the Airprox occurred (i.e. Controlled Airspace or Uncontrolled Airspace).³ The colour of each bar represents the Board's assessment of the effectiveness of the associated barrier in this incident (either Fully Effective, Partially Effective, Ineffective, or Unassessed/Inapplicable). The chart thus illustrates which barriers were effective and how important they were in contributing to collision avoidance in this incident.
