# AIRPROX REPORT No 2016178

Date: 23 Aug 2016

PART A: SUMMARY OF INFORMATION REPORTED TO UKAB

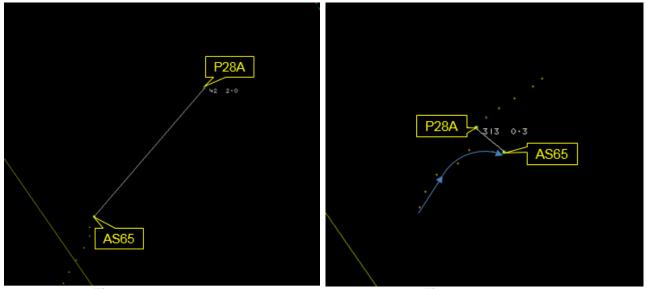
Figure 2 – 1732:37

The AS365 pilot reports obtaining a TCAS alert in the 12 o'clock position at a range of 2nm. (Figure 1). He then reported making a turn to the right into a known clear area and, during this time, the PA28 was sighted. This is evidenced on the radar recording and a CPA of 0.3nm was observed. (Figure 2). Neither aircraft were in receipt of an ATC service.

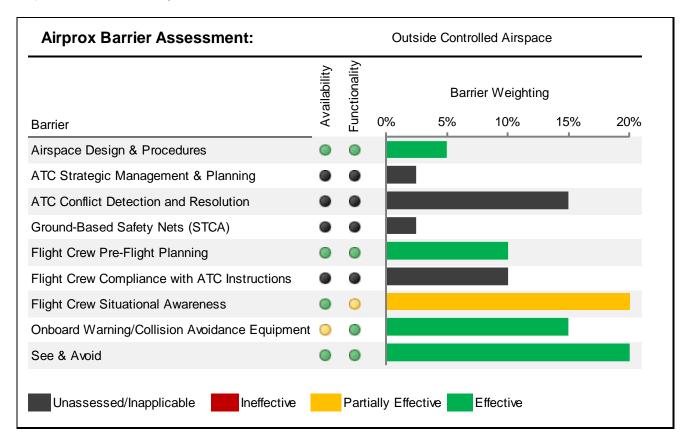
- Flight Crew Situational Awareness was considered only partially effective because the pilots were on different frequencies and the PA28 pilot had no means of receiving any information about the AS365. Whilst this can often be the case in Class G airspace, the Board felt that the availability and use of a VHF common frequency for low-level flights and transits in areas where air traffic services are limited would have increased the information available to both pilots regarding the other's presence.
- Onboard Warning/Collision Avoidance Equipment was assessed as being partially available because only one aircraft had the system fitted; however it was assessed as being fully effective because the PA28 was transponding and the AS365's system alerted the AS365 pilot to the proximity of the PA28.
