**AIRPROX REPORT No 2016180**

Date: 09 Aug 2016 Time: 1243Z Position: 5137N 00123W Location: NE of Wantage

**PART A: SUMMARY OF INFORMATION REPORTED TO UKAB**

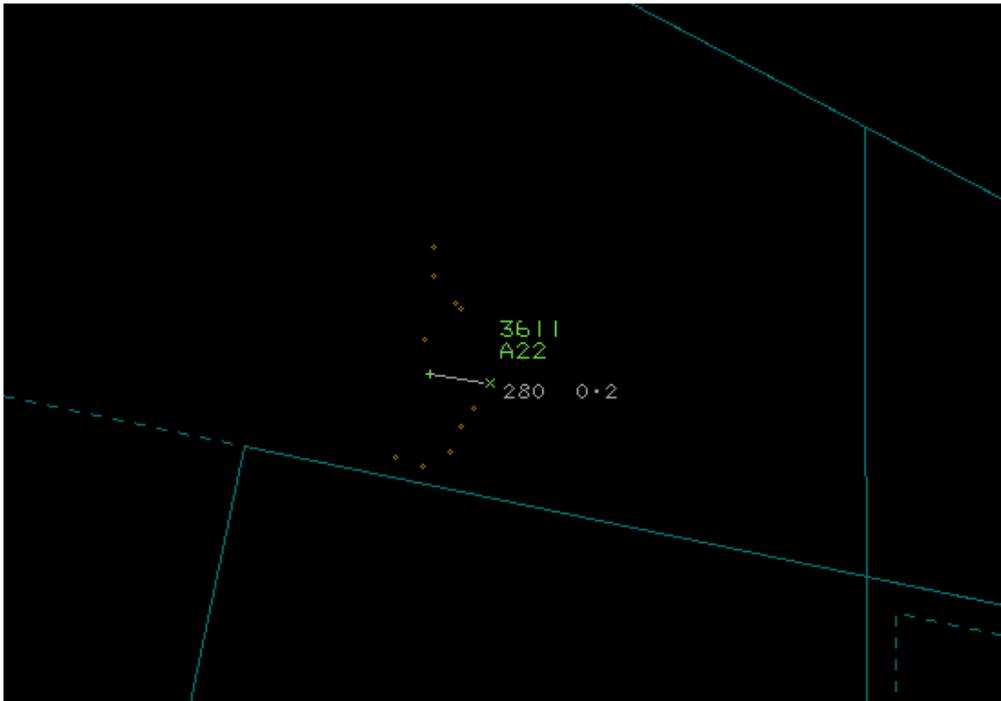
**Figure 1: Geometry at 12:43:47 (Tutor SSR 3611; primary contact)**

The radar analysis shows a primary contact in close vicinity to the Tutor which first appears at 12:41:38 then disappears and reappears over a period of several minutes until the Tutor calls for recovery at 12:48:33. During this time, the Benson Approach controller was working two other general handling Tutors and an IFR departure. The 2 aircraft were closest at 12:43:47 (Figure 1).

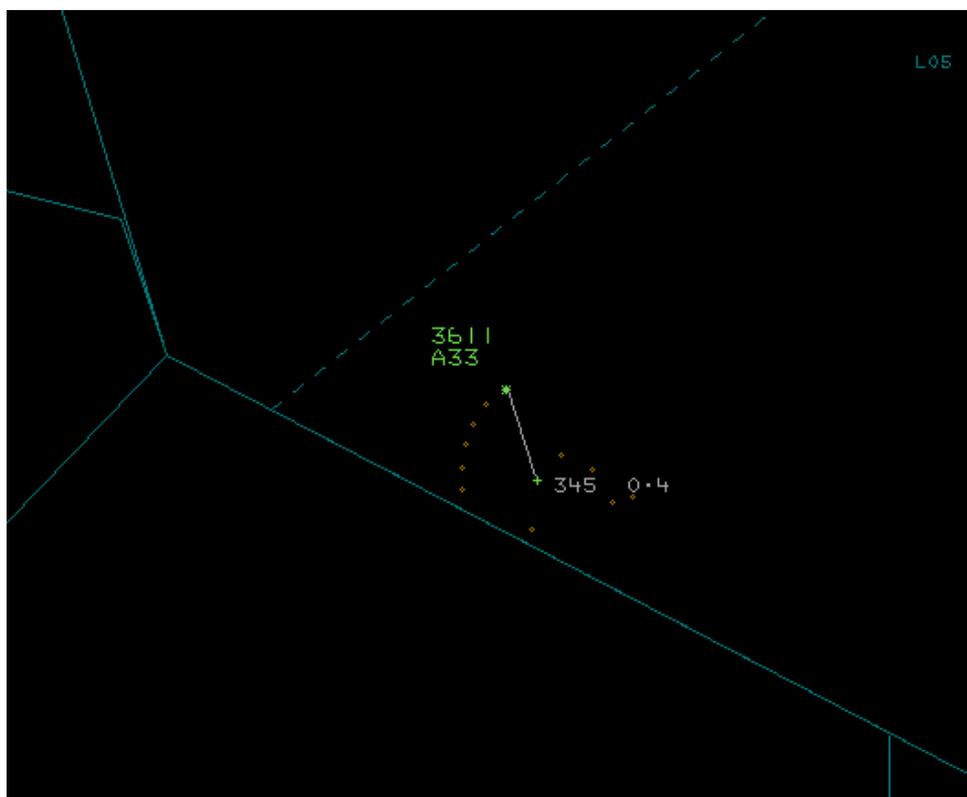
**Figure 2: Geometry at 12:45:18 (Tutor SSR 3611; primary contact)**

At 12:45:18 (Figure 2), Benson Approach passed traffic information on a primary contact to the West and within 1nm of the Tutor.

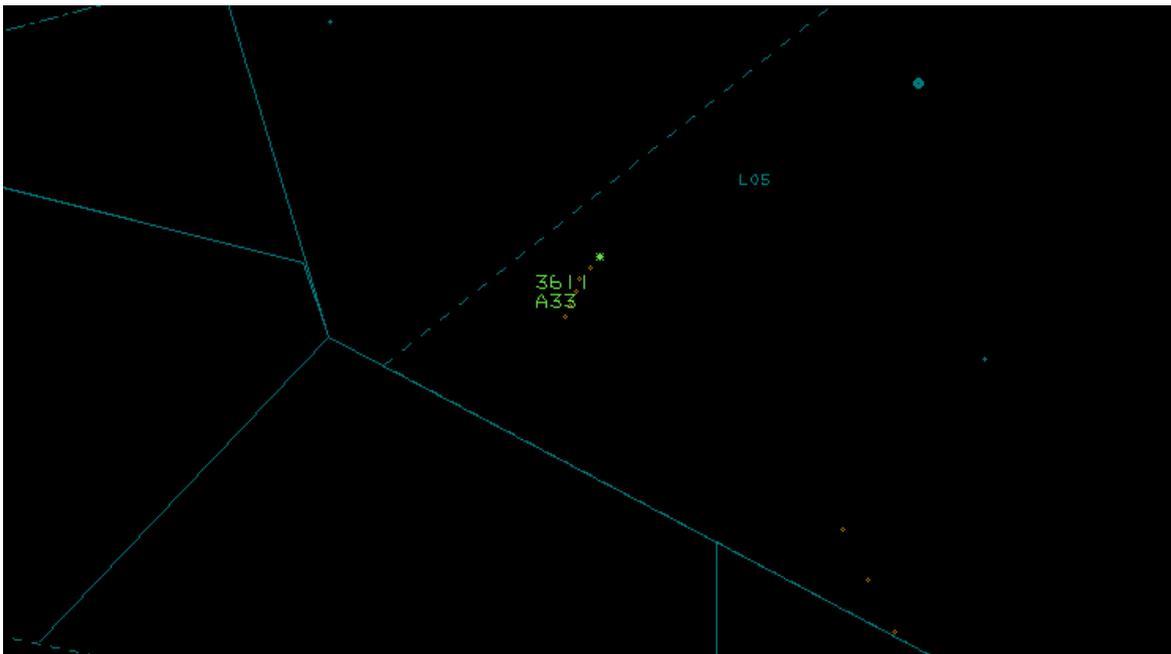
**Figure 3: Geometry at 12:47:00 (Tutor squawking 3611; primary contact not shown on radar)**

At 12:47:00 (Figure 3), the Tutor pilot described the movements of the light aircraft as tail-chasing. Although not visible at that time, throughout the period radar analysis shows that the primary

contact follows a similar flight path to the Tutor and correlates with the pilot's report of the conflicting aircraft positioning itself in the Tutor's 6 o'clock.

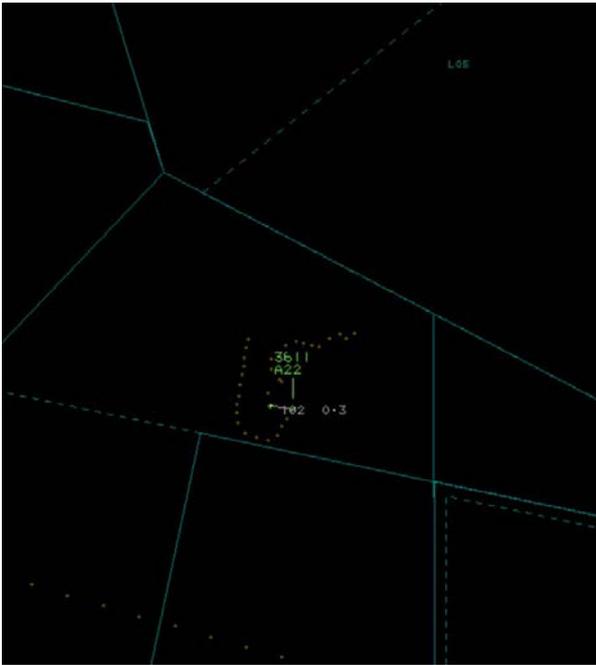
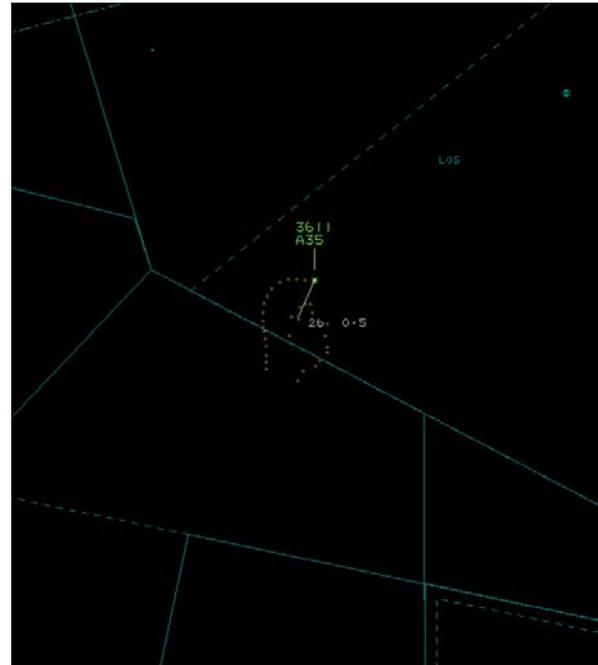
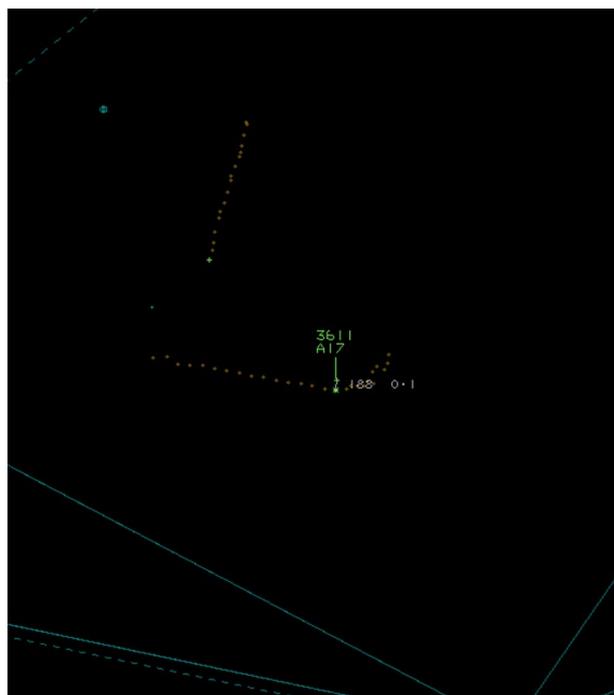
The radar recordings show the Tutor in proximity to unknown aircraft three times during the sortie (Figures 4, 5 and 6). Unfortunately it is not possible to determine if this was the same aircraft as that reported near Wantage because the contact is intermittent and therefore cannot be positively tracked throughout the encounter. As only primary-radar tracks, no height information is available to determine the vertical separation from the Tutor. Figure 4 has been used as the main Airprox CPA, this is based on the area the Tutor pilot reported the Airprox occurring but this may not be the closest point (vertically and horizontally) that the aircraft came due to the absence of Mode C from the unknown light aircraft.

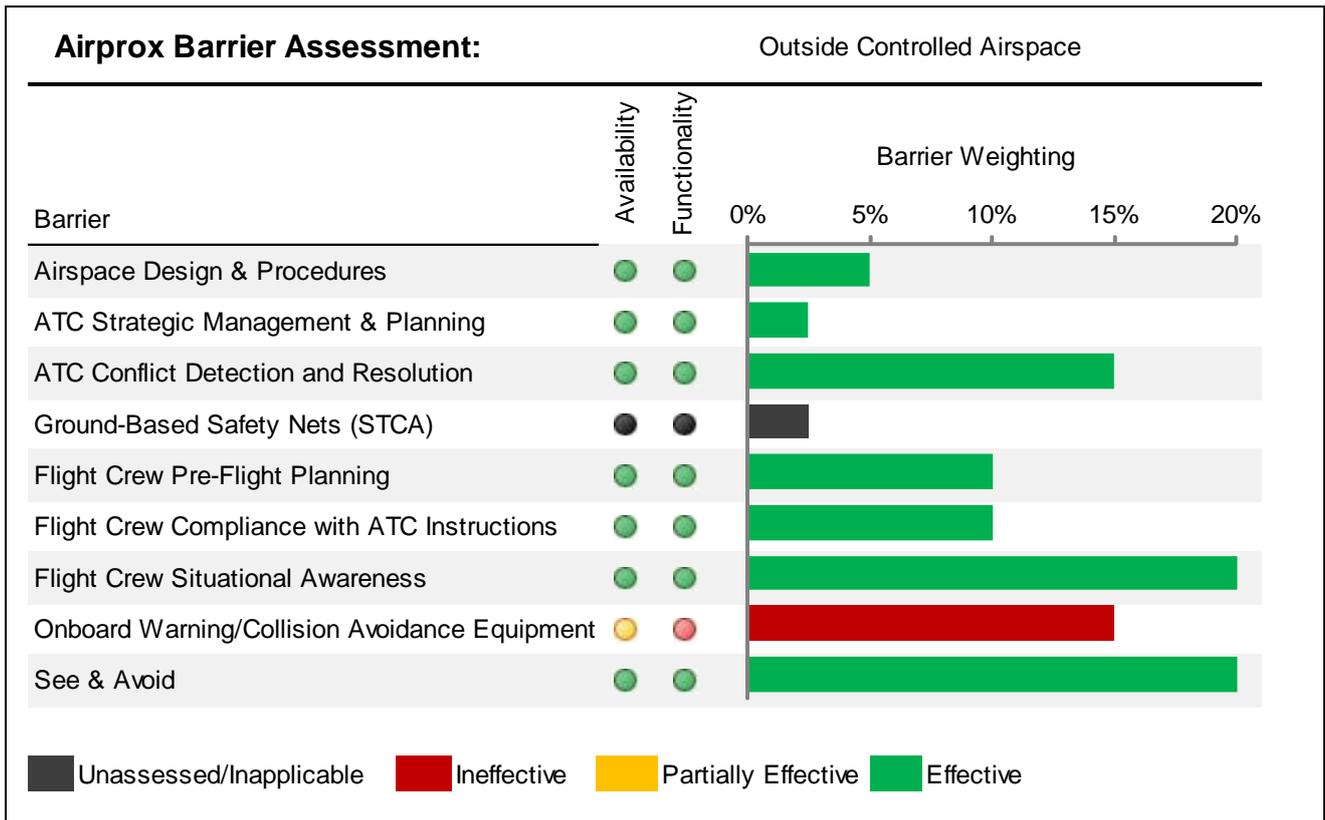
- **Onboard Warning/Collision Avoidance Equipment** was assessed as being **ineffective** because the unknown light aircraft either did not have a transponder fitted or switched on and therefore the Tutor's TAS was not able to function to alert the Tutor pilot to the other aircraft's proximity.

The Board then considered the cause and risk of the incident. They agreed that the aircraft had been in proximity to each other and that the Tutor pilot had believed the other aircraft was deliberately flying close to his aircraft. Unable to assess the separation between them or intentions of the other aircraft, the incident was assessed as the Tutor pilot being concerned by the proximity of the unknown light aircraft. Turning to the risk, members reluctantly agreed that there was insufficient evidence to reach a conclusion, and so the Board assessed the risk as Category D.
