AIRPROX REPORT No 2016186

Date: 23 Aug 2016 Time: 1615Z Position: 5240N 00036E Location: 2.5nm NE Marham

PART A: SUMMARY OF INFORMATION REPORTED TO UKAB

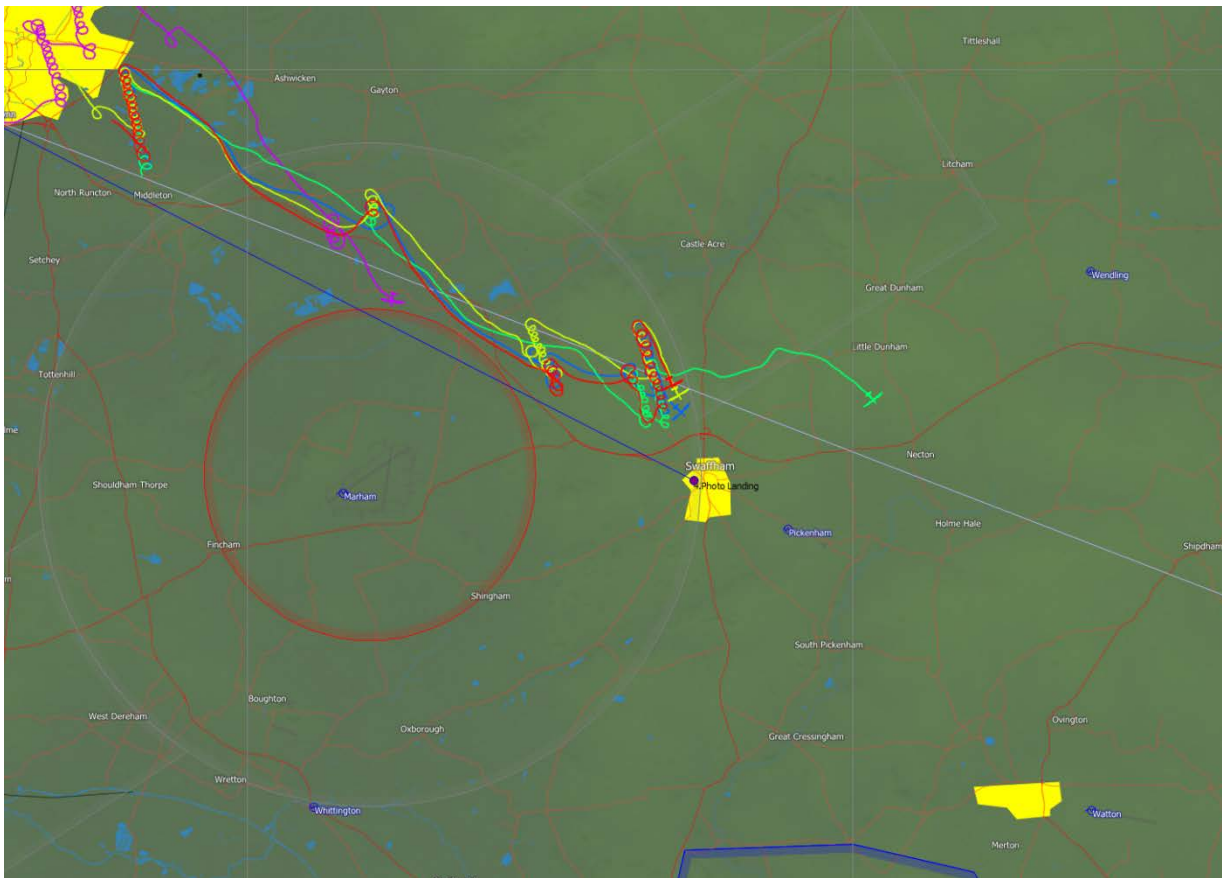
At Figure 2 is a copy of SeeYou provided by the BGA showing the position of the gliders in the competition at 1615.

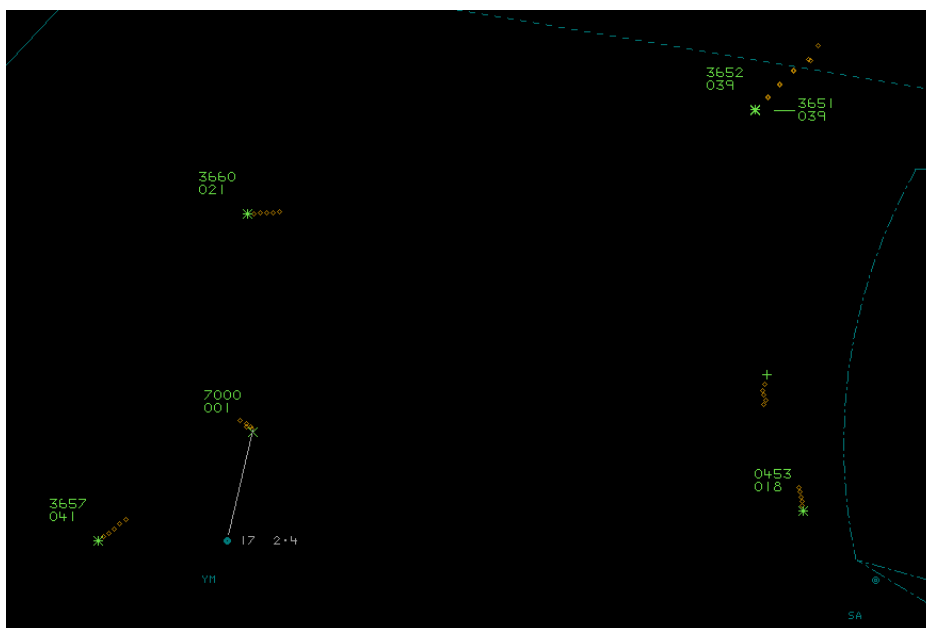
Figure 3: Geometry at 16:16:09 (Voodoo 31 Flt SSR 3651/2; unknown ac SSR 7000)

At 16:16:09 (Figure 3), the Marham Approach controller passed Traffic Information to Voodoo 31 Flt on a contact north-northeast of Marham 2nm and another at 3nm.

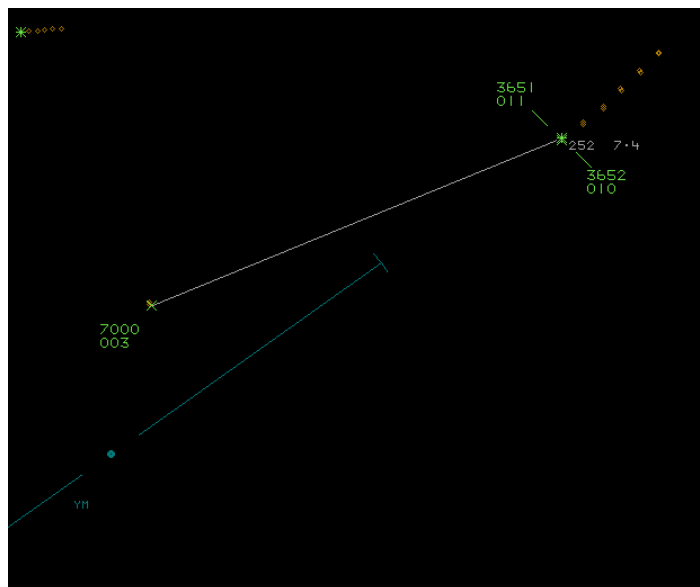
Figure 4: Geometry at 16:17:04 (Voodoo 31Flt SSR 3651/2; unknown ac SSR 7000)

At 16:17:04 (Figure 4), the Marham Approach controller advised Voodoo 31 Flt that there was no traffic on radar to affect and instructed them to continue with Marham Tower.

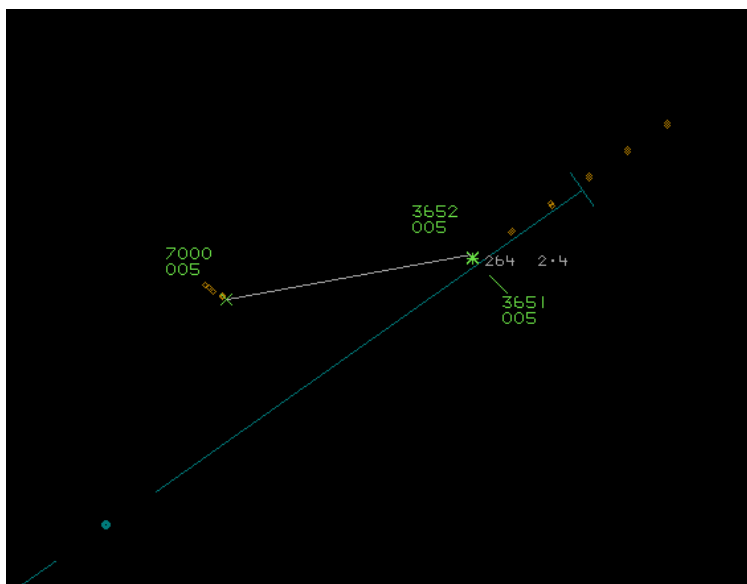
Figure 5: Geometry at 16:17:50 (Voodoo 31 Flt SSR 3651/2; unknown ac SSR 7000)

At 16:17:50 (Figure 5), the Marham Tower controller passed Traffic Information to Voodoo 31 Flt on traffic in their right 1 o'clock, half a mile, crossing right to left, indicating 500ft.

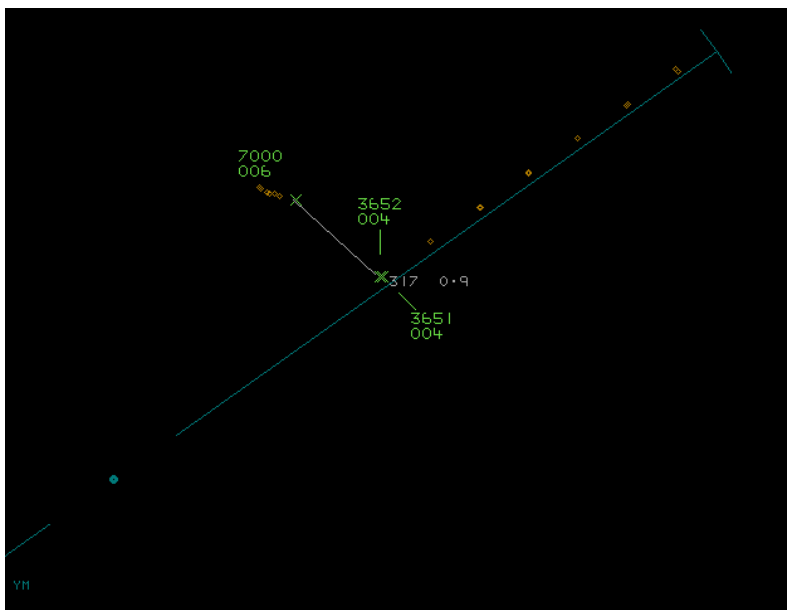
Figure 6: Geometry at 16:18:02 (Voodoo 31 Flt SSR 3651/2; unknown aircraft SSR 7000)

At 16:18:02 (Figure 6), Voodoo 31 Flt passed the unknown aircraft with 0.9nm lateral separation, the closest point of approach.

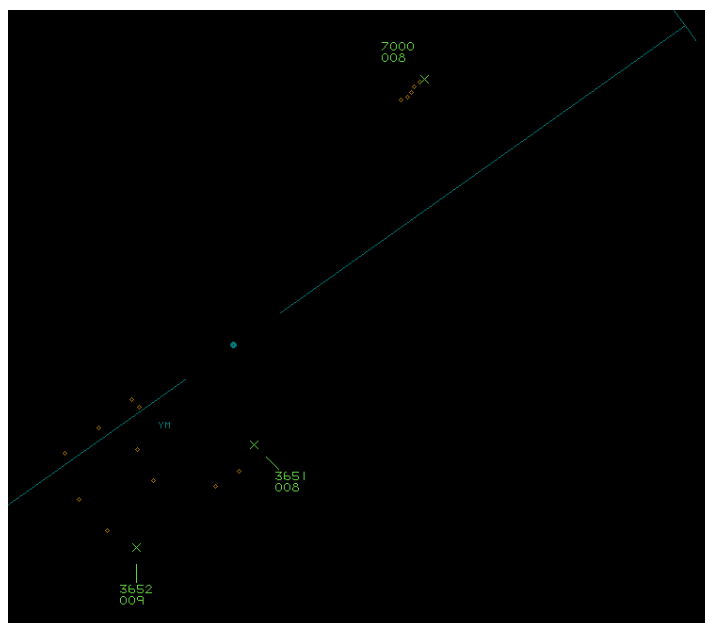
Figure 7: Geometry at 16:18:55 (Voodoo 31 Flt SSR 3651/2; unknown aircraft SSR 7000; glider 63C not visible)

At 16:18:55 (Figure 7), a glider pilot called the Marham Zone frequency and proceeded to describe his position as 3nm South East, 1400ft and visual with two fast-jets in the circuit. The pilot added that he intended to remain outside of the ATZ. This position report did not correlate with the previous traffic SSR 7000.

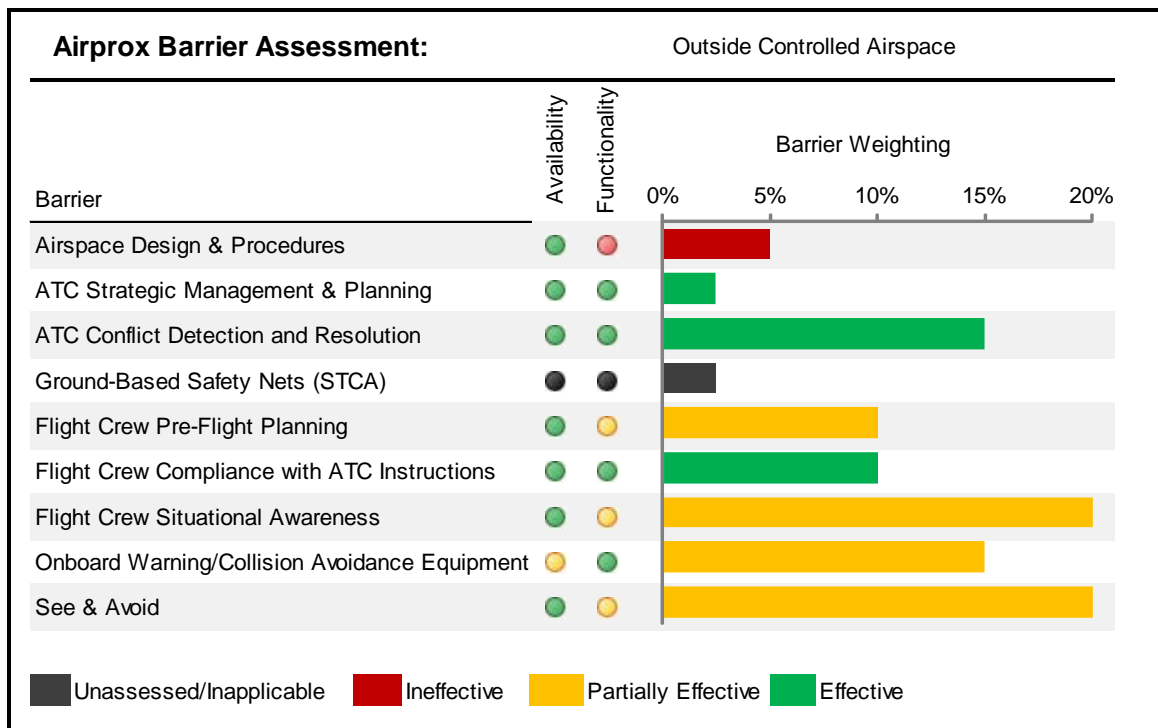
- **Airspace Design and Procedures** had been an **ineffective** barrier because the glider competition planners had not taken into consideration the effect the competition routing would have on other airspace users.

- **Ground-based Safety Nets** was assessed as **absent** because RAF Marham did not have a FLARM receiver, which would have offered at least some generic information to the controllers.

- **Flight Crew Pre-Flight Planning** was assessed as **partially effective** because the Tornado pilots (and the Marham controllers), had not realised that the competition NOTAM would affect them.

- **Flight Crew Situational Awareness** was assessed as **partially effective** because the glider pilots had no information about the Tornados, and the Tornado pilot only had generic information about the gliders from ATC.

- **Onboard Warning/Collision Avoidance Equipment** was assessed as **partially effective** because although the two aircraft had incompatible systems, it was only once the glider's transponder was switched on that the TCAS warned the Tornado pilots of the glider's proximity.

- **See-and-Avoid** was considered **partially effective** because the Board considered that the glider pilot had probably only seen the Tornados just before or after CPA.
