AIRPROX REPORT No 2016191

Date: 06 Aug 2016 Time: 1141Z Position: 5048N 00031W Location: 1nm S Littlehampton

PART A: SUMMARY OF INFORMATION REPORTED TO UKAB

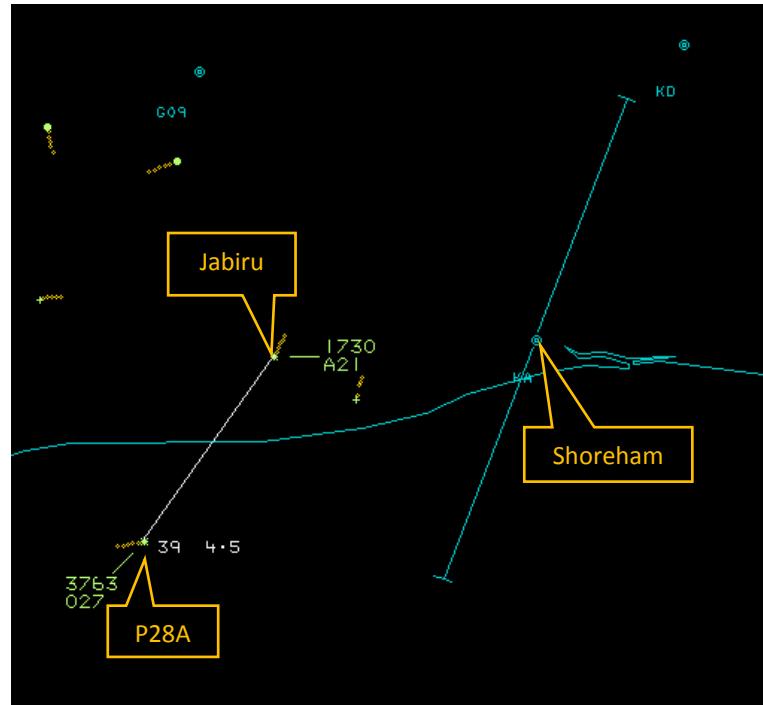
Figure 1 – 1138:40

The Jabiru had been receiving a Basic Service from Farnborough. At 1138:40, (Figure 1), having been advised by the Farnborough LARS controller that he was approaching the edge of their radar cover, the pilot elected to change to Solent Radar and to select the appropriate frequency monitoring transponder code (listening squawk). The code was observed to change at 1139:20.

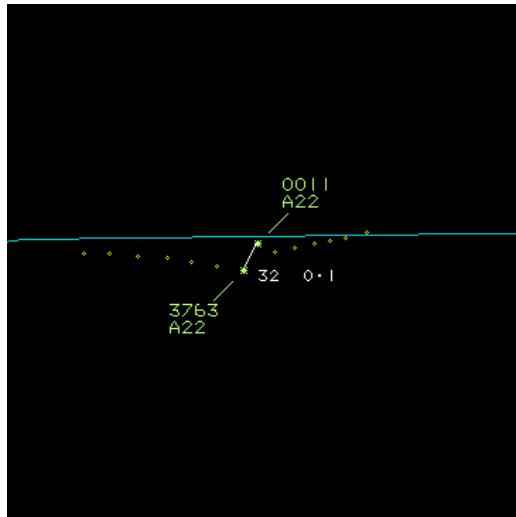
Figure 2 – CPA at 1141:30

CPA was assessed to have taken place at 1141:30, with the aircraft separated by 0.1nm laterally and <100ft vertically.

The Jabiru was not receiving any ATC service at the time the Airprox occurred. The PA28 was receiving a Basic Service from Shoreham, but the controller did not have access to radar. In accordance with CAP774, a Basic Service relies on the pilot avoiding other traffic, unaided by controllers/ FISOs.

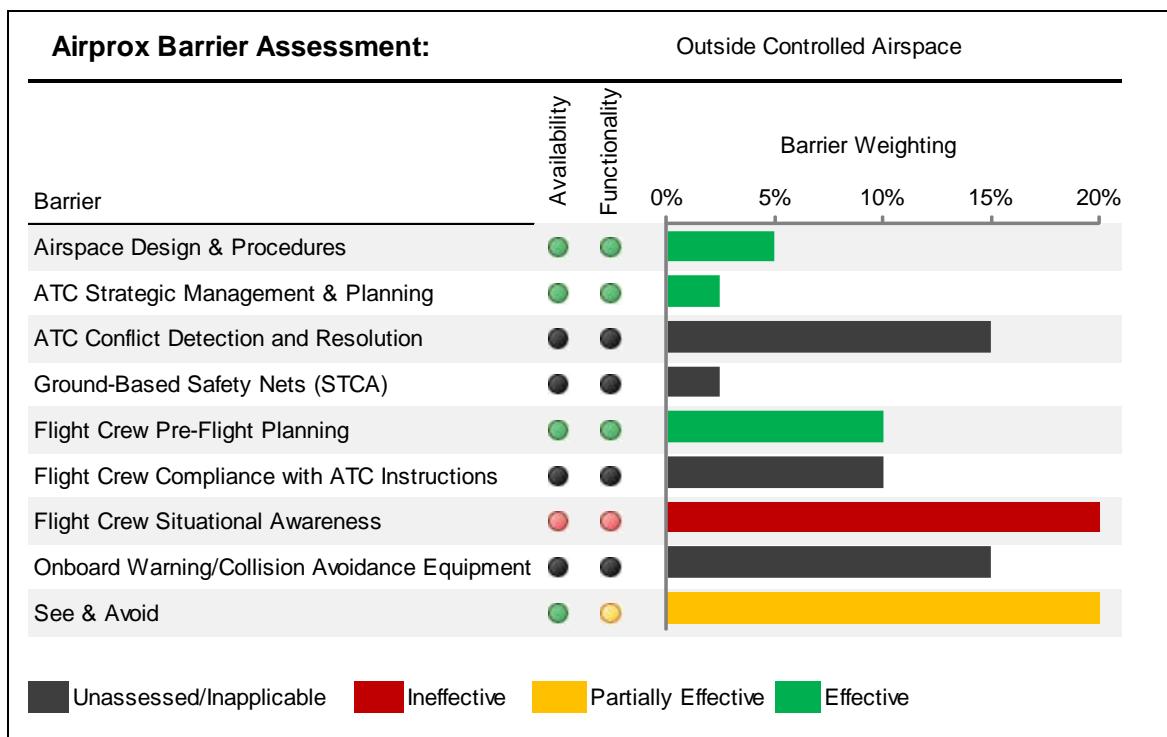
- **Situational Awareness** had been **ineffective** – neither pilot was aware of the other's close proximity.
- **Onboard Warning/Collision Warning Equipment** was also assessed as **absent** because neither aircraft was fitted with such equipment.
- **See-and-Avoid** was assessed as **partially effective** because the relatively late sighting by both pilots meant that, even with avoiding action, the encounter was closer than desirable.

Modern safety management processes employ the concept of safety barriers that prevent contributory factors or human errors from developing into accidents. Based on work by EASA, CAA, MAA and UKAB, the following table depicts the barriers associated with preventing mid-air-collisions. The length of each bar represents the barrier's weighting or importance (out of a total of 100%) for the type of airspace in which the Airprox occurred (i.e. Controlled Airspace or Uncontrolled Airspace).³ The colour of each bar represents the Board's assessment of the effectiveness of the associated barrier in this incident (either Fully Effective, Partially Effective, Ineffective, or Unassessed/Inapplicable). The chart thus illustrates which barriers were effective and how important they were in contributing to collision avoidance in this incident.
