**AIRPROX REPORT No 2016210**

Date: 08 Sep 2016 Time: 1042Z Position: 5214N 00253W Location: Shobdon airfield

**PART A: SUMMARY OF INFORMATION REPORTED TO UKAB**

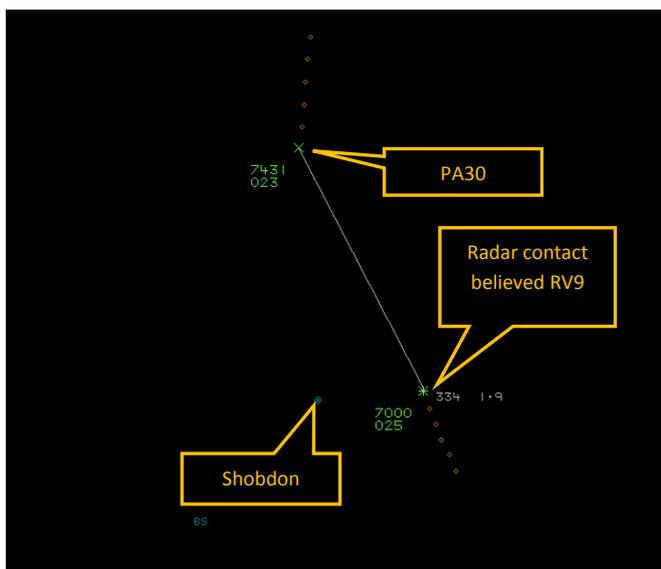
Figure 1 – 1041:07.

The RV9 pilot reported overhead before the PA30. Figure 1 shows the traffic situation at 1041:07; at this time the radar contact believed to be the RV9 was overhead Shobdon Aerodrome indicating Flight Level (FL)025. The PA30 was opposite direction 1.9nm north-north-west of the RV9 indicating FL023.

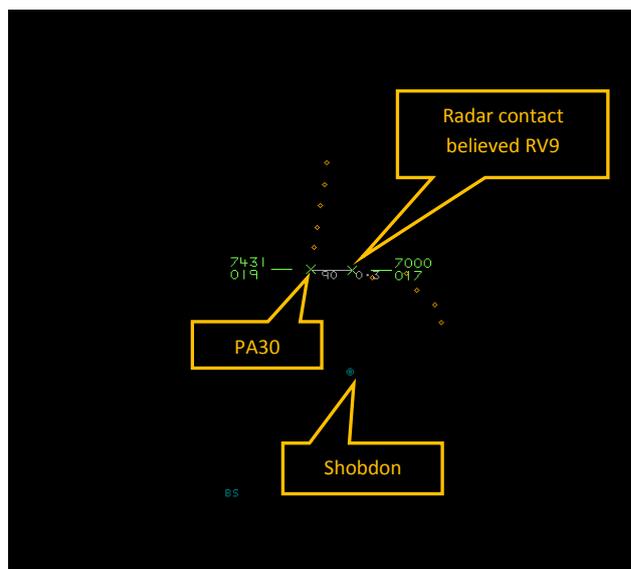
Figure 2 – 1041:35.

When the PA30 pilot reported overhead at 2000ft, the Shobdon AFISO requested that he descend not below 1500ft on the deadside for noise abatement reasons. The AFISO then passed Traffic Information on the RV9 to the PA30 pilot, describing the RV9 as being “ahead” and “also overhead”. The PA30 pilot reported to the AFISO that he was looking for the traffic. Figure 2 shows the traffic situation at 1041:35, with the PA30 pilot having descended deadside on a southerly track and the traffic believed to be the RV9 in a left-hand turn to the north of the aerodrome.

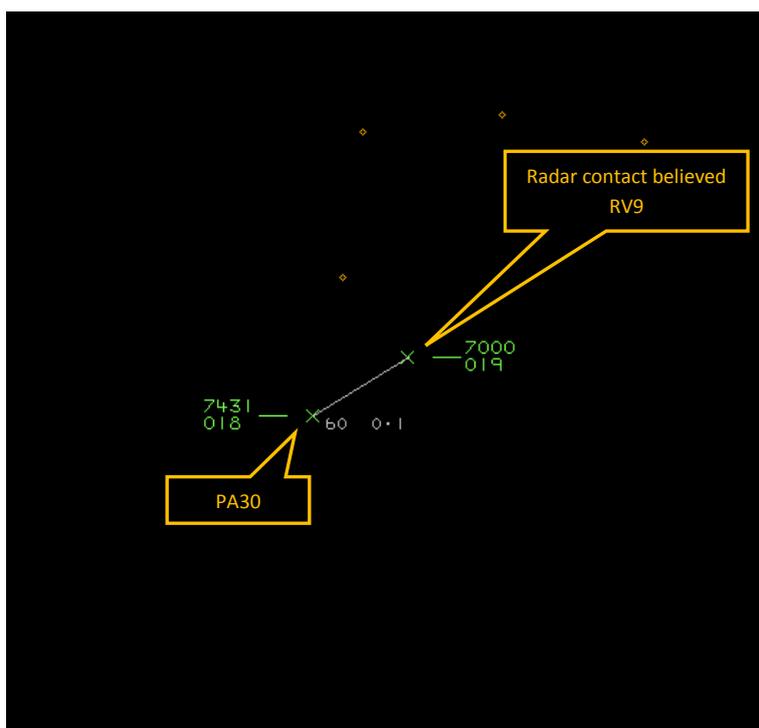
Figure 3 – 1041:44 (CPA).

The Shobdon AFISO updated the Traffic Information to the RV9 pilot on the PA30. In response, the RV9 pilot reported that he was just about to cross the RW09 threshold at 1500ft and not being visual with the PA30. The PA30 pilot then reported visual with the RV9. In the PA30 pilot’s written report he stated that he “...spotted the RV to the left of our aircraft and behind at approximately our 8 o’clock and about 300 metres away”. CPA between the PA30 and the radar contact believed to be the RV9 occurred at 1041:44 (Figure 3) with a minimum horizontal distance of 0.1nm and a minimum vertical distance of 100ft.

the radar recordings showed that at CPA the two aircraft were only 100ft vertically and 0.1nm horizontally apart, and that neither pilot had seen the other aircraft until after CPA, the Board agreed that it had only been chance that had prevented an actual collision. Accordingly the Board assessed the Airprox as risk Category A

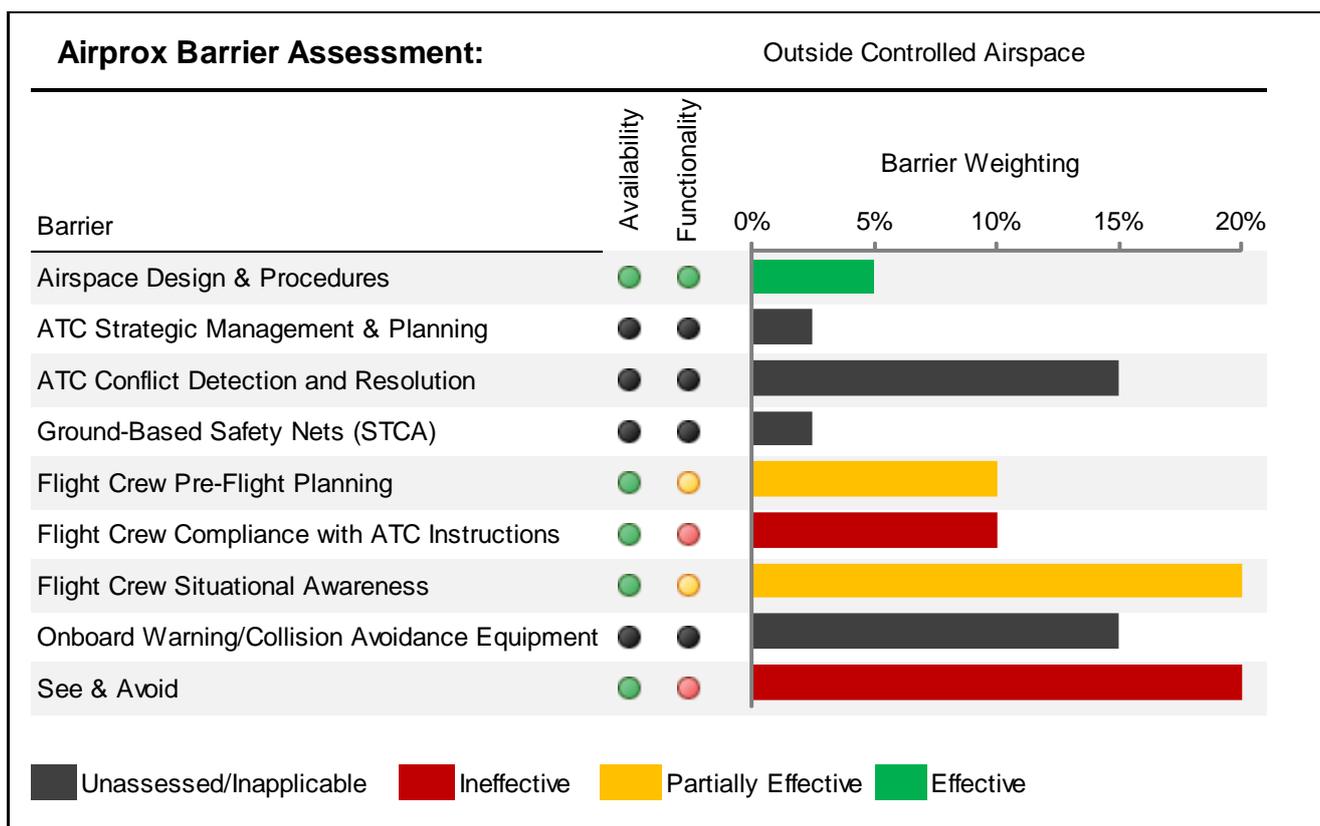
- **Flight Crew Pre-Flight Planning** was assessed as only **partially effective** because the PA30 pilot did not appear to have a properly formed plan to join overhead.
- **Flight Crew Compliance With ATC Instructions** was considered **ineffective** because the PA30 pilot did not fly an overhead join as requested.
- **Flight Crew Situational Awareness** was considered to be **partially effective** because the RV9 pilot was not aware of the PA30's position as a result of its pilot not flying the standard overhead join.
- **See-and-Avoid** was assessed as **ineffective** because neither pilot saw the other until effectively after CPA.
