AIRPROX REPORT No 2016228

Date: 29 Oct 2016 Time: 1540Z Position: 5413N 00129W Location: 3nm W Topcliffe

PART A: SUMMARY OF INFORMATION REPORTED TO UKAB

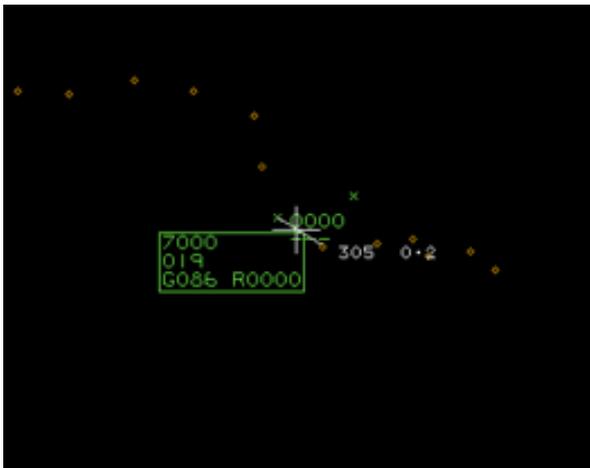
Figure 1: 1540:28

Figures 1-4 are a series of screen shots taken from the NATS area radars. Figure 1 is taken at 1540:28, just after both aircraft have taken avoiding action. The untraced aircraft is squawking 7000, the glider 4576, although it has garbled on the radar screen to 0000 in this instance. Figure 2 and 3 are taken at 1540:40 and 1541:23 respectively and show how the untraced aircraft turns behind the glider to follow his track for several minutes until at 1542:19, Figure 4, it can be seen departing to the north-west.

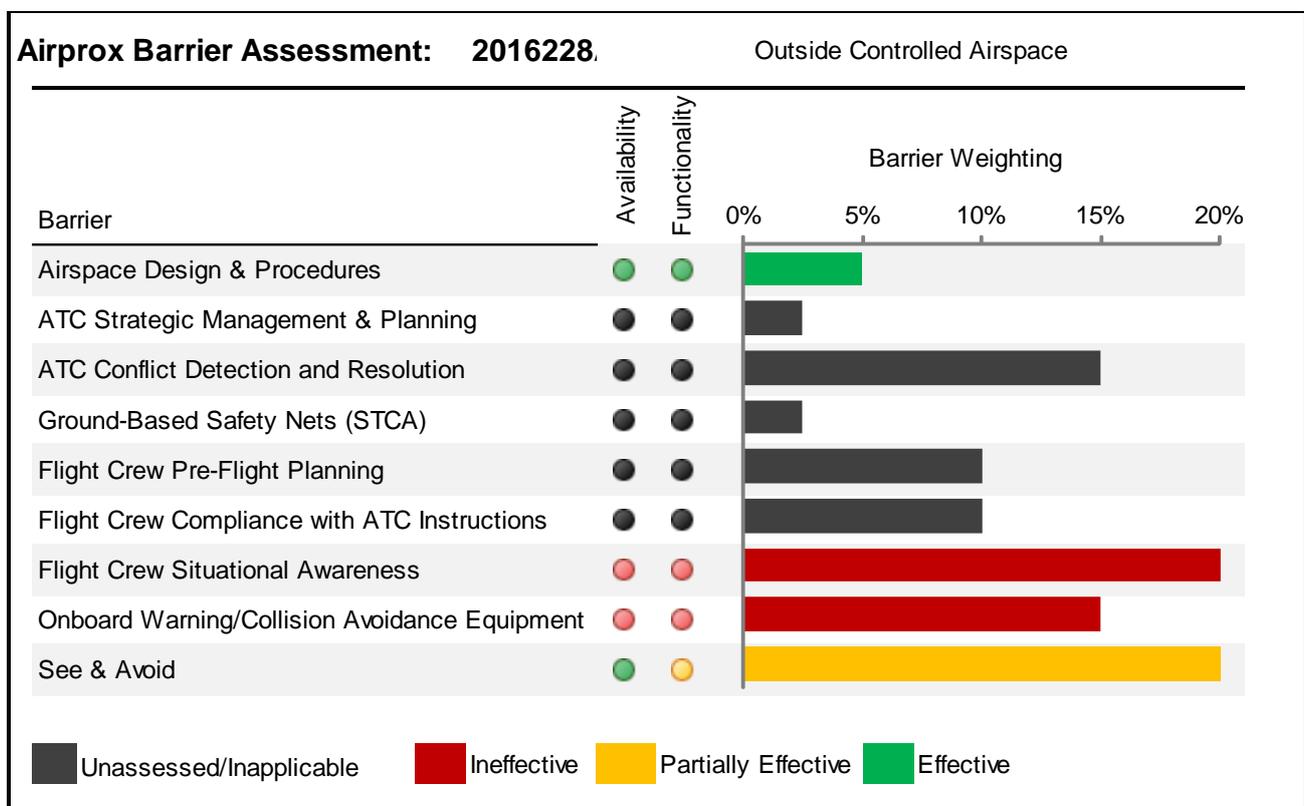
Barrier Assessment³:

- **Flight Crew Situational Awareness** was assessed as **ineffective** because neither pilots had any means of gaining situational awareness about the other.
- **Onboard Warning/Collision Avoidance Equipment** was also assessed as **ineffective** because the Vigilant was not fitted with a CWS.

- **See and Avoid** was considered to have been **partially effective** because both pilots took avoiding action, albeit late.
