## AIRPROX REPORT No 2016234

Date: 02 Nov 2016 Time: 1426Z Position: 5112N 00041W Location: 3nm SW Guildford

### PART A: SUMMARY OF INFORMATION REPORTED TO UKAB

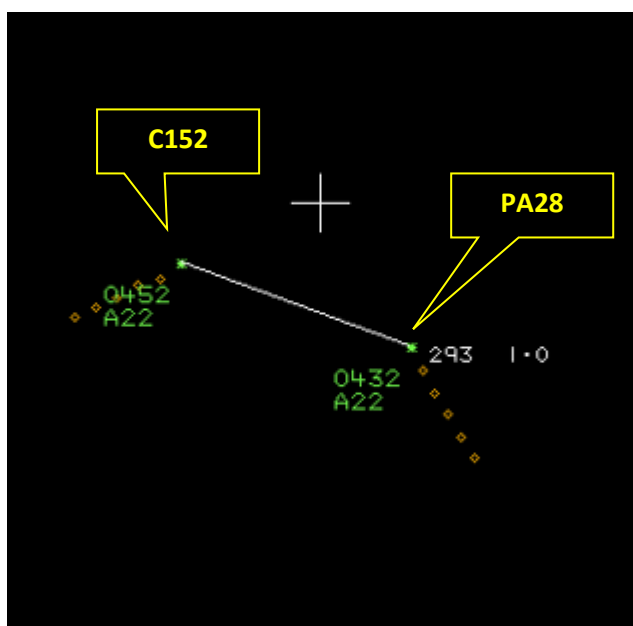
Figure 1 – Swanwick MRT 1426:10.

UKAB Secretariat note: Whilst CPA (Figure 2) shows the C152 at 2300ft and therefore above the PA28, prior to this the aircraft had been converging at approximately the same height, Figure 1 shows the relative positions 30 seconds prior to CPA, with both aircraft indicating 2200ft on the radar. Radar tolerances mean that it is feasible that the PA28 could well be higher than the C152 at this point, as described by the C152 pilot.

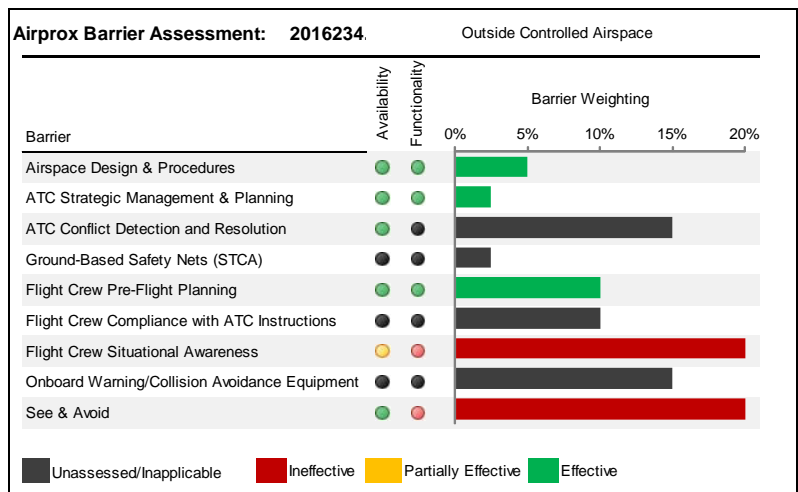
- **ATC Conflict Detection and Resolution and Flight Crew Compliance with ATC Instructions** were both assessed as **inapplicable** because neither pilot was receiving an ATS that included provision of Traffic Information.

- **Flight Crew Situational Awareness** was considered **ineffective** because, although both pilots were in communication with the same controller, the level of service that they had requested meant that neither pilot knew about the close proximity of the other aircraft.

- **Onboard Warning/Collision Avoidance Equipment** was **inapplicable** because neither aircraft was fitted with such a system.
- **See and Avoid** was assessed as being **ineffective** because the PA28 pilot did not see the C152 and the C152 pilot only saw the PA28 at too late a stage to take any avoiding action. This lack of sighting was probably exacerbated because the low-wing aircraft (the PA28) was above the high-wing aircraft (C152) and both were likely in each other’s potential blind spots as they converged. Members commented that this highlighted the need to ensure a robust lookout at all times by moving one’s head to overcome cockpit obscurations, and dipping/raising the wing to ensure that blind spots were cleared.
