AIRPROX REPORT No 2016252

Date: 29 Nov 2016 Time: 1146Z Position: 5046N 00108W Location: Solent

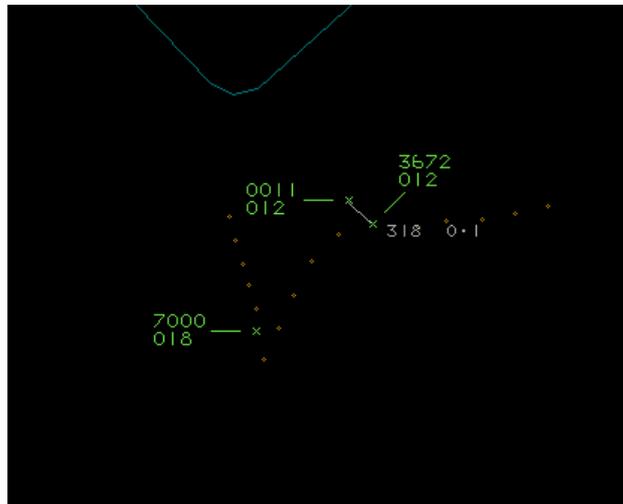
CPA between the Chinook and the PA28 occurred at 1145:55 (Figure 1) with no vertical separation and 0.1nm lateral separation.

Figure 1 -1145:55: Chinook squawk 0011, PA28 3672

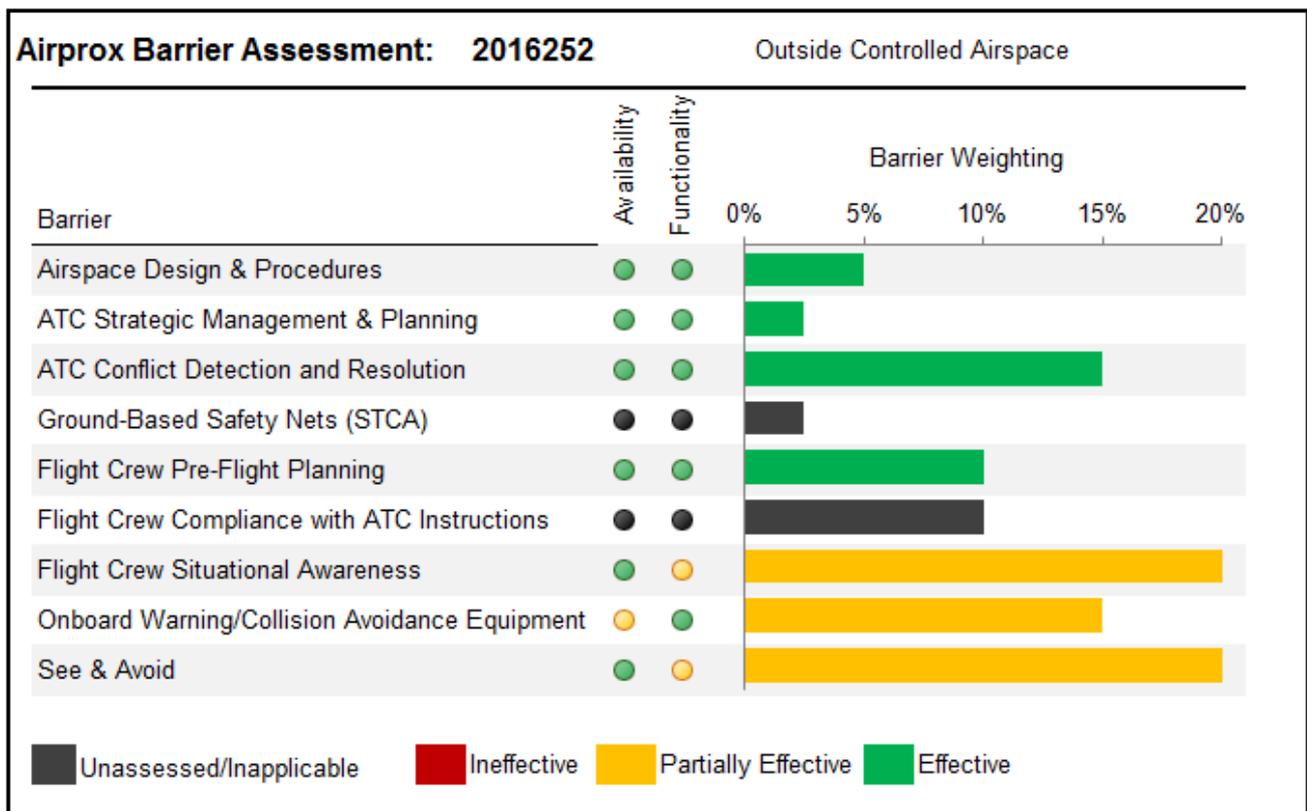
Flight Crew Situational Awareness was considered only **partially effective** because, although both pilots were in communication with the same controller, the level of service that they had requested meant that neither pilot knew about the close proximity of the other aircraft other than in general terms for the Chinook pilot.

Onboard Warning/Collision Avoidance Equipment was **partially effective** because only the Chinook was fitted with such a system. However, it was **effective** because the Chinook pilot had received a TA about the PA28 at a range of 1.5nm.

See and Avoid was assessed as being **partially effective** because the Chinook pilot only saw the PA28 at a range of 400m and the PA28 pilot only observed the Chinook after CPA.
