AIRPROX REPORT No 2016254

Date: 05 Dec 2016 Time: 1143Z Position: 5149N 00118W Location: Oxford ATZ

PART A: SUMMARY OF INFORMATION REPORTED TO UKAB

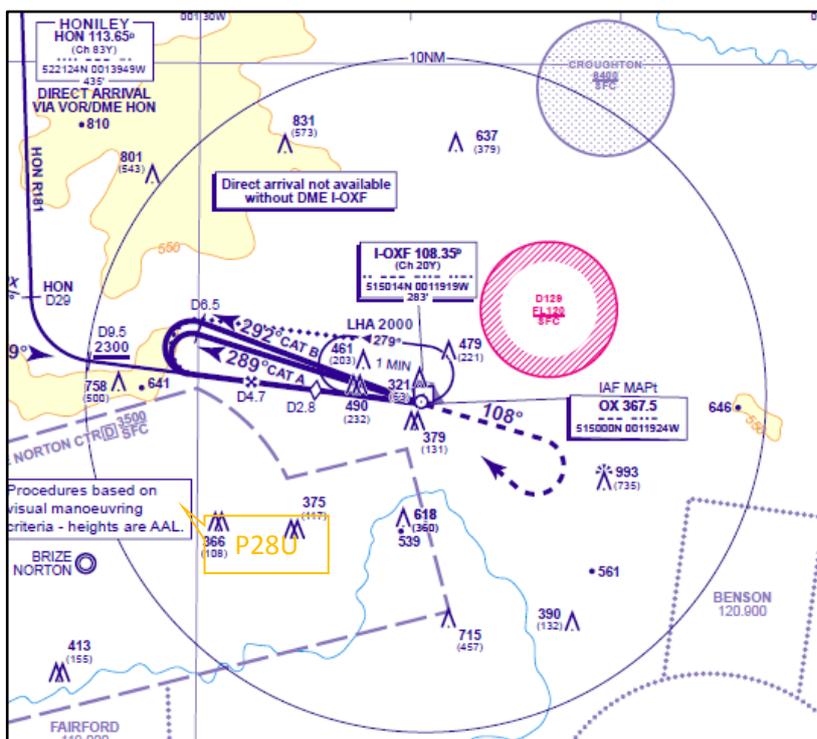
The DA42 was completing the NDB/DME 099 approach at Oxford, and had been transferred from Oxford Radar to Oxford Tower. This approach (extract at Figure 1), is not an approach to a runway, but rather to the airfield, (RW09 does not exist).

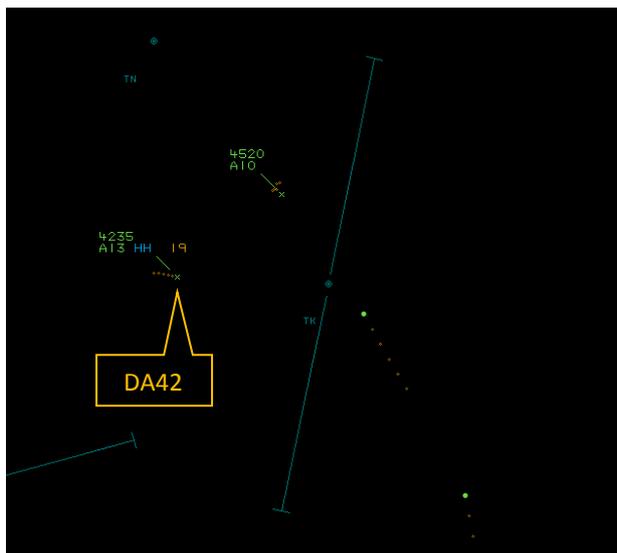
Figure 2 – 1140:30

The PA28 had taxied out for a departure from the runway in use (RW01), and at 1140:30 was given a clearance for take-off with a right turn-out by the Oxford Tower controller. The DA42, (transpondering code 4235), was at 3.4nm on the NDB approach (Figure 2).

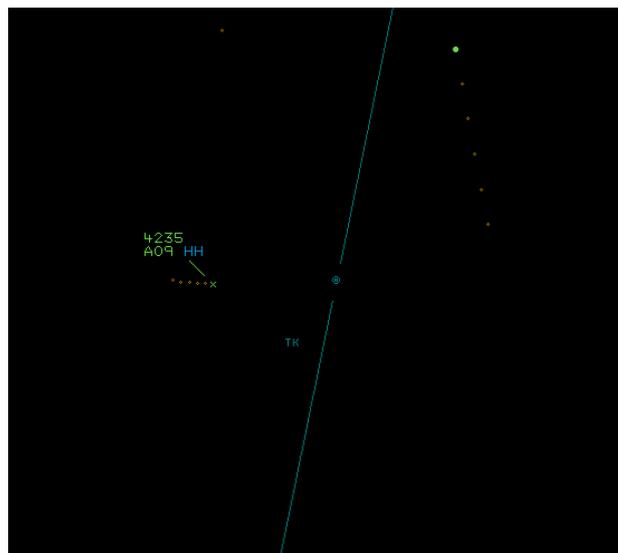
Figure 3 – 1141:36

The controller then took calls from an inbound helicopter and another helicopter on the ground requiring repositioning prior to start. At 1141:36 the tower controller instructed the DA42, which was now at 1.6nm, to report going around from the approach which was acknowledged (Figure 3).

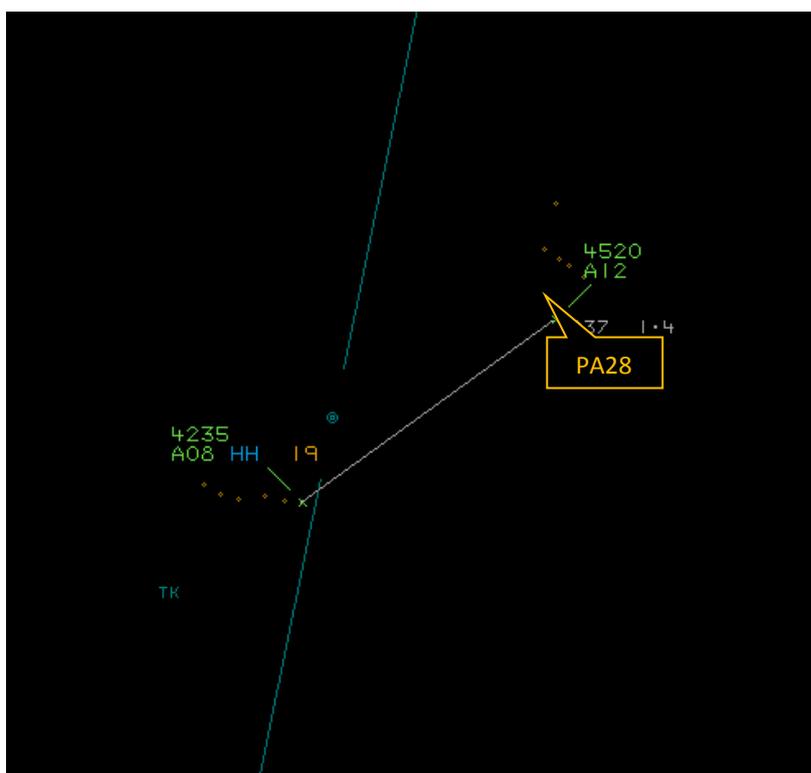
Figure 4 – 1142:45

At 1142:45 Traffic Information was passed by the controller to the DA42 pilot on the PA28 (transponder code 4520), reported as being midpoint downwind right-hand, which was acknowledged (Figure 4).

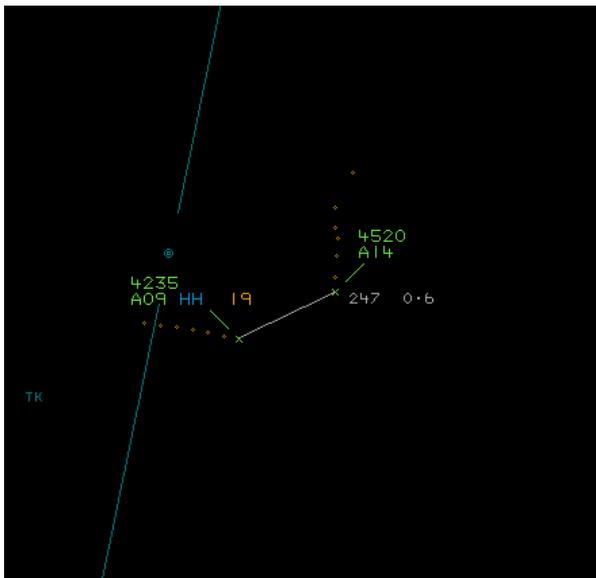
Figure 5 – 1143:07

At 1143:07 the DA42 pilot reported being visual with the PA28, adding that if they were to go around at that moment, then it would place them in conflict with the PA28. The DA42 pilot reported that they would therefore maintain their current level (Figure 5).

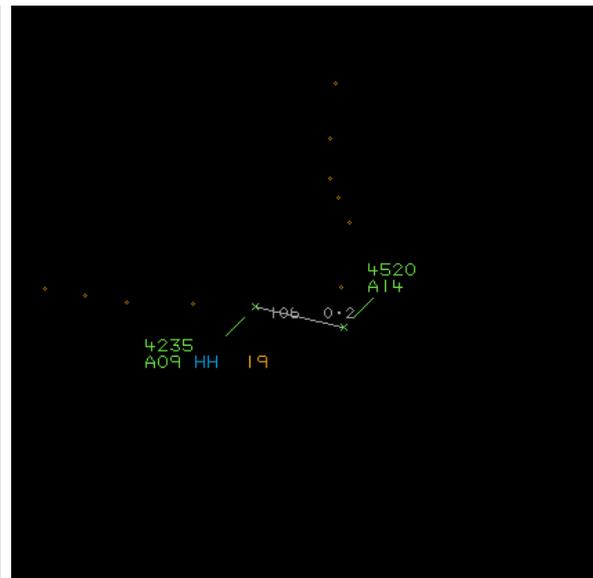
Figure 6 – 1143:21

CPA took place at 1143:21 with the aircraft separated by 0.2nm laterally and 500ft vertically (Figure 6).

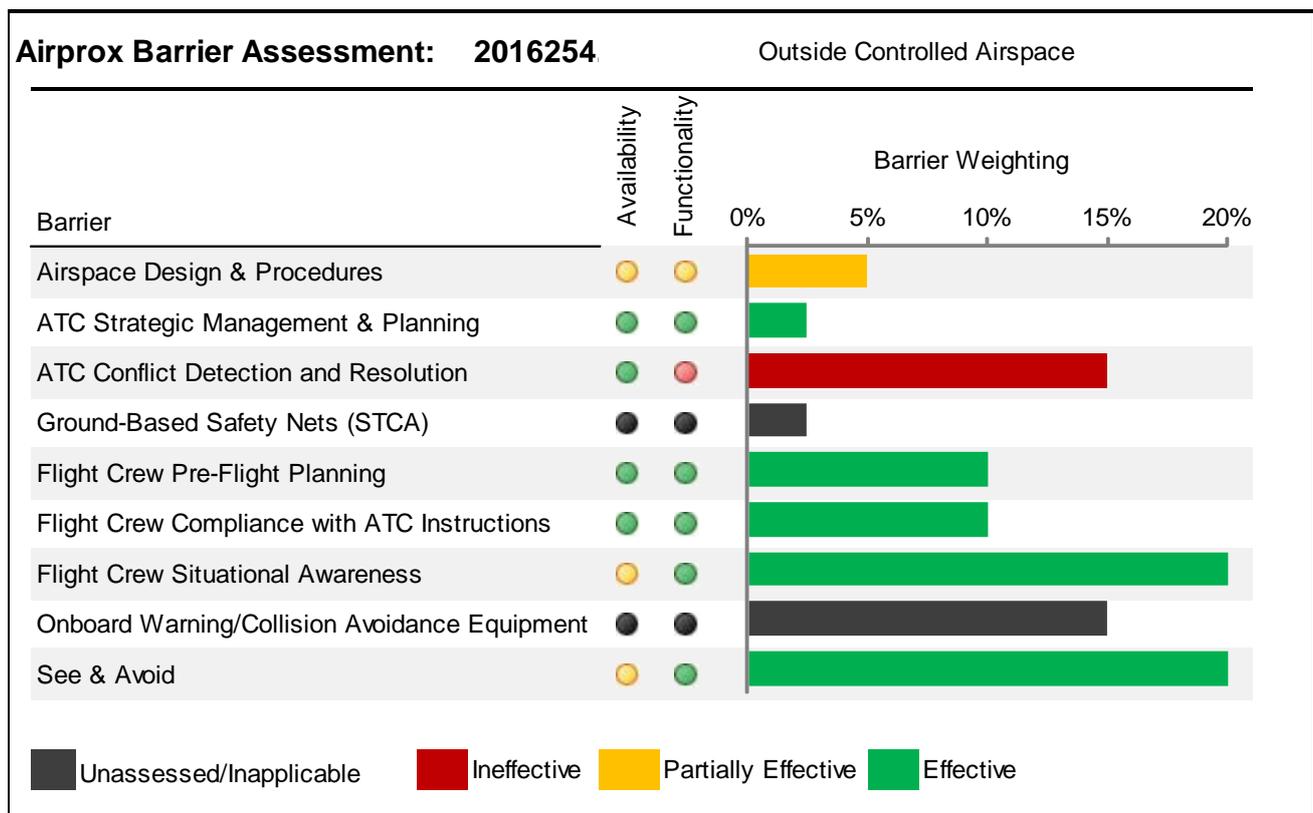
The Board decided that the following key safety barriers were contributory in this Airprox:

Airspace Design and Procedures was only **partially effective** because the Oxford MATS part 2 needed further clarification on procedures when using the NDB 099.

ATC Conflict Detection and Resolution was **ineffective** because Oxford ATC did not provide timely traffic information.

Onboard Warning/ Collision Avoidance Equipment was **inapplicable** because neither aircraft had a CWS.

See and Avoid was **effective** because the DA42 pilot took action to resolve the conflict.
