AIRPROX REPORT No 2016259

Date: 02 Nov 2016 Time: 1213Z Position: 5210N 00007W Location: Gransden Lodge Glider Site

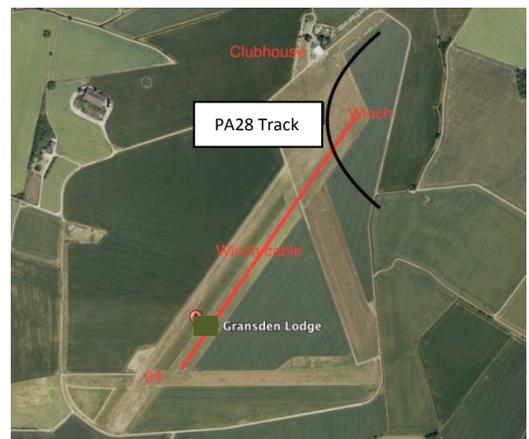
THE ASK 21 PILOT reports that the event occurred during a winch launch on RW04. It appeared to him that a PA28 attempted to land on RW22 and, at the very last minute turned left (east) across the front of the winch. At the time it turned, the PA28 was just past the winch with the glider launch still in progress. The incident was witnessed from the ground by two witnesses, one a glider pilot and the other the Duty Instructor, who estimated that the PA28 was at 300-400ft agl and turned within feet of the live rope. The Duty Instructor watched the PA28 and believed it landed at Little Gransden A/F, 2-3nm west of Gransden Lodge airfield. The ASK 21 pilot was unaware of the event during his flight [because of his high nose-up attitude] and was only informed of the Airprox event after landing by the Duty Instructor. He included a plan view of the perceived PA28 track.

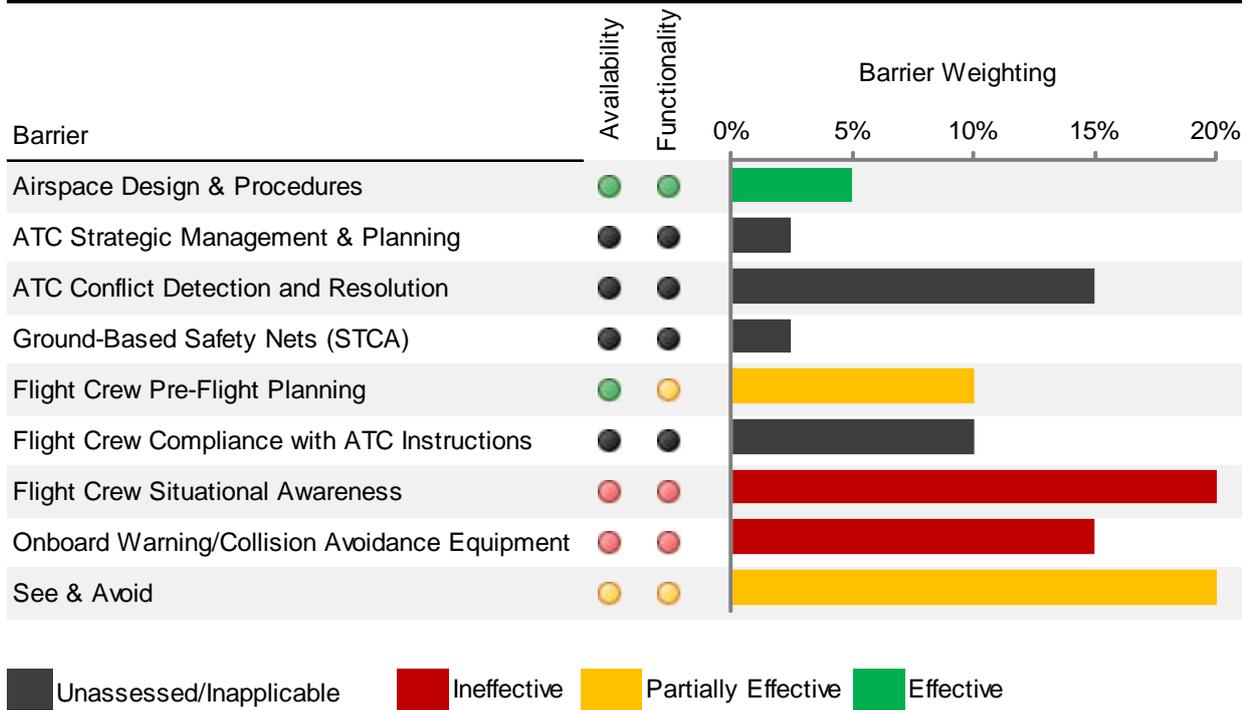
Airprox Barrier Assessment: 2016259

Flight Crew Pre-Flight Planning was considered to be **partially effective** because although the PA28 pilot had presumably not intended to infringe the glider site he had either not recognised the different runway profiles and had made an approach to the wrong airfield, or had not planned his route sufficiently to safely avoid the glider site by a sufficient margin.

Flight Crew Situational Awareness was considered to be **ineffective** because there was no information available to either pilot on each other's aircraft, and the PA28 pilot did not appear to be sufficiently aware of Gransden Lodge glider site.

Onboard Warning/ Collision Avoidance Equipment was considered to be **ineffective** because although the ASK21 had FLARM fitted, this could not detect the PA28, and the PA28 did not have a system fitted.

See and Avoid was considered to be only **partially effective** because the ASK21 pilot did not see the PA28 and, although the PA28 pilot reported that he saw the ASK21, his avoiding turn would have likely taken him across the winch launching glider's cable.
