AIRPROX REPORT No 2016268

Date: 20 Dec 2016 Time: 1256Z Position: 5124N 00309W Location: Lavernock Point, Cardiff

PART A: SUMMARY OF INFORMATION REPORTED TO UKAB

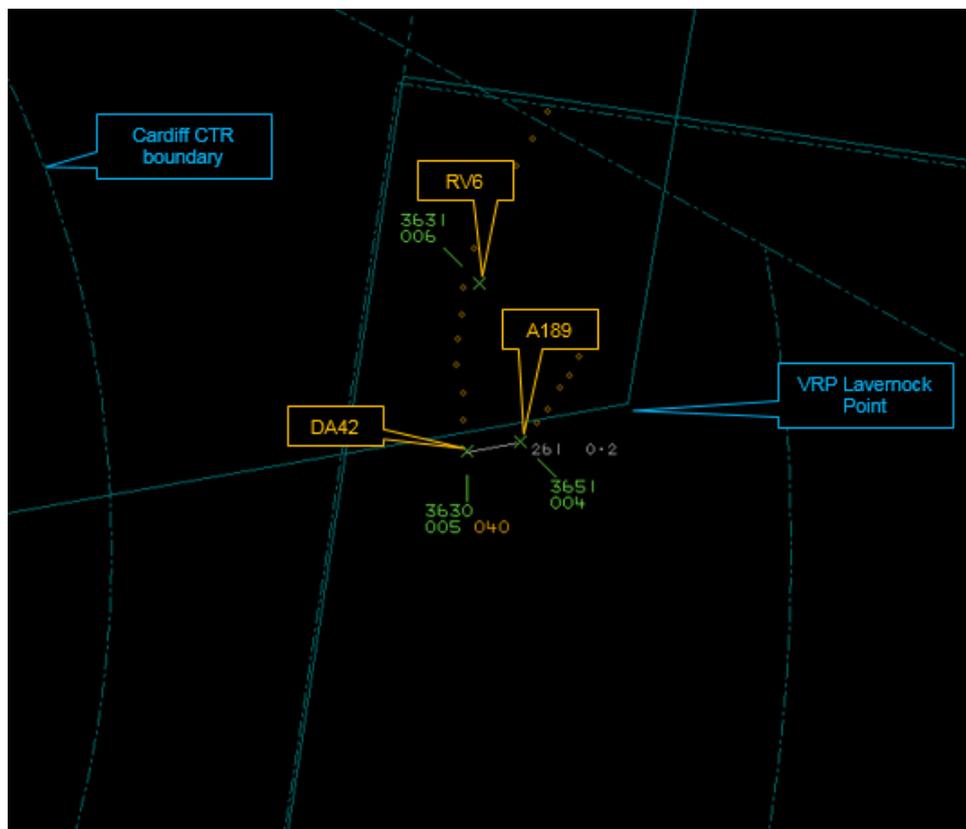
Figure 1 -1256:56

CPA between the AW189 and the DA42 occurred at 1256:56 (Figure 1) with 100ft vertical separation and 0.2nm lateral. Height information is displayed in terms of Flight Levels, the levels indicated being approximately 200ft lower than the associated equivalent altitude.(004 would be approximately 600ft).

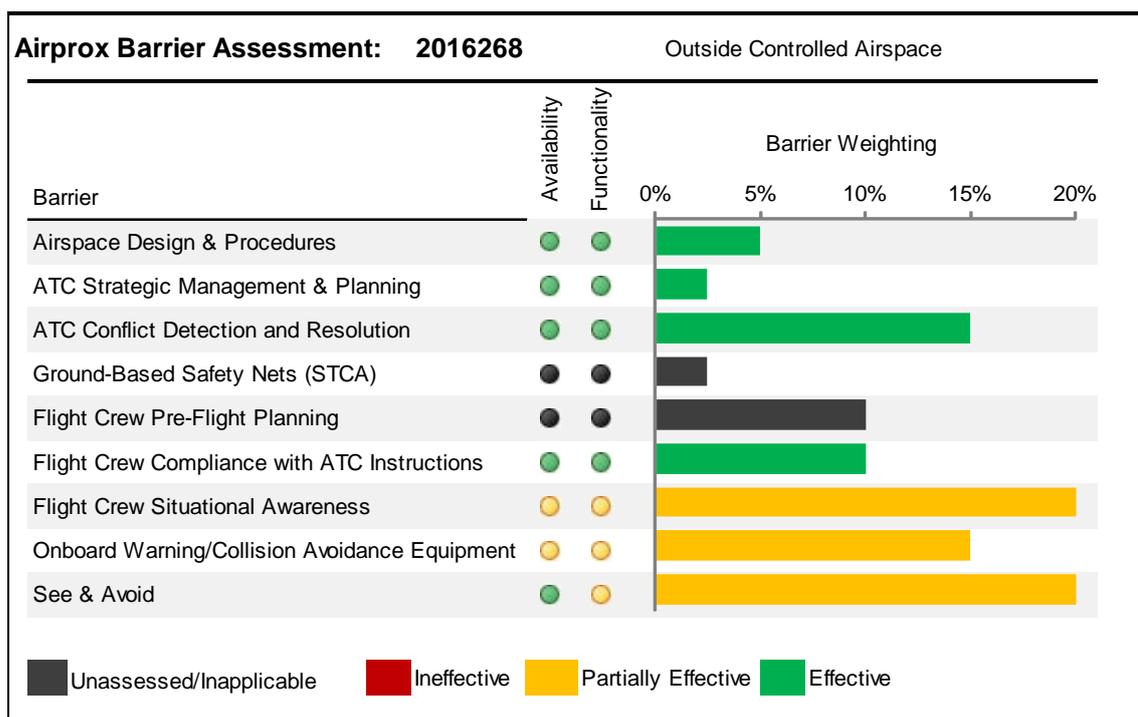
Flight Crew Situational Awareness was only **partially effective** because the AW189 pilot had no specific information about the DA42.

Onboard Warning/ Collision Avoidance Equipment was **partially effective** because the AW189 TCAS gave ambiguous indications and the DA42 did not have a CWS.

See and Avoid was **partially effective** because the AW189 pilot only saw the DA42 at CPA.
