## AIRPROX REPORT No 2016269

Date: 18 Dec 2016 Time: 1353Z Position: 5331N 00238W Location: 9.5nm WNW Barton

### PART A: SUMMARY OF INFORMATION REPORTED TO UKAB

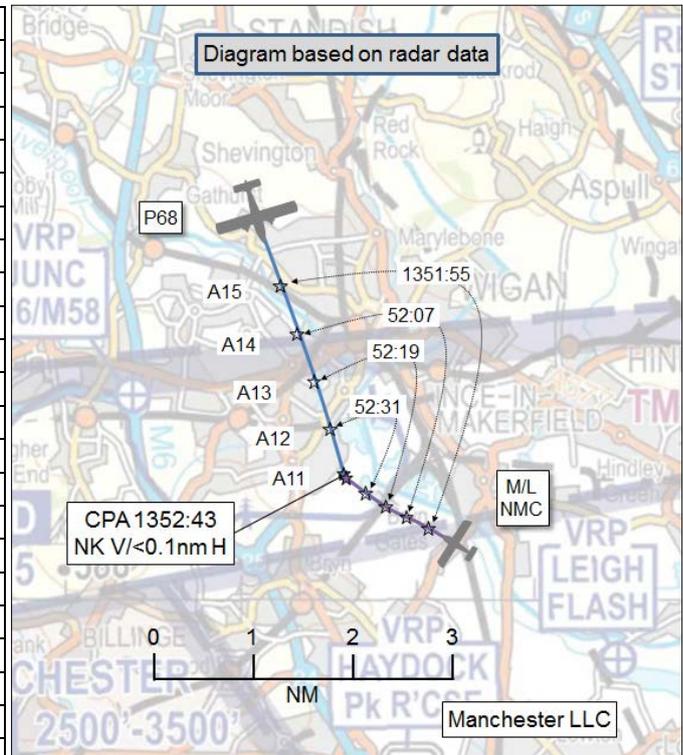
Recorded	Aircraft 1	Aircraft 2
Aircraft	P68	Microlight
Operator	Civ Comm	Unknown
Airspace	London FIR	London FIR
Class	G	G
Rules	VFR	
Service	None	
Provider	(Liverpool)	
Altitude/FL	1300ft	
Transponder	A, C, S	
Reported		Not reported
Colours	White, blue	
Lighting	Strobes, landing	
Conditions	VMC	
Visibility	>10km	
Altitude/FL	1300ft	
Altimeter	QNH (1034hPa)	
Heading	165°	
Speed	140kt	
ACAS/TAS	Not fitted	
Alert	N/A	
Separation		
Reported	200ft V/0m H	
Recorded	NK V/<0.1nm H

**THE P68 PILOT** reports setting course for Hawarden with the aim of gaining a VFR transit through the Liverpool CTR via the LPL NDB. Radar were busy with R/T, and a timely request for a Traffic Service couldn't be made. As he approached the CTA, having been unable to establish a service, he initiated a descent and turned towards the Manchester low-level corridor (LLC). Although he could not recall the details of his transit entirely, he considered it possible that one of his heading changes either allowed the other aircraft to come into view from behind the 'A' pillar, or that some relative movement became apparent. His recollection was that the other aircraft, which he assessed to be a '3-axis microlight', was in the left 1030 position, growing in size rather than moving across the windscreen, and at the same altitude, with a relative track of about 120° to his own (i.e. heading northwest-bound). He initiated a descent to gain vertical separation; the other aircraft may have given a small wing-waggle, but it was subtle and may have been turbulence. Shortly after, Liverpool called back for his request. After passing his message, he advised the controller that he'd had an Airprox.

He assessed the risk of collision as 'Medium'.

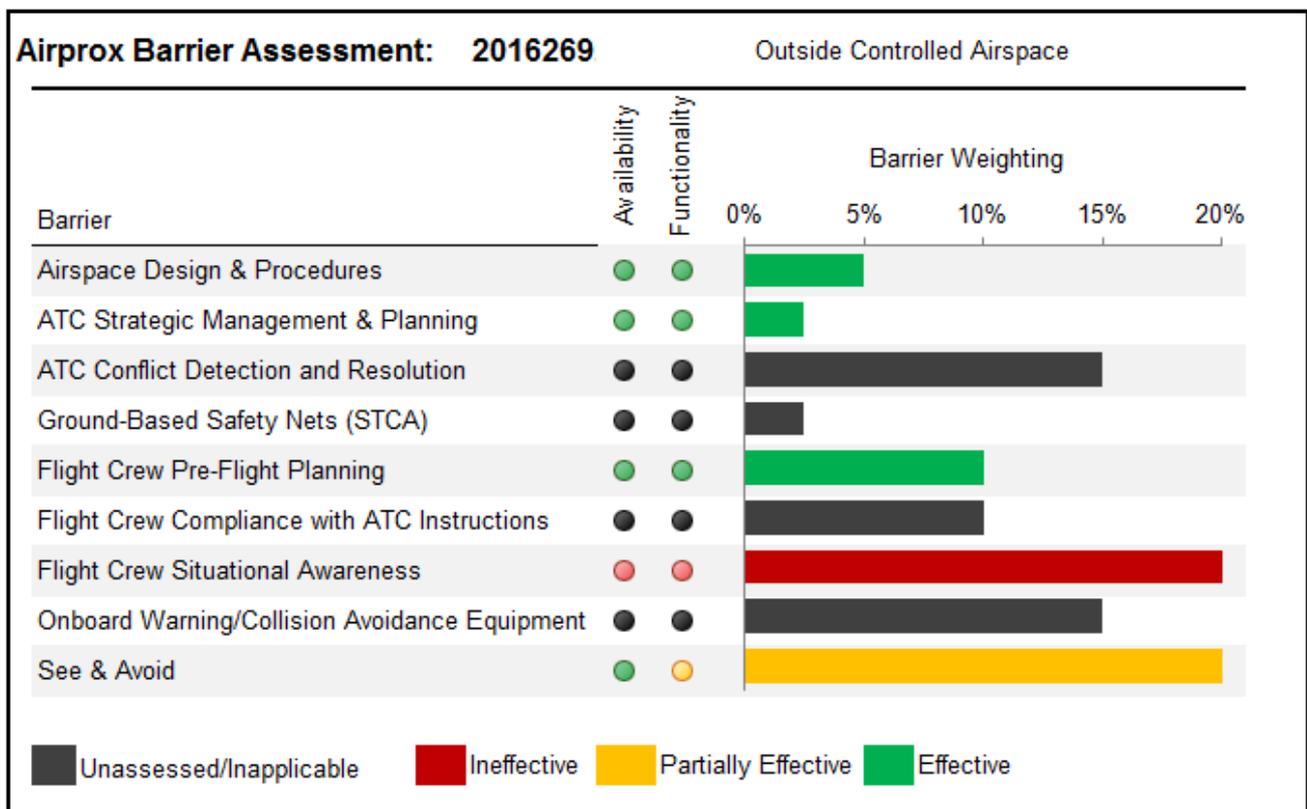
### **Safety Barrier Assessment<sup>4</sup>**

In assessing the effectiveness of the safety barriers associated with this incident, the Board concluded that the key factors had been that:

**Flight Crew Situational Awareness** was assessed as **ineffective** because no systems were present to give the pilots information to improve SA, the P68 pilot was unaware of the microlight until very shortly before CPA and, by virtue of separation at CPA, it was considered likely that the microlight pilot was unaware of the P68.

**See and Avoid** was assessed as **partially effective** because the P68 pilot saw the microlight, albeit at a late stage.

<sup>4</sup> Modern safety management processes employ the concept of safety barriers that prevent contributory factors or human errors from developing into accidents. Based on work by EASA, CAA, MAA and UKAB, the following table depicts the barriers associated with preventing mid-air-collisions. The length of each bar represents the barrier's weighting or importance (out of a total of 100%) for the type of airspace in which the Airprox occurred (i.e. Controlled Airspace or Uncontrolled Airspace).<sup>4</sup> The colour of each bar represents the Board's assessment of the effectiveness of the associated barrier in this incident (either Fully Effective, Partially Effective, Ineffective, or Unassessable/Absent). The chart thus illustrates which barriers were effective and how important they were in contributing to collision avoidance in this incident. The UK Airprox Board scheme for assessing the Availability, Functionality and Effectiveness of safety barriers can be found on the [UKAB Website](#).
