AIRPROX REPORT No 2017001

Date: 05 Jan 2017 Time: 1512Z Position: 5307N 00038W Location: SW Waddington

PART A: SUMMARY OF INFORMATION REPORTED TO UKAB

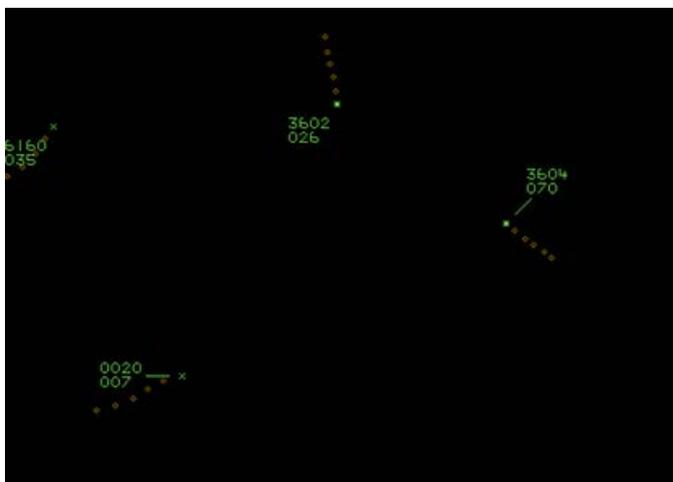
Figure 1: Geometry at 15:08:15
(MD902 squawking 0020)

At 15:08:15 (Figure 1), the Waddington Zone controller passed TI to the MD902 on traffic right, 1 o'clock, 4nm, crossing right to left, no height information (not visible in screen shot).

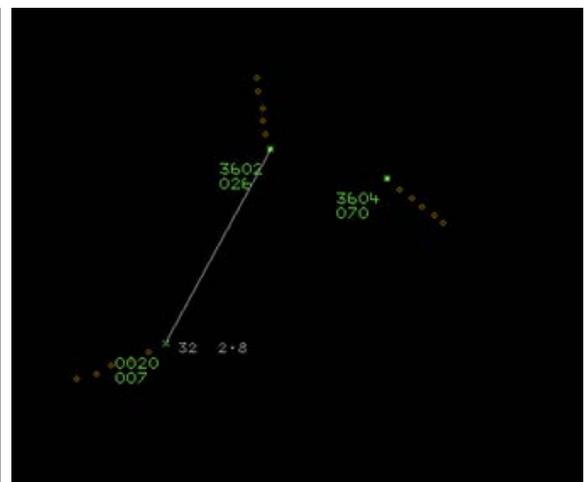
Figure 2: Geometry at 15:08:48

At 15:08:48 (Figure 2), the Waddington Zone controller passed TI on traffic left, 11 o'clock, 2nm, crossing left to right, indicating 2000ft above.

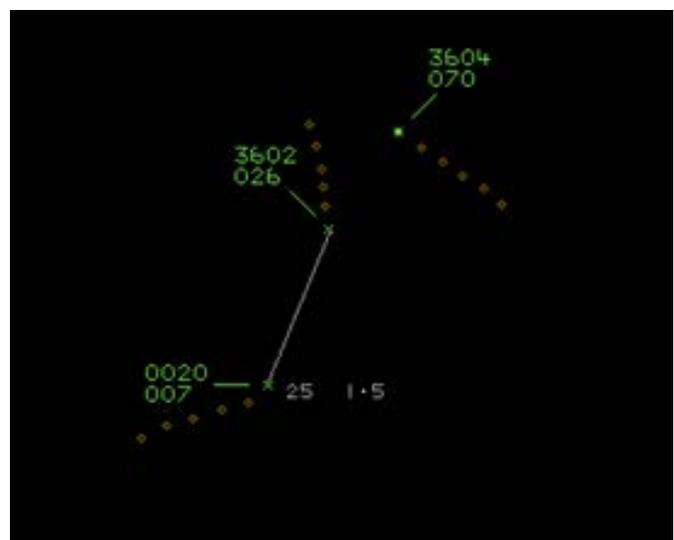
Figure 3: Geometry at 15:09:18 (MD902 0020)

At 15:09:18 (Figure 3), the Waddington Zone controller passed TI on traffic 12 o'clock, 2nm, opposite direction, no height information (not visible in screen shot) and further traffic left, 10 o'clock, 1nm, crossing left to right, indicating 2000ft above. The Airprox is believed to have occurred within the next minute.

While looking for the traffic detailed in Figure 3, the MD902 pilot became visual with a light, fixed-wing aircraft in the 12 o'clock position, moving slowly from right to left, and took avoiding action to the right. From the narrative, it is not apparent whether the TI-induced scan enabled the pilot to become visual with the Airprox traffic or whether searching for traffic at a greater range distracted from lookout in the closer vicinity.

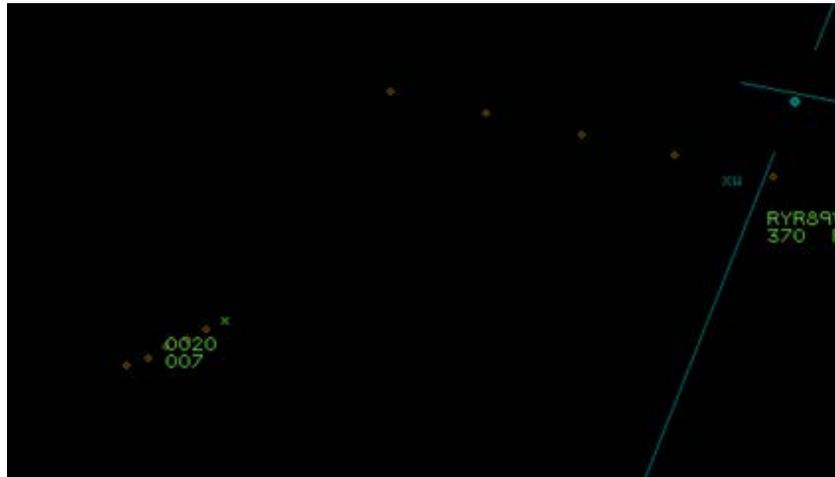
Figure 4: Geometry at 15:12:06 (MD902 0020)

At 15:12:06 (Figure 4), the Waddington Zone controller passed TI on traffic right, 2 o'clock, 4nm, manoeuvring, no height information (not visible in screen shot) prior to releasing the aircraft to Waddington Tower.

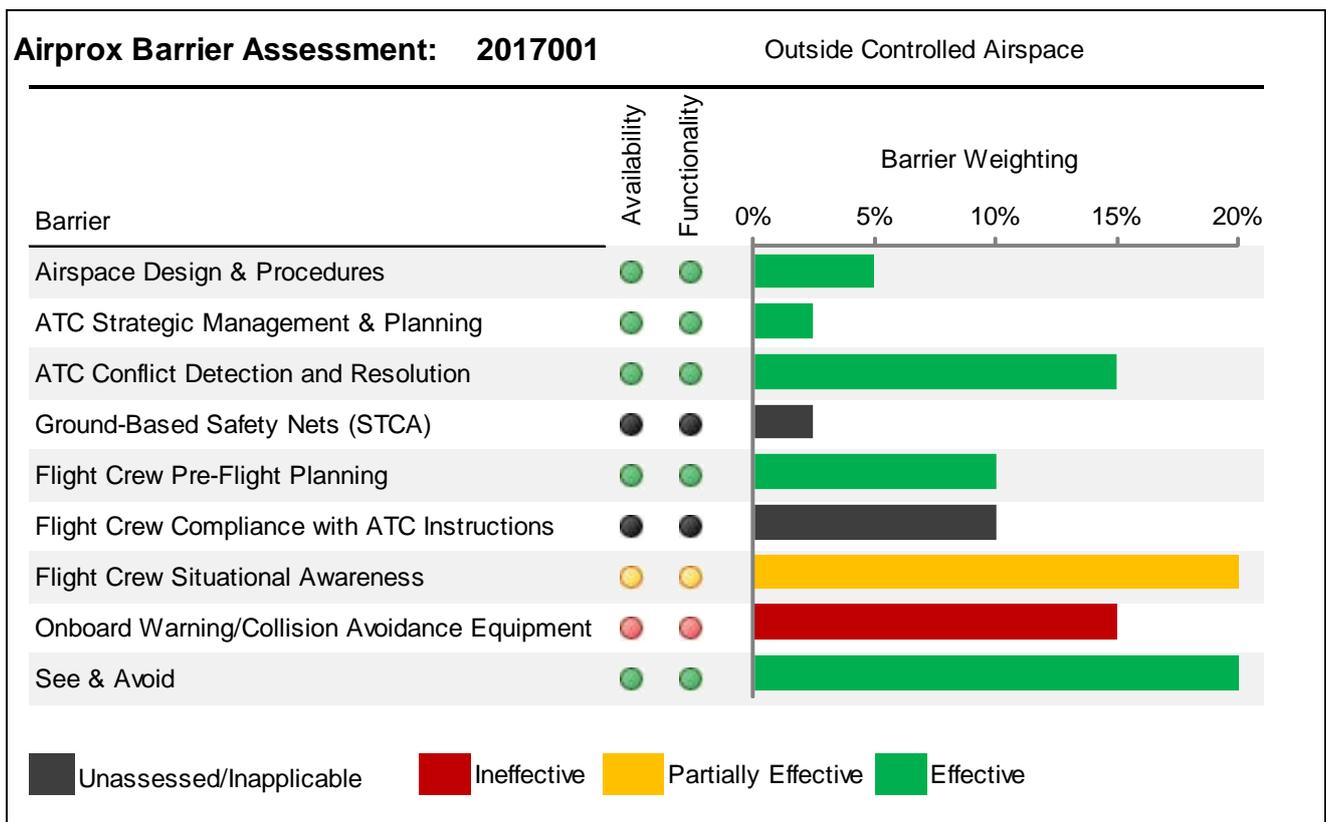
The Board decided that the following key safety barriers were contributory in this Airprox:

Flight Crew Compliance with ATC Instructions was **inapplicable** because ATC had not passed any specific information on the microlight.

Flight Crew Situational Awareness was **partially effective** because the MD902 pilot had been given Traffic Information on other aircraft in the area and this had cued him to see the microlight.

Onboard Warning/Collision Avoidance Equipment was **ineffective** because the micro-light was not transponder equipped.

See and Avoid was considered **effective** because although this was a late sighting the MD902 pilot was able to take timely and effective avoiding action.
