## AIRPROX REPORT No 2017026

Date: 28 Feb 2017 Time: 1127Z Position: 5516N 00129E Location: AARA7

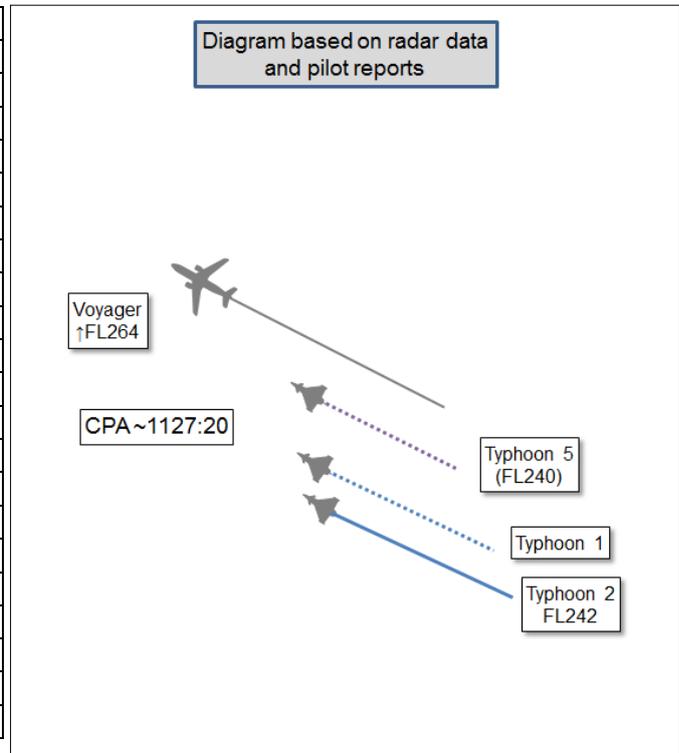
**THE TYPHOON 1 PILOT** reports leading a formation pair to Tow Line 7 (TL7) to conduct air-to-air refuelling (AAR). Ahead was another Typhoon pair and Typhoon 5, a singleton. The tanker was established in TL7 at FL250 with a single Typhoon in contact and the preceding Typhoon pair alongside. Typhoon 5 was established at FL230 in IMC, attempting to gain visual with the tanker and other aircraft. Typhoon 1 flight were level at FL220 as the next in order to join. Typhoon 1 flight were cleared to FL240, in radar trail of the tanker, with FL240 being confirmed as clear by the tanker on the tactical (join) frequency, which was being controlled by HOTSPUR [a Boulmer controller]. Whilst closing to the tanker in IMC for the join, Typhoon 1 pilot became visual with a Typhoon in his right, 2 o'clock, co-height, assessed to be within 0.25nm. Typhoon 1 flight ceased their join on the tanker and informed HOTSPUR on the tactical frequency that he was visual with a Typhoon, at FL240, in trail of the tanker. HOTSPUR asked the tanker if FL240 was clear, to which the response was 'FL240 should be clear'. Typhoon 1 pilot then informed the tanker that he was visual with a Typhoon at FL240 and ensured no follow on conflict by maintaining visual. Typhoon 1 flight then ceased their join and returned to base due to fuel. On subsequent post-flight tape review, Typhoon 1 and Typhoon 5 were assessed to have been as close as 1100ft, co-level, prior to Typhoon 1 pilot gaining visual with Typhoon 5. Of note, Typhoon 5 had inhibited transponder M3/C and data-link transmissions iaw Typhoon AAR checks.

**THE TYPHOON 5 PILOT** reports that he gained visual with the tanker and all aircraft alongside, began a visual join and switched across [from the join] to the boom frequency. During this process he lost visual with the tanker as it entered cloud. He descended back to FL240 and ceased overtake whilst maintaining 2.5nm radar trail. The pilot communicated this to the tanker on the boom frequency which was acknowledged by the tanker crew, who stated they would commence a climb to FL270 in

pilot that he was 'currently still 2.5 miles trail India Mike at 240'. Shortly after this, Typhoon 1 and 2 broke out of cloud and saw Typhoon 5 co-altitude at a lateral range estimated to be 0.25nm (1500ft) initially and confirmed to be of the order of 1100ft after data analysis.

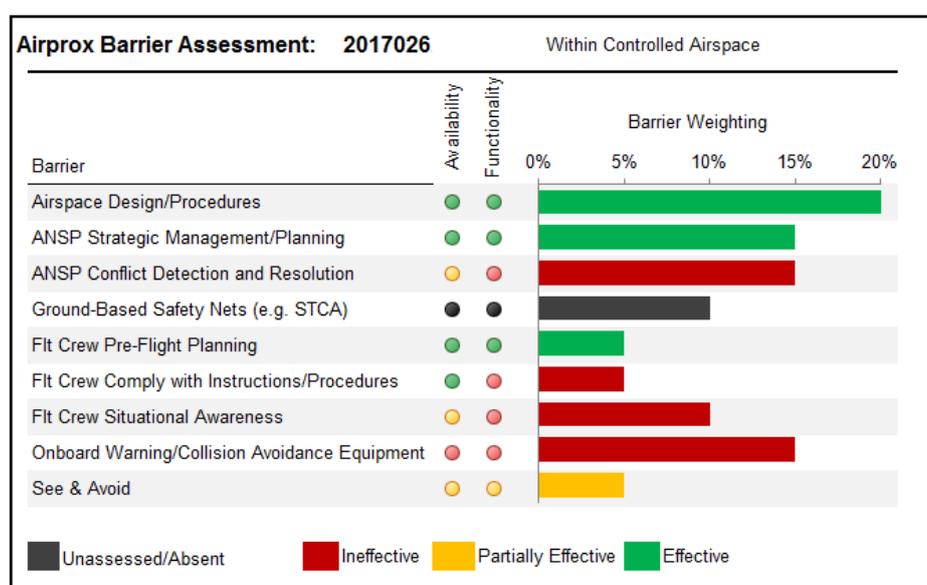
In assessing the effectiveness of the safety barriers associated with this incident, the Board concluded that the key factors had been that:

- **ANSP Conflict Detection and Resolution** was assessed as **ineffective** because HOTSPUR were not able to detect the confliction.
- **Flight Crew Compliance with Instructions/Procedures** was assessed as **ineffective** because the tanker crew allowed Typhoon 1 flight to climb to FL250 whilst FL240 was occupied by Typhoon 5.
- **Flight Crew Situational Awareness** was assessed as **ineffective** because the tanker crew and Typhoon 1 flight were not aware that Typhoon 5 was level at FL240.
- **Onboard Warning/Collision Avoidance System** was assessed as **ineffective** because all equipment associated with traffic awareness/collision avoidance had been selected to standby.
- **See and Avoid** was assessed as **partially effective** because neither Typhoon pilot was able to see the other, due to cloud, until at a very late stage.
