**AIRPROX REPORT No 2017032**

Date: 16 Feb 2017 Time: 0934Z Position: 5055N 00120W Location: SAM hold

**PART A: SUMMARY OF INFORMATION REPORTED TO UKAB**

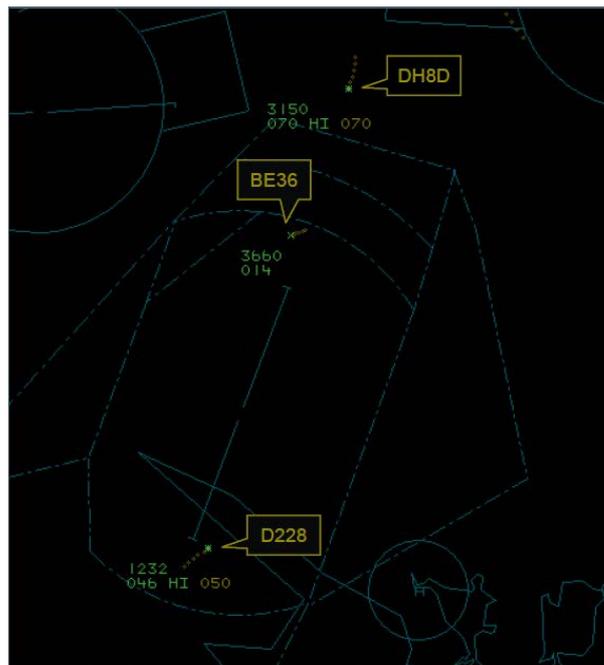
Figure 1 Swanwick MRT (levels are FL) – 0929:25.

At 0929:25 the Solent Radar controller advised the D228 pilot that the BE36 pilot was having problems with the approach and instructed the D228 pilot to again route to the hold (Figure 1).

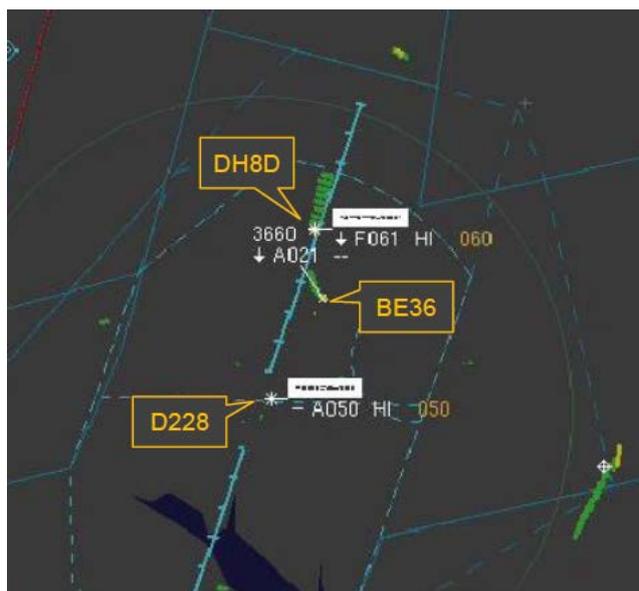
Figure 2 Solent Radar – 0931:35.  
(callsigns obscured)

At 0931:35 the controller instructed the D228 pilot to descend to 4000ft (Figure 2). [He did not report vacating 5000ft.]

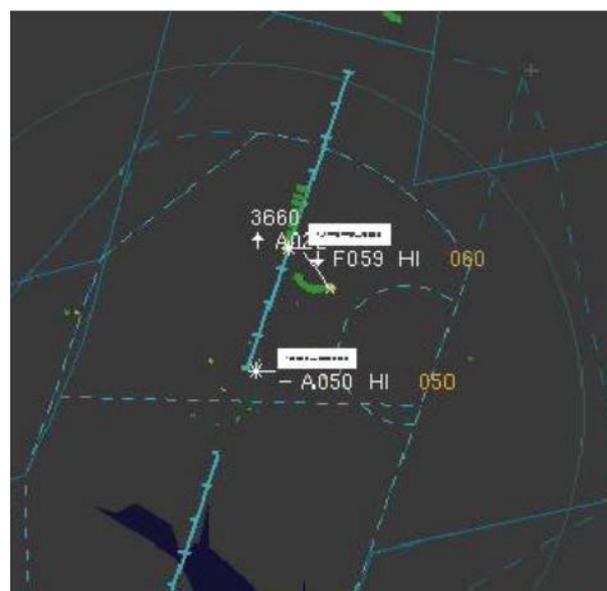
Figure 3 Solent Radar – 0931:47.

At 0931:47 the controller instructed the DHC8 pilot to descend to 5000ft (Figure 3).

The loss of separation occurred some 37 seconds after having cleared the DHC8 pilot to descend above the D228. At interview, the controller admitted that they still have no idea why descent instructions were issued to the DHC8 pilot before vertical separation had been assured against the D228. They thought that they might have crossed out the level being vacated by the D228 (5000ft) on their corresponding flight progress strip (uncorroborated), leading to the controller incorrectly believing that the level was now available for the DHC8. The controller did not refer to the radar screen to ascertain the levels, and it was noted that the label of the DHC8 was garbling with that of the BE36 at the time.

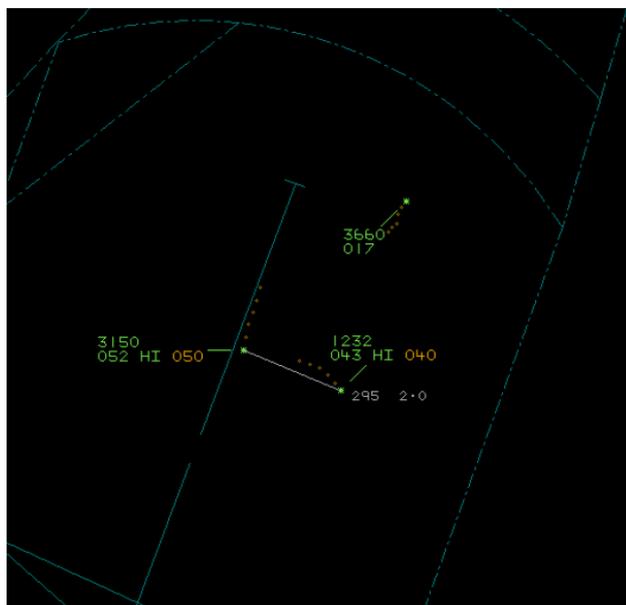
Figure 4 Swanwick MRT - 0932:32.

At 0932:32 standard separation between the D228 and the DHC8 was eroded, with the aircraft being 2nm apart laterally and separated by less than 1000ft, (3nm or 1000ft required) (Figure 4).

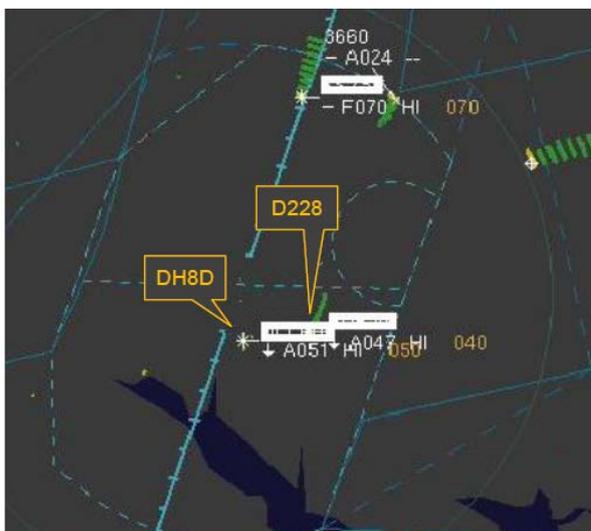
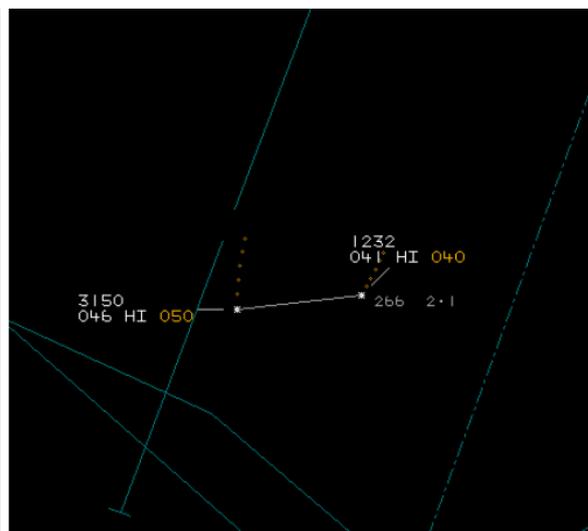
At 0933:31 the controller cancelled the D228 pilot's hold again, instructing them to turn right onto a heading of 050° (Figures 5 & 6).

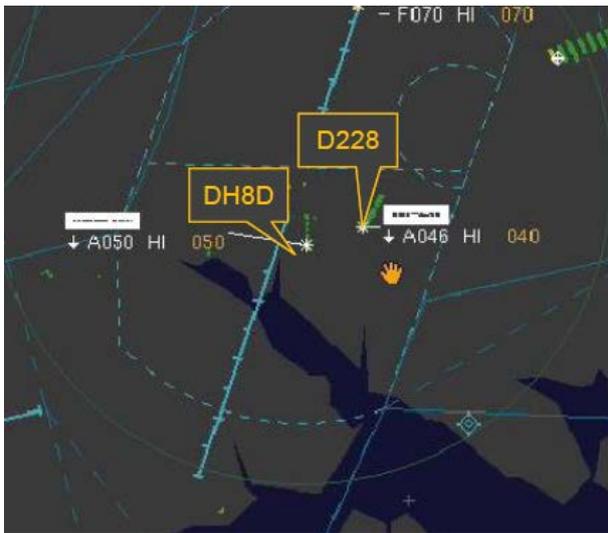
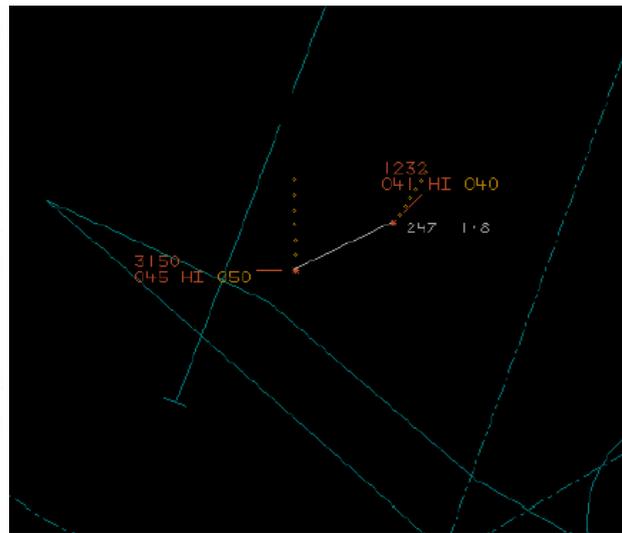
At 0933:45 the Solent Radar display showed the controller re-orientating the labels of the D228 and DHC8 on their radar display, whilst at the same time they asked the DHC8 pilot to confirm that they were maintaining 5000ft. This coincided with CPA when the aircraft were separated by 1.8nm laterally and 400ft vertically (Figures 7 & 8).
