AIRPROX REPORT No 2017038

Date: 08 Mar 2017 Time: 1201Z Position: 5310N 00236W Location: Oulton Park VRP

PART A: SUMMARY OF INFORMATION REPORTED TO UKAB

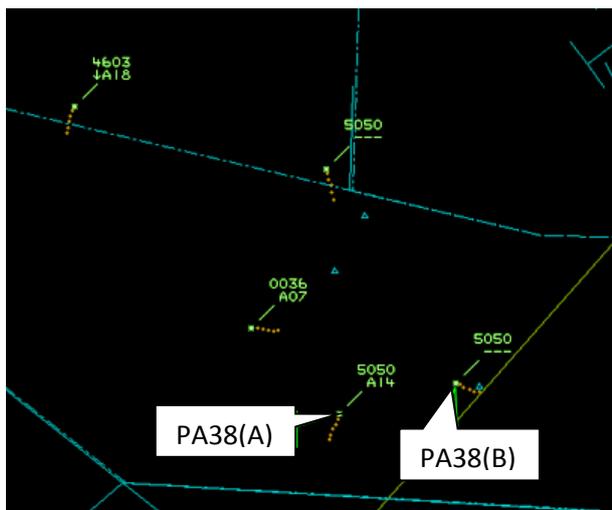
Figure 2 - 1159:52

At 1159:52 (Figure 2), PA38(B) pilot called Liverpool Radar to request re-join at Oulton Park. The same clearance was issued to him as to PA38(A) pilot, and was readback correctly by the pilot.

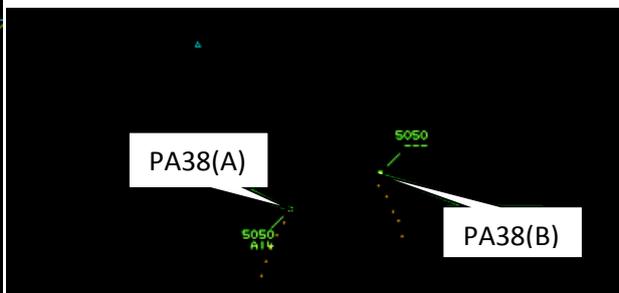
Figure 3 - 1200:51

At 1200:51 (Figure 3), the controller instructed the PA38(A) pilot to select the SSR code 5051.

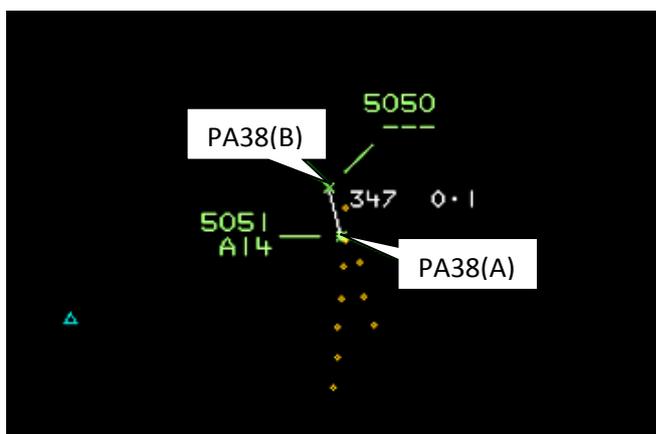
Figure 4 - 1201:51

CPA first occurred at 1201:51 (Figure 4). There was 0.1nm between the two aircraft, but as there was no height information from the PA38(B), it was not possible to measure the vertical distance.

Although CPA was first observed at 1201:51 (and reported by the PA38(A) pilot approximately 20 seconds later), the distance between the two aircraft remained constant until after 1203:05.

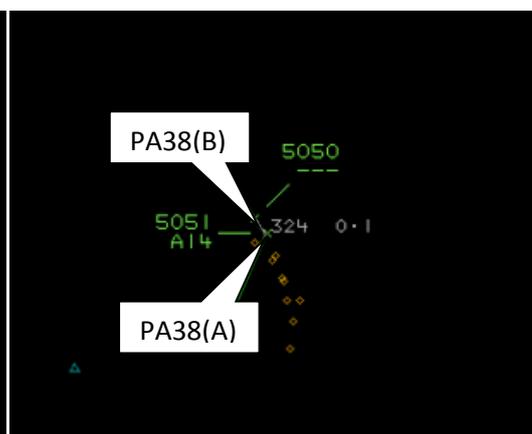
Figure 5 - 1202:05

At 1202:05 (Figure 5) the controller advised the PA38(B) pilot to: *“Keep a good lookout there’s also another aircraft er joining, I can’t erm figure out which of you is in front or behind, same altitude”*. The PA38(B) pilot acknowledged the warning.

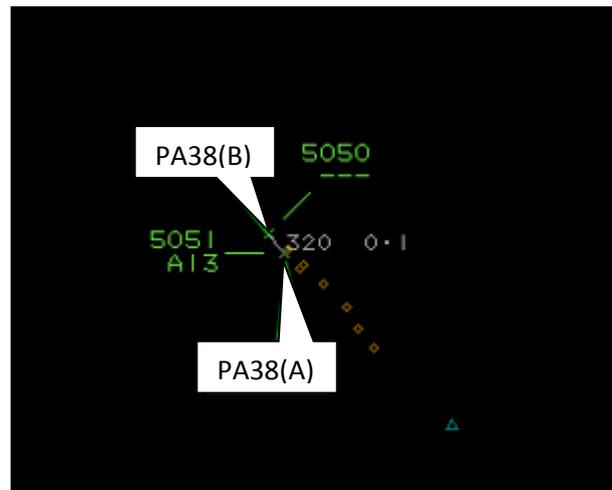
Figure 6 - 1203:05

At 1203:05 (Figure 6) the PA38(A) pilot replied that they were at Delamere Forest and were taking up an orbit for spacing purposes. The PA38(A) was still 0.1nm behind the PA38(B).

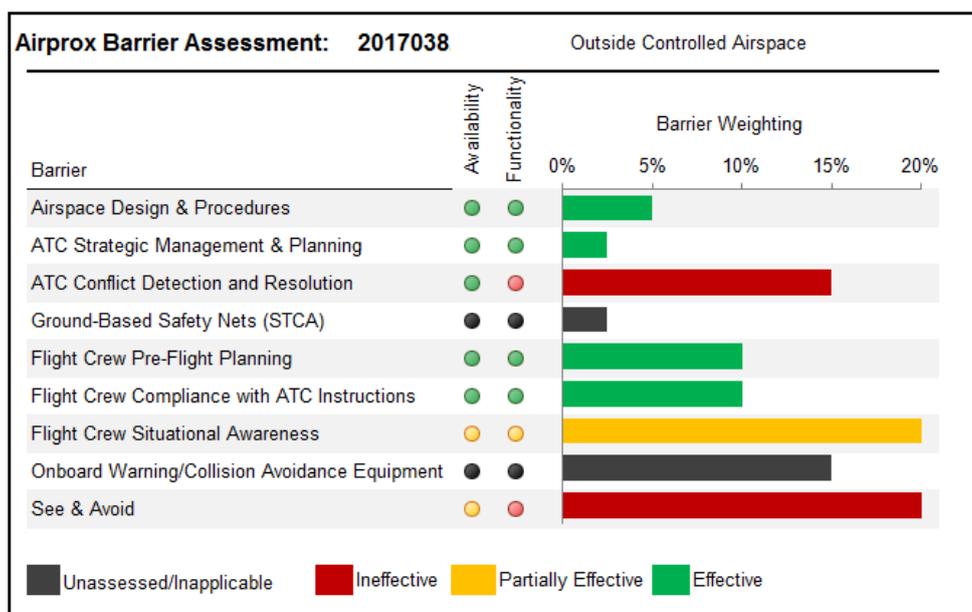
ATC Conflict Detection and Resolution was assessed as **ineffective** because although the controller endeavoured to identify one of the aircraft, he passed TI after CPA rather than generic TI prior to the conflict occurring.

Flight Crew Situational Awareness was assessed as **partially effective** because although both pilots were on the same frequency and could have assimilated the presence of the other aircraft through radio calls, they were only generically aware of each other because there was no specific TI from ATC.

Onboard Warning/Collision Avoidance Equipment was assessed as **inapplicable** because neither aircraft was fitted with a system that would have alerted to the presence of the other aircraft thus allowing the pilots to take effective avoiding action.

See and Avoid was assessed as **ineffective** because neither aircraft saw the other until CPA when the PA38(A) pilot saw PA38(B), even though PA38(B) was ahead and to the right of PA38(A) up to and after CPA.
