**AIRPROX REPORT No 2017047**

Date: 02 Apr 2017 Time: 1358Z Position: 5231N 00215W Location: Halfpenny Green (elev 283ft)

**PART A: SUMMARY OF INFORMATION REPORTED TO UKAB**

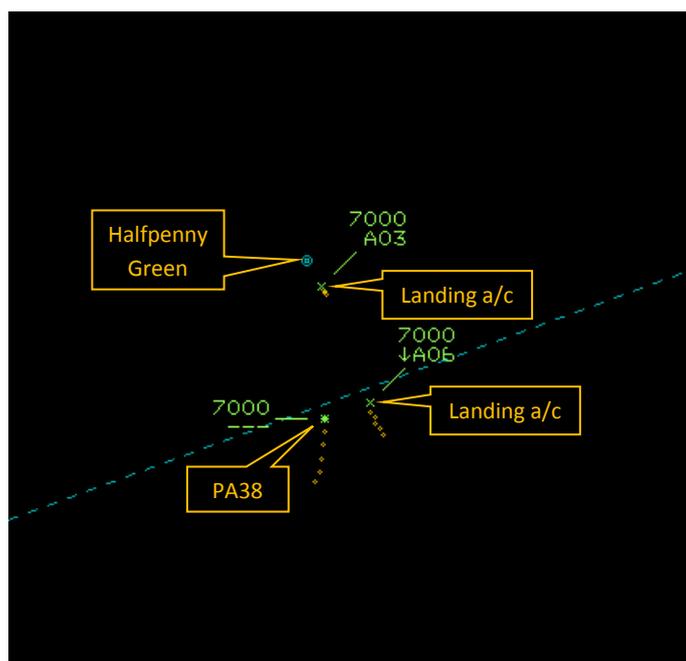
Figure 1 – 1356:15

The PA38 was inbound to the airfield from the south, and the pilot reported overhead at 1356:15. Although the PA38 could not be positively identified on the radar replay, by a process of elimination, the contact labelled as the PA38 in Figure 1, is considered, with a high degree of confidence, to be that aircraft.

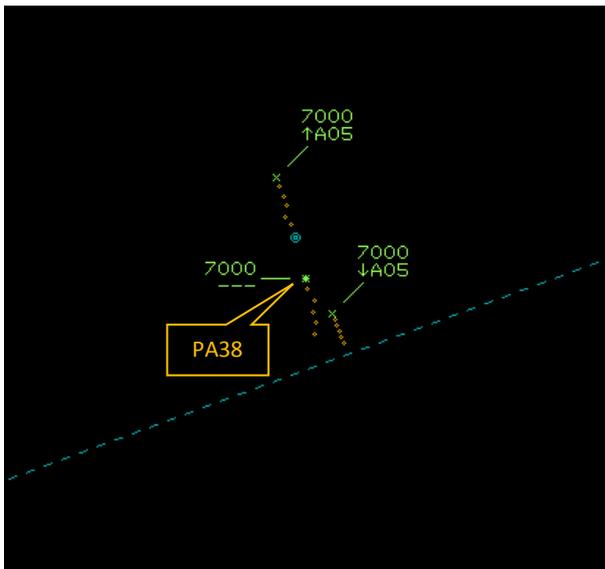
Figure 2 – 1356:54

The DA40 was number 3 in a sequence of 6 departures during this period, and, at 1356:54, the pilot reported ready and was asked by the AFISO to report lining up in turn (Figure 2).

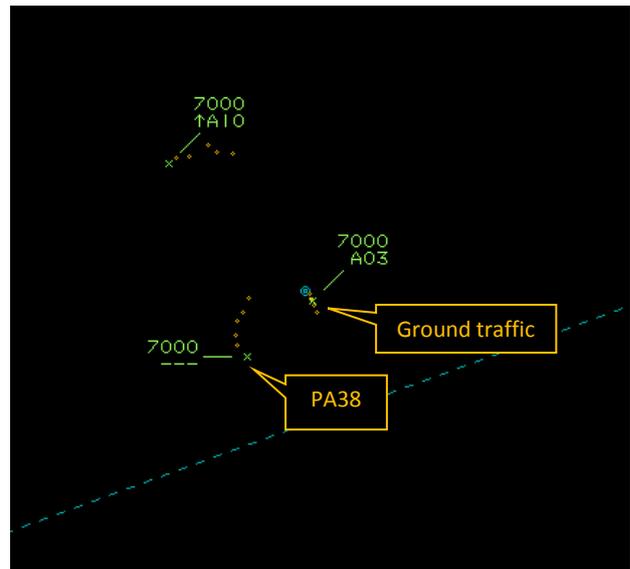
Figure 3 – 1357:40

At 1357:40, following two preceding departures, the DA40 pilot was advised by the AFISO that he could take-off at his discretion (Figure 3).

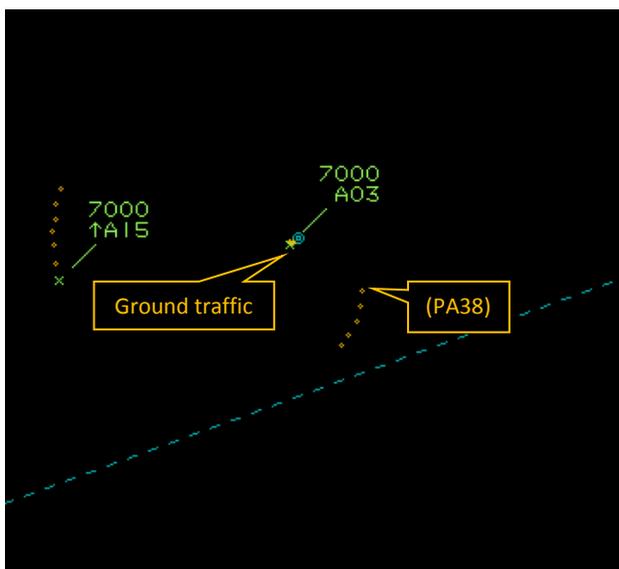
Figure 4 – 1358:42

No further calls were made by the PA38 pilot, and, at 1358:42, radar contact was lost (Figure 4).

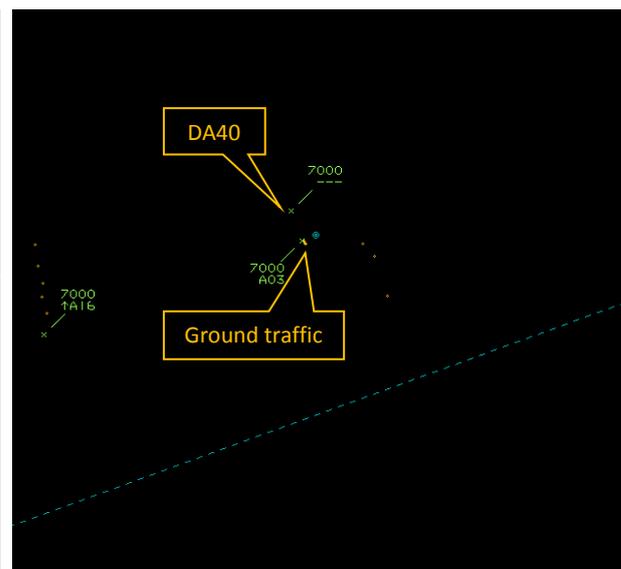
Figure 5 – 1358:56

At 1358:56, the DA40 appeared on the radar replay, but radar contact with the PA38 had not been re-established (Figure 5).

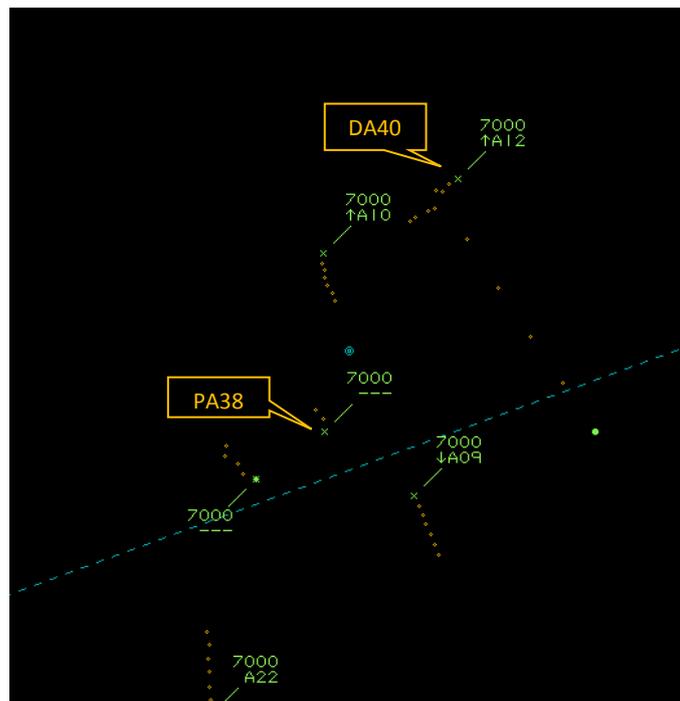
Figure 6 – 1400:30

At 1359:45, the PA38 pilot reported downwind, although the aircraft was not visible on the radar replay. At 1400:30, a contact appeared on the radar replay which could not be positively identified, but which was considered to be, with a high degree of confidence, the PA38 (Figure 6).

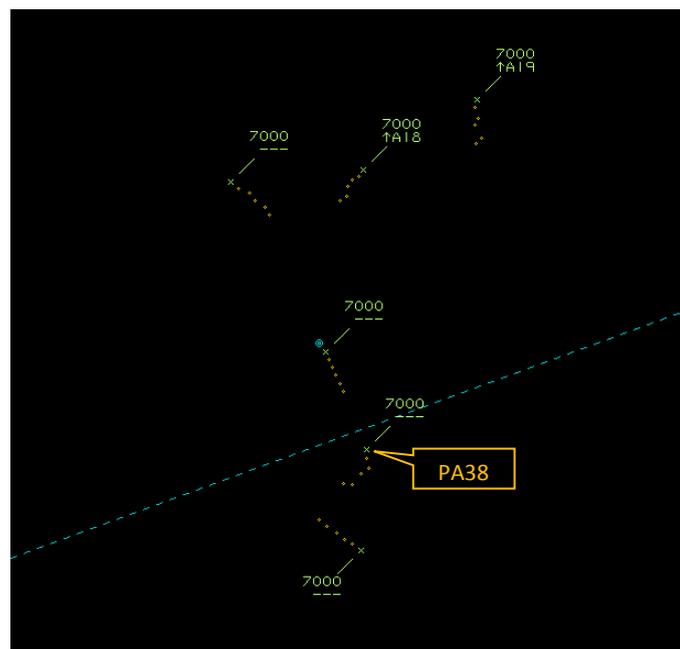
Figure 7 – 1401:28

At 1401:28, the PA38 pilot reported on final approach and was advised that the runway was occupied (Figure 7).

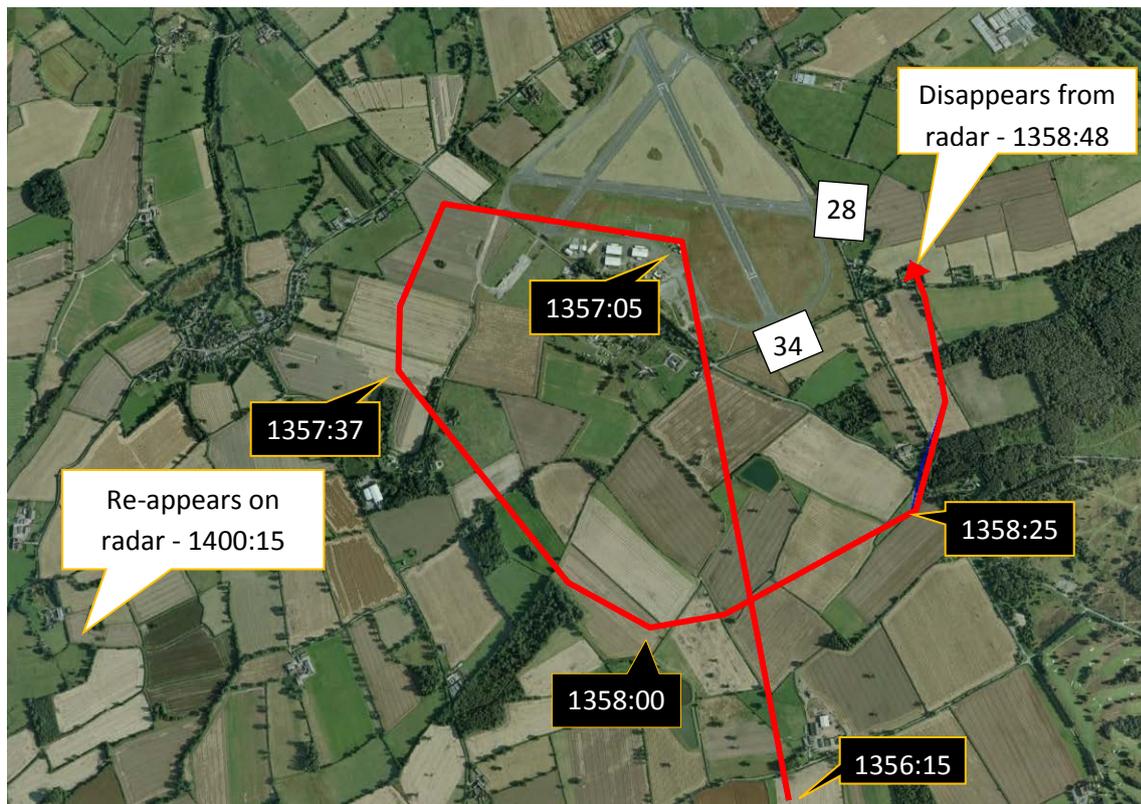
Figure 8 – recorded track of contact believed to be the PA38

In analysing this incident, with the evidence available from the radar replay, and having spoken to one of the AFISO on duty at the airfield that day, ATSI believe there is sufficient information to suggest that the PA38 pilot may have made his initial approach to RW28 and not to the runway in use, which was RW34. This is based on the following points:

- The track of the aircraft, and its subsequent disappearance from radar for over 2 minutes, in an area where the secondary radar contacts with other aircraft were visible at reported altitudes as low as 300ft (airfield elevation 283ft), (Figure 8).
