AIRPROX REPORT No 2017132

Date: 14 Jun 2017 Time: 1513Z Position: 5101N 00251W Location: Curry Rivel

PART A: SUMMARY OF INFORMATION REPORTED TO UKAB

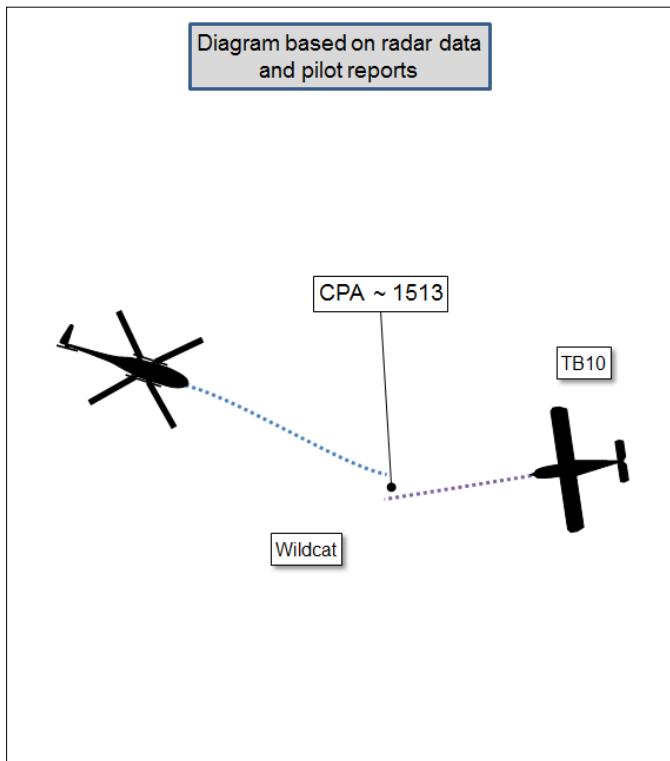
THE WILDCAT PILOT reports that he was at the end of a GH sortie recovering to his base at 700ft on the Southern Route. Abeam Curry Rivel he made a late spot on a civilian fixed-wing aircraft which passed approximately 150 to 200ft below and to the left. No avoiding action was required. The aircraft was immediately called to Merryfield Tower by the aircraft commander and an Airprox subsequently called over the radio. Nothing was seen on TAS. The aircraft was recovered to Yeovilton without further incident.

THE TB10 PILOT reports that he saw the helicopter 1km away and was aware it would overfly his airstrip; he considered the safest option was to continue his approach and descend to land. He endeavoured to ensure full visibility by displaying his strobe and landing lights. This was not the first occasion when military helicopters had over flown his airstrip following the runway direction below circuit height. On this occasion it was passing above and to the port side so he did not consider there to be a risk of collision. He has been discouraged from using the Merryfield Tower frequency in the past but remained very willing to liaise with those responsible for the military operations in their zone over ways to collectively reduce the risk to the respective operations.

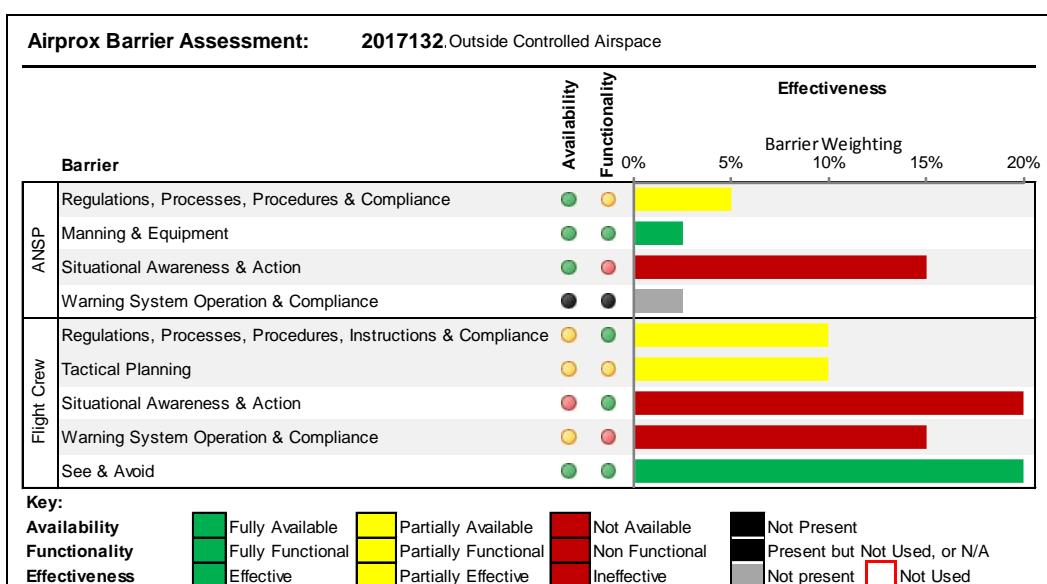
In assessing the effectiveness of the safety barriers associated with this incident, the Board concluded that the key factors had been that:

Regulations, Processes, Procedures & Compliance was assessed as **partially effective** because although Curry Rivel should be known to controllers as an airfield beneath the helicopter route between Merryfield and Yeovilton, it was not marked on the radar map nor subject to a local agreement between all involved parties.

Situational Awareness & Action was assessed as **ineffective** because the LARS controller had full information on the TB10 pilot's intentions, she did not pass this information on to the Merryfield controller, which would have enabled him to pass the relevant information to the Wildcat pilot regarding the TB10 on his transit route.

Regulations, Processes, Procedures, Instructions & Compliance was assessed as **partially effective** because although Curry Rivel was likely known to some local Wildcat pilots as an airstrip beneath the helicopter route between Merryfield and Yeovilton, it was not part of the local area brief to crews operating to and from Yeovilton.

Tactical Planning was assessed as **partially effective** because the location and type of activity of Curry Rivel airfield was not specifically available to the Wildcat pilot within the Yeovilton local operations pilot briefing and, because ATC did not provide the information about the TB10 to him, he could not change his airborne plan to take it into account.

Situational Awareness & Action was assessed as **ineffective** because the Wildcat pilot had no SA on the TB10 as a result of the LARS controller not liaising with the Merryfield controller.

Warning System Operation and Compliance was assessed as **ineffective** because although the Wildcat was equipped with TAS and the TB10 was transponding, the Wildcat pilot received no TAS indications.
