## AIRPROX REPORT No 2017165

Date: 19 Jul 2017 Time: 0945Z Position: 5210N 00007E Location: 3nm SW Cambridge Airport

### PART A: SUMMARY OF INFORMATION REPORTED TO UKAB

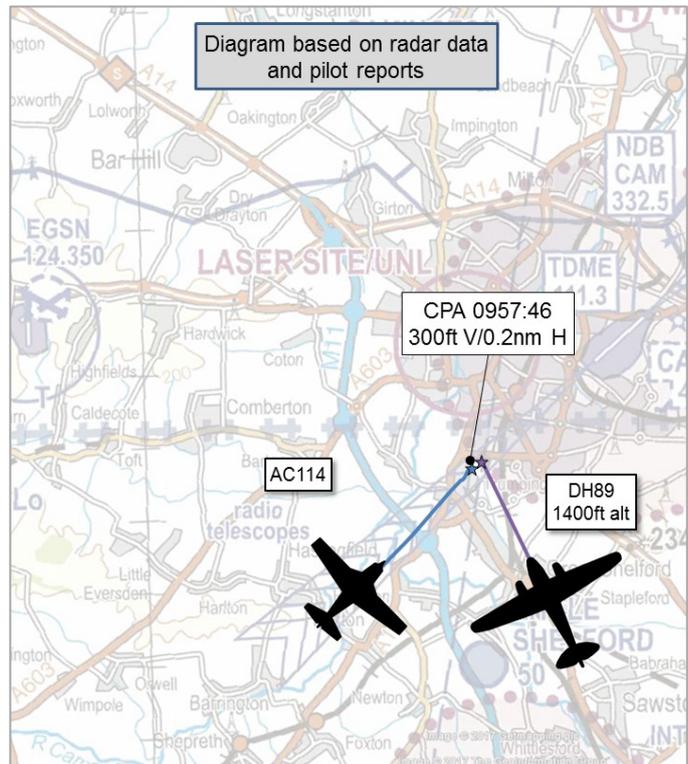
Recorded	Aircraft 1	Aircraft 2
Aircraft	AC114	DH89
Operator	Civ Trg	Civ Comm
Airspace	London FIR	London FIR
Class	G	G
Rules	IFR	VFR
Service	Procedural	Basic
Provider	Cambridge	Cambridge
Altitude/FL	↓1700ft	1400ft
Transponder	A, C, S	A, S
<b>Reported</b>		
Colours	White, Blue	Silver, White
Lighting	Beacon	NK
Conditions	IMC	VMC
Visibility	0nm	>10km
Altitude/FL	1700ft	1500ft
Altimeter	QNH (1004hPa)	QNH (1004hPa)
Heading	050°	340°
Speed	100kt	90kt
ACAS/TAS	TCAS I	Not fitted
Alert	TA	N/A
<b>Separation</b>		
Reported	300ft V/NK H	500ft V/0.25nm H
Recorded	300ft V/0.2nm H

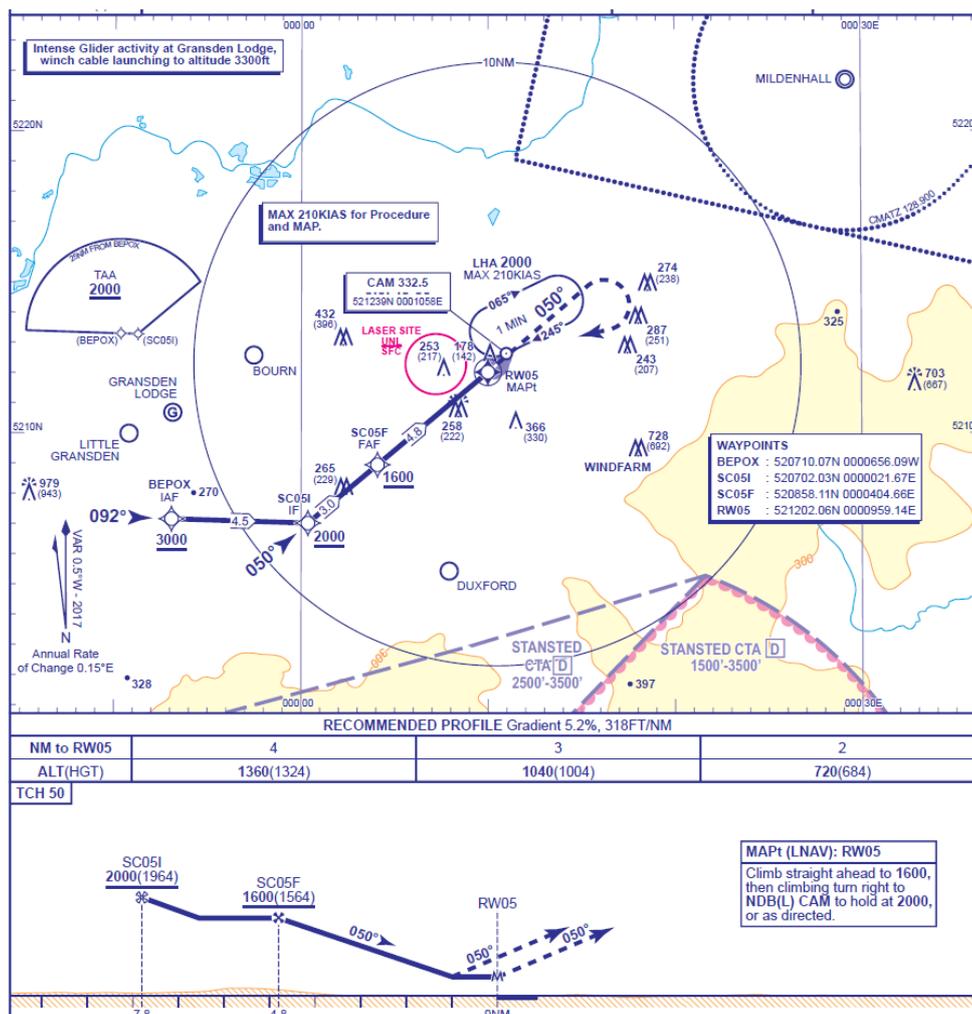
Figure 1 – RNAV 05

The AC114 was conducting an RNAV approach to RW05, and had flown outbound to the Initial Approach Fix, BEPOX, from the north-east, before turning back towards the Intermediate Fix, located 7.8nm south-west of the airfield (Figure 1).

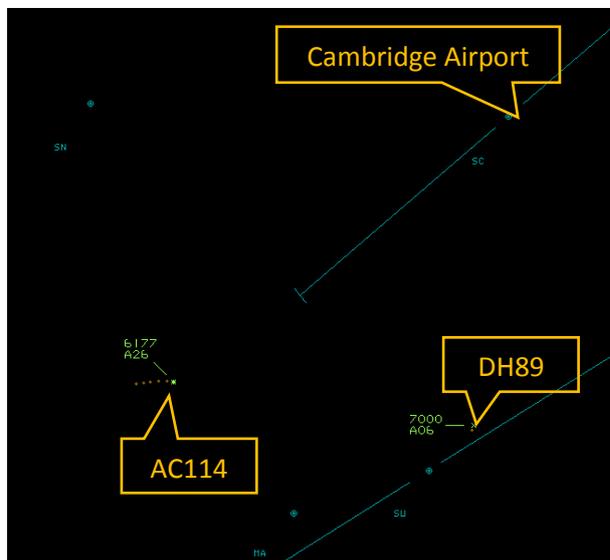
Figure 2 – 0955:00

At 0955:00 the DH89, having got airborne from Duxford, called the Cambridge Approach controller, requesting to route around Cambridge City before continuing to Ely and then Newmarket. The pilot advised that they were passing 700ft, hoping to climb as high as 2000ft, although they stated that they didn't think they would be able to get that high. A Basic Service was agreed, and the pilot of the DH89 reported being aware of traffic on the Cambridge final approach (Figure 2).

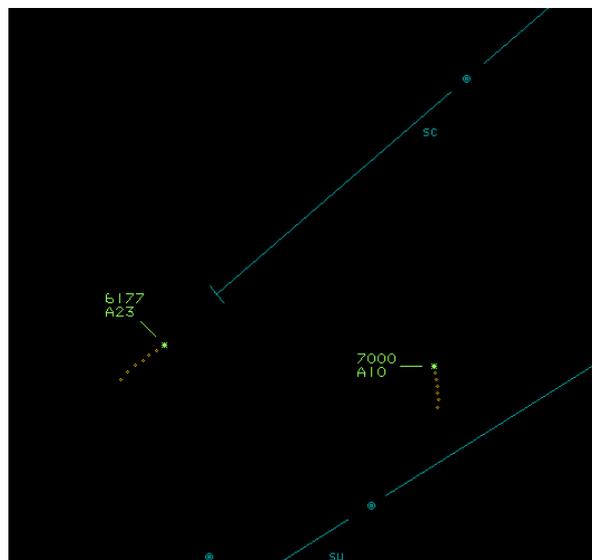
Figure 3 – 0955:50 (AC11 at 6.5NM)

The controller acknowledged this and requested, at 0955:50, that the pilot report before crossing the RW05 final approach, advising that they would update the pilot on the position of the AC114. This was acknowledged by the pilot of the DH89 (Figure 3).

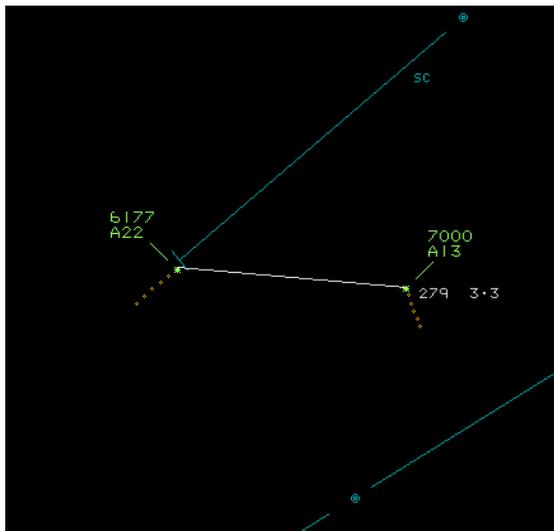
Figure 4 – 0956:20

At 0956:20 the DH89 pilot reported passing 1300ft, advising that they would be going through the centreline very shortly (Figure 4).

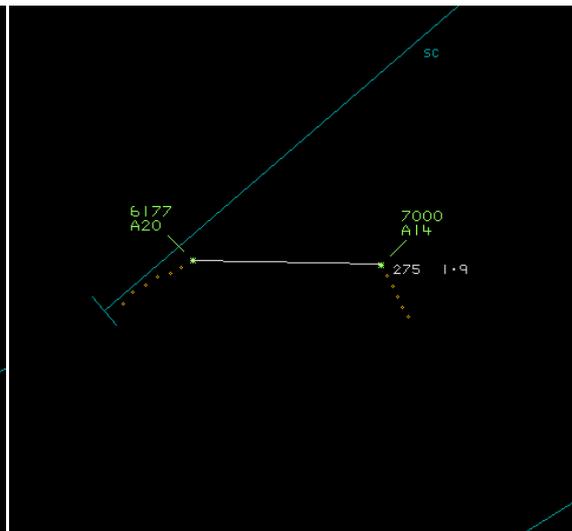
Figure 5 – 0956:50

At 0956:28 the controller requested a level check from the AC114, but received no reply. They repeated the request at 0956:40, and at 0956:50, the AC114 reported that they were leaving 2000ft in accordance with the procedure (Figure 5).

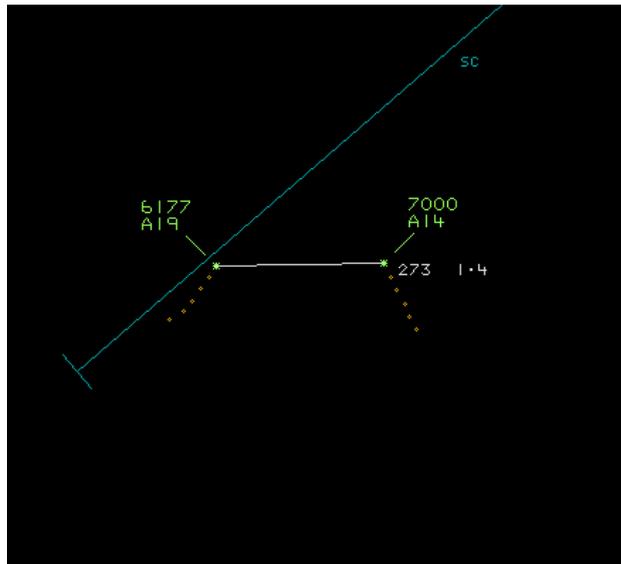
Figure 6 – 0957:08

Between 0956:55 and 0957:07 the controller was busy with another aircraft which had called them. At 0957:08 the controller passed Traffic Information to the DH89 on the AC114, advising that they believed the aircraft to be on a 3nm final descending from 2000ft (Figure 6).

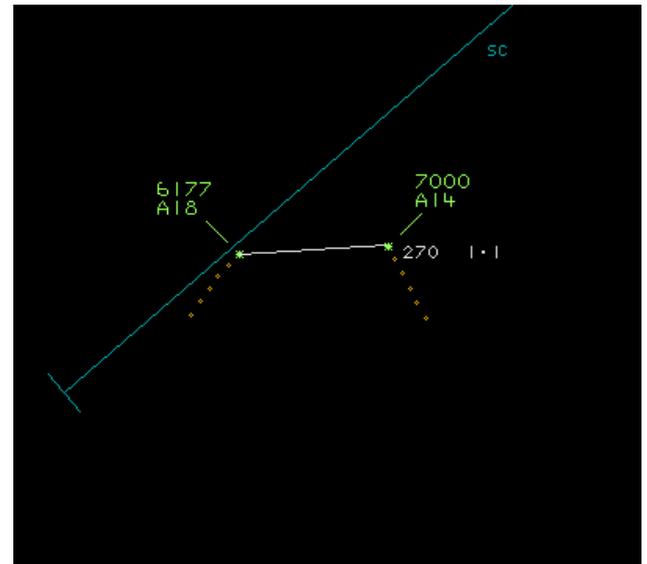
Figure 7 – 0957:15

At 0957:15 the DH89 pilot reported being at 1400ft and tracking around the edge of the city (Figure 7). The controller acknowledged this call and, at 0957:27, advised the AC114 that they had traffic crossing ahead at 1400ft to which they received no response (Figure 8).
